SUBJECT: FY18 Periodic Inspection, Flood Risk Management Project, Reno Beach-Howard Farms, Lucas County, Ohio (08/22/18)

Lake Erie – Reno Beach

FY 2018 PERIODIC INSPECTION REPORT

INSPECTED 22 AUGUST 2018

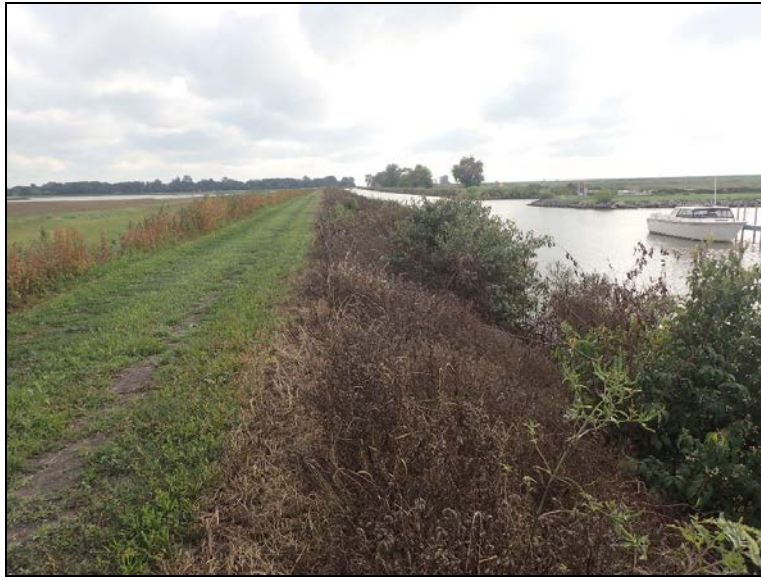
Inspect ID: OH29_2018_p_0002 **Title:** USACE_CELRB_OH29_2018_p_0002_1.jpg
Rated Item: 1. Unwanted Vegetation Growth **Caption:** Rating: Unacceptable; Remarks:
 Heavy unwanted vegetation and trees on landside and waterside slopes, crown is clear.;
 Action: Remove unwanted vegetation within the vegetation free zone (toe to toe).
 Perform regular maintenance to prevent further unwanted vegetation development.

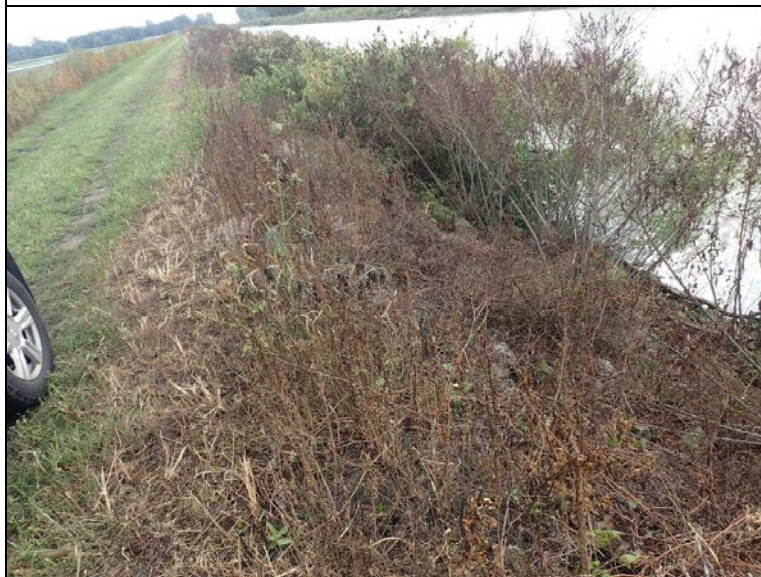
Inspect ID: OH29_2018_p_0002 **Title:** USACE_CELRB_OH29_2018_p_0002_2.jpg
Rated Item: 1. Unwanted Vegetation Growth **Caption:** Rating: Unacceptable; Remarks:
 Heavy unwanted vegetation and trees on landside and waterside slopes, crown is clear.;
 Action: Remove unwanted vegetation within the vegetation free zone (toe to toe).
 Perform regular maintenance to prevent further unwanted vegetation development.

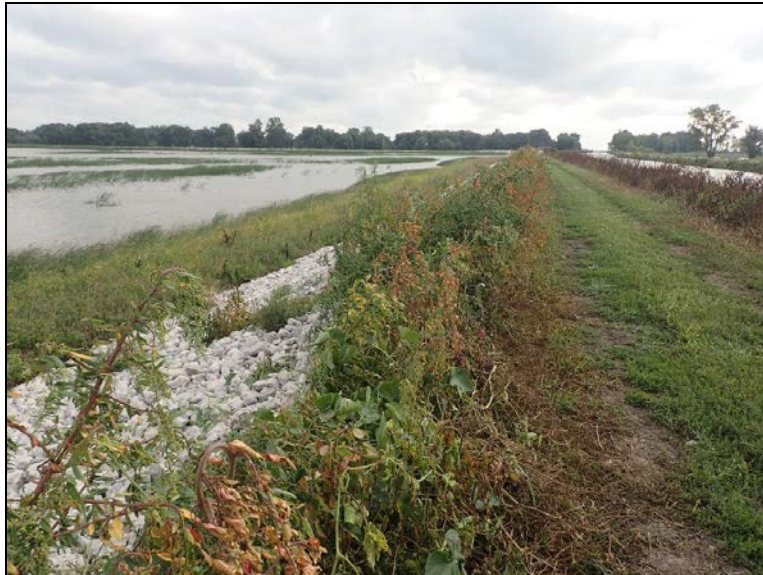
Inspect ID: OH29_2018_p_0002 **Title:** USACE_CELRB_OH29_2018_p_0002_3.jpg
Rated Item: 1. Unwanted Vegetation Growth **Caption:** Rating: Unacceptable; Remarks:
Heavy unwanted vegetation and trees on landside and waterside slopes, crown is clear.;
Action: Remove unwanted vegetation within the vegetation free zone (toe to toe).
Perform regular maintenance to prevent further unwanted vegetation development.

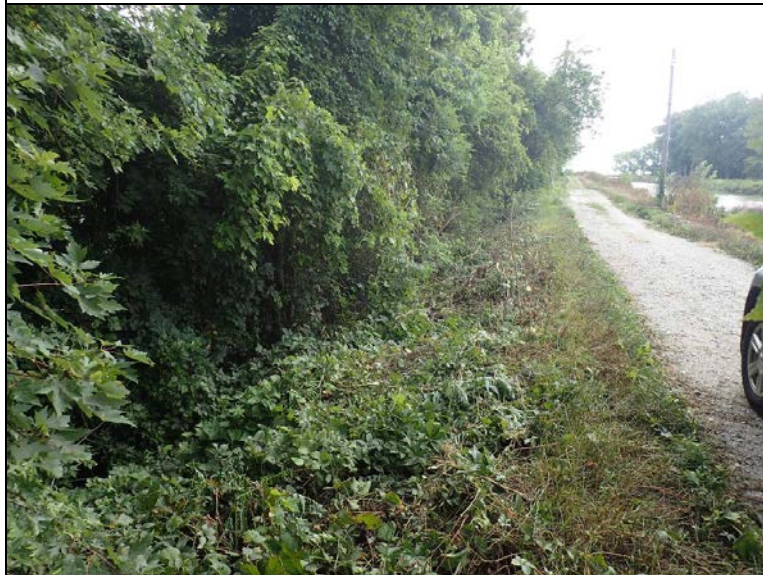
Inspect ID: OH29_2018_p_0010 **Title:** USACE_CELRB_OH29_2018_p_0010_1.jpg
Rated Item: 1. Unwanted Vegetation Growth **Caption:** Rating: Unacceptable; Remarks:
Significant unwanted vegetation and trees on landside and waterside.; Action: Remove
unwanted vegetation and trees.

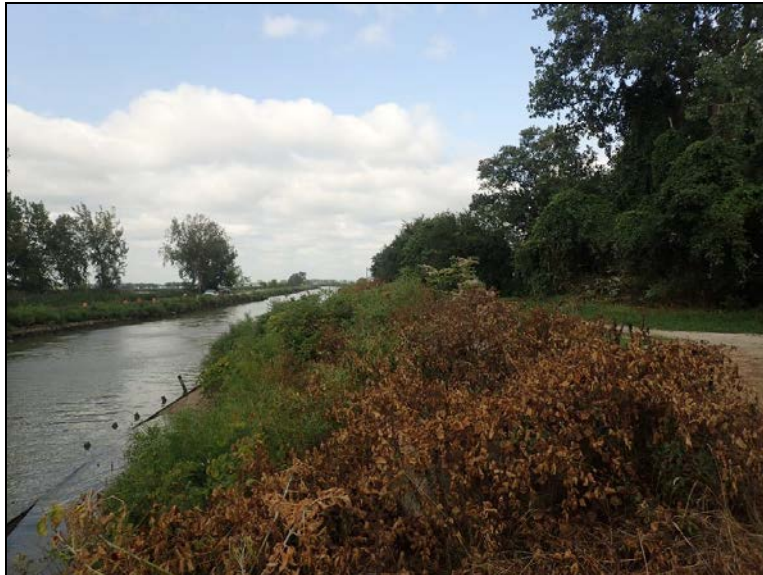
Inspect ID: OH29_2018_p_0010 **Title:** USACE_CELRB_OH29_2018_p_0010_2.jpg
Rated Item: 1. Unwanted Vegetation Growth **Caption:** Rating: Unacceptable; Remarks:
Significant unwanted vegetation and trees on landside and waterside.; Action: Remove
unwanted vegetation and trees.

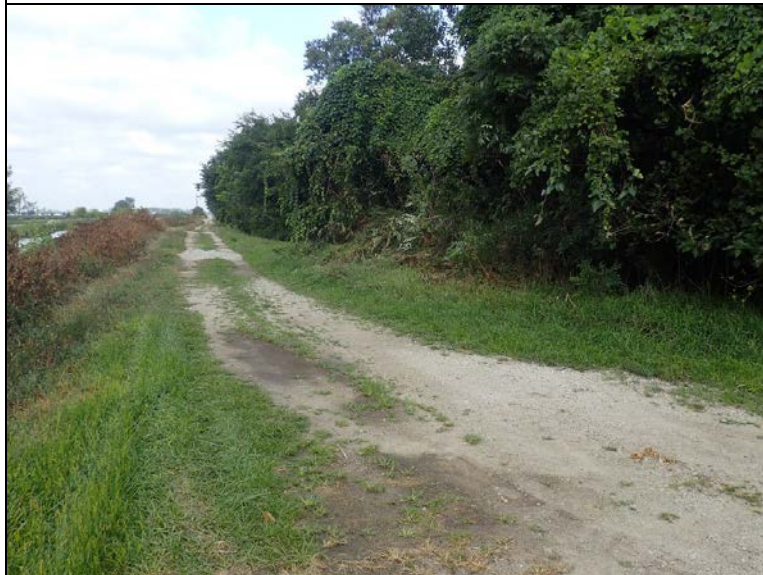
Inspect ID: OH29_2018_p_0010 **Title:** USACE_CELRB_OH29_2018_p_0010_3.jpg
Rated Item: 1. Unwanted Vegetation Growth **Caption:** Rating: Unacceptable; Remarks:
Significant unwanted vegetation and trees on landside and waterside.; Action: Remove
unwanted vegetation and trees.

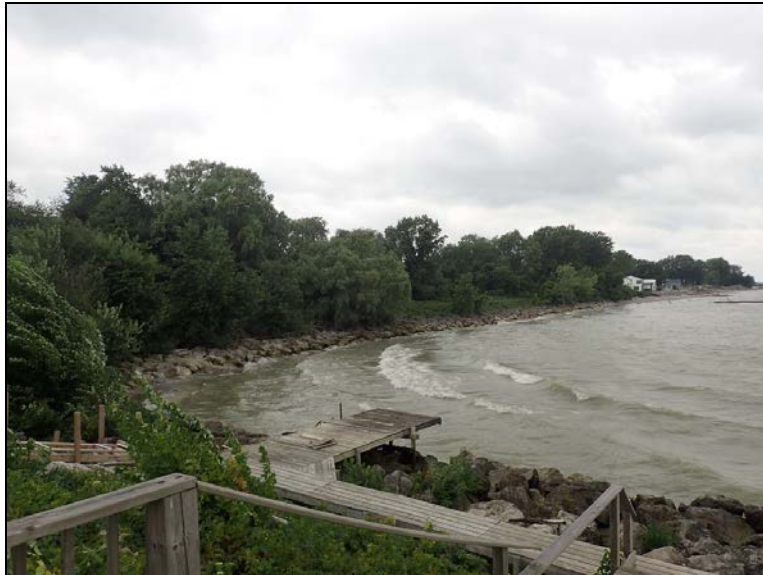
Inspect ID: OH29_2018_p_0030 **Title:** USACE_CELRB_OH29_2018_p_0030_1.jpg
Rated Item: 1. Unwanted Vegetation Growth **Caption:** Rating: Unacceptable; Remarks: Trees and heavy vegetation on crown and both slopes from west end of Lagoon Drive to La Course Drive.; Action: Remove trees and heavy vegetation from levee (toe to toe) and reestablish adequate sod cover. Perform regular maintenance to prevent further unwanted vegetation development.

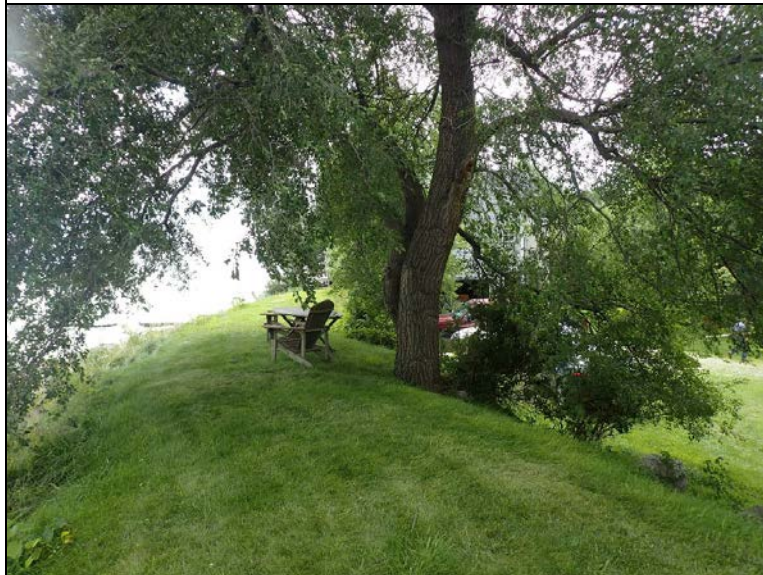
Inspect ID: OH29_2018_p_0038 **Title:** USACE_CELRB_OH29_2018_p_0038_1.jpg
Rated Item: 1. Unwanted Vegetation Growth **Caption:** Rating: Unacceptable; Remarks: Trees and unwanted vegetation on levee landside at residential home on Corduroy.; Action: Remove unwanted vegetation within the vegetation free zone (15 feet from the levee toe) and reestablish levee prism with adequate sod cover. Perform regular mowing to prevent further unwanted vegetation development.

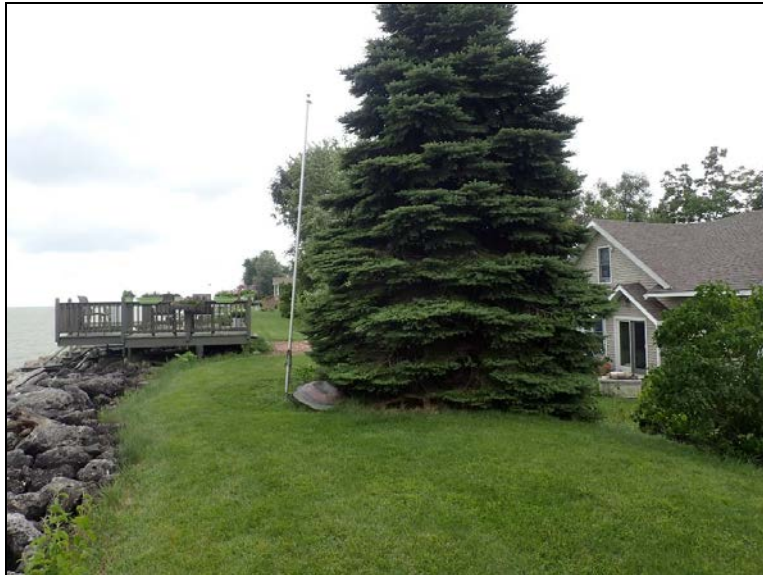
Inspect ID: OH29_2018_p_0054 **Title:** USACE_CELRB_OH29_2018_p_0054_1.jpg
Rated Item: 1. Unwanted Vegetation Growth **Caption:** Rating: Unacceptable; Remarks:
Large conifer tree on levee crown at west-most house on Dyke Road.; Action: Remove
tree within the vegetation free zone and reestablish adequate sod cover. Perform regular
mowing to prevent further unwanted vegetation development.

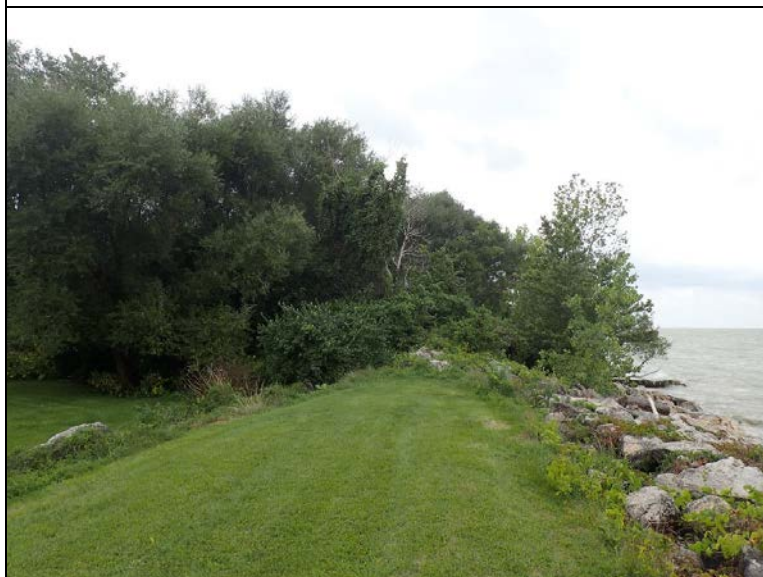
Inspect ID: OH29_2018_p_0055 **Title:** USACE_CELRB_OH29_2018_p_0055_1.jpg
Rated Item: 1. Unwanted Vegetation Growth **Caption:** Rating: Unacceptable; Remarks:
Significant trees and unwanted vegetation on both sideslopes and crown along Lakeway
Drive between Dyke Roads.; Action: Remove unwanted vegetation within the vegetation
free zone (toe to toe) and reestablish levee prism with adequate sod cover. Perform
regular mowing to prevent further unwanted vegetation development.

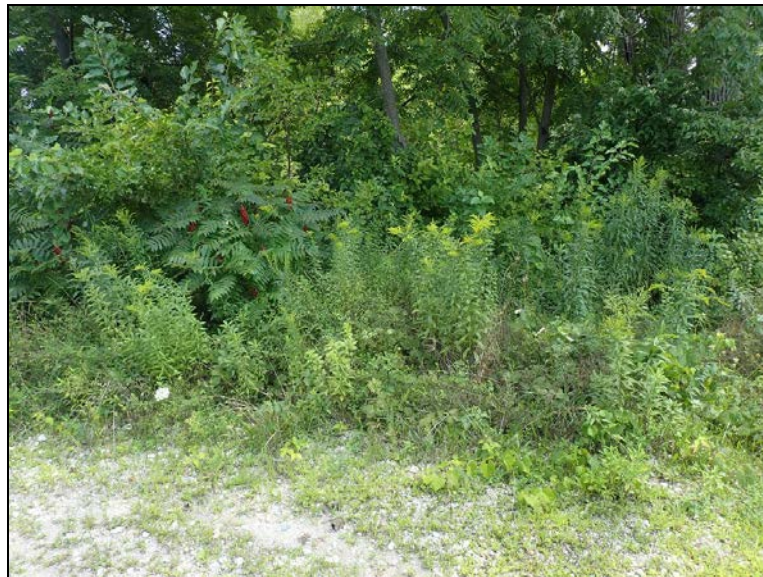
<p>Inspect ID: OH29_2018_p_0055 Title: USACE_CELRB_OH29_2018_p_0055_2.jpg Rated Item: 1. Unwanted Vegetation Growth Caption: Rating: Unacceptable; Remarks: Significant trees and unwanted vegetation on both sideslopes and crown along Lakeway Drive between Dyke Roads.; Action: Remove unwanted vegetation within the vegetation free zone (toe to toe) and reestablish levee prism with adequate sod cover. Perform regular mowing to prevent further unwanted vegetation development.</p>

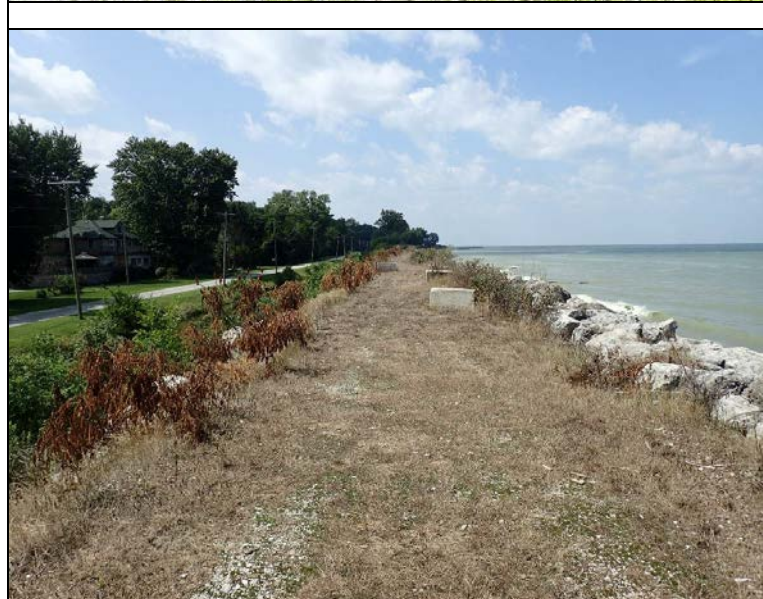
<p>Inspect ID: OH29_2018_p_0055 Title: USACE_CELRB_OH29_2018_p_0055_3.jpg Rated Item: 1. Unwanted Vegetation Growth Caption: Rating: Unacceptable; Remarks: Significant trees and unwanted vegetation on both sideslopes and crown along Lakeway Drive between Dyke Roads.; Action: Remove unwanted vegetation within the vegetation free zone (toe to toe) and reestablish levee prism with adequate sod cover. Perform regular mowing to prevent further unwanted vegetation development.</p>

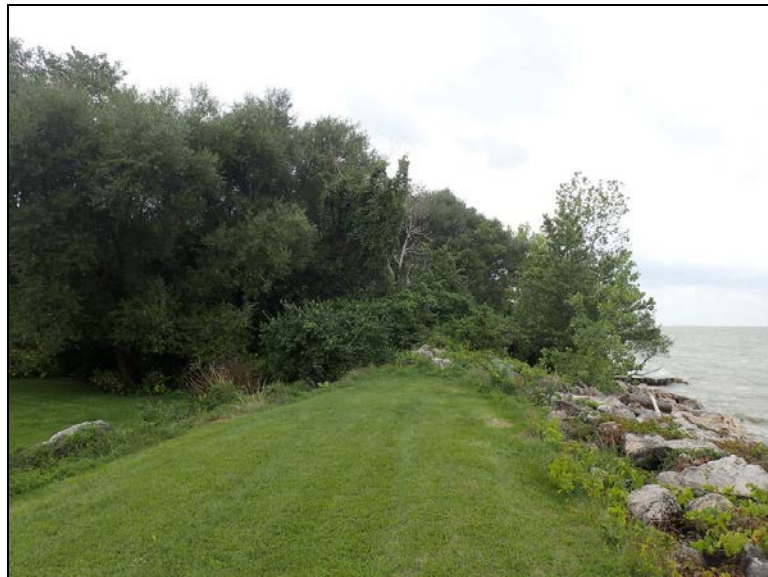
<p>Inspect ID: OH29_2018_p_0056 Title: USACE_CELRB_OH29_2018_p_0056_1.jpg Rated Item: 1. Unwanted Vegetation Growth Caption: Rating: Unacceptable; Remarks: Levee inaccessible from west end of Dyke Road to Lakeway Drive.; Action: Remove vegetation and encroachments to provide a clear path for operations and maintenance, inspection, emergency patrols, and flood-fighting.</p>

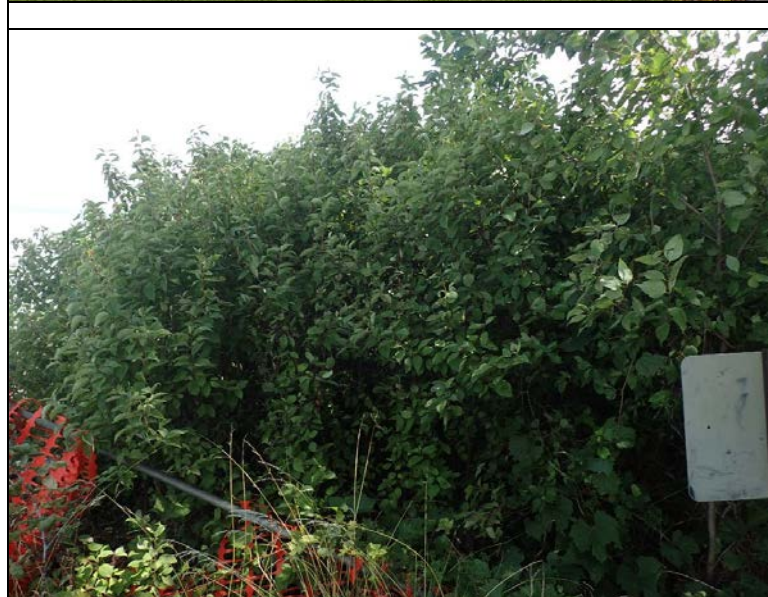
<p>Inspect ID: OH29_2018_p_0069 Title: USACE_CELRB_OH29_2018_p_0069_1.jpg Rated Item: 1. Unwanted Vegetation Growth Caption: Rating: Unacceptable; Remarks: Levee inaccessible at west end of Dyke Road due to heavy vegetation and trees.; Action: Remove vegetation and encroachments to provide a clear path for operations and maintenance, inspection, emergency patrols, and flood-fighting.</p>

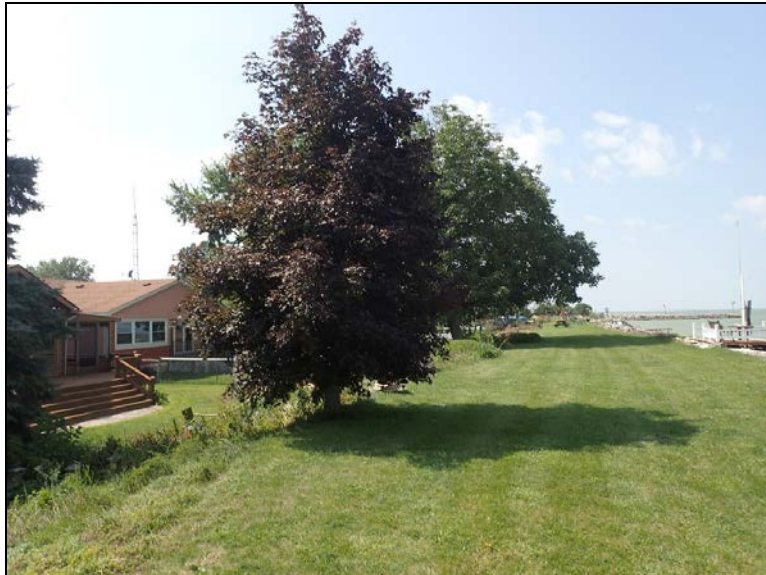
<p>Inspect ID: OH29_2018_p_0071 Title: USACE_CELRB_OH29_2018_p_0071_7.jpg Rated Item: 1. Unwanted Vegetation Growth Caption: Rating: Unacceptable; Remarks: Significant trees, unwanted vegetation, and gardens on levee landside slope along Dyke Road.; Action: Remove unwanted vegetation within the vegetation free zone and reestablish levee prism with adequate sod cover. Perform regular mowing to prevent further unwanted vegetation development.</p>

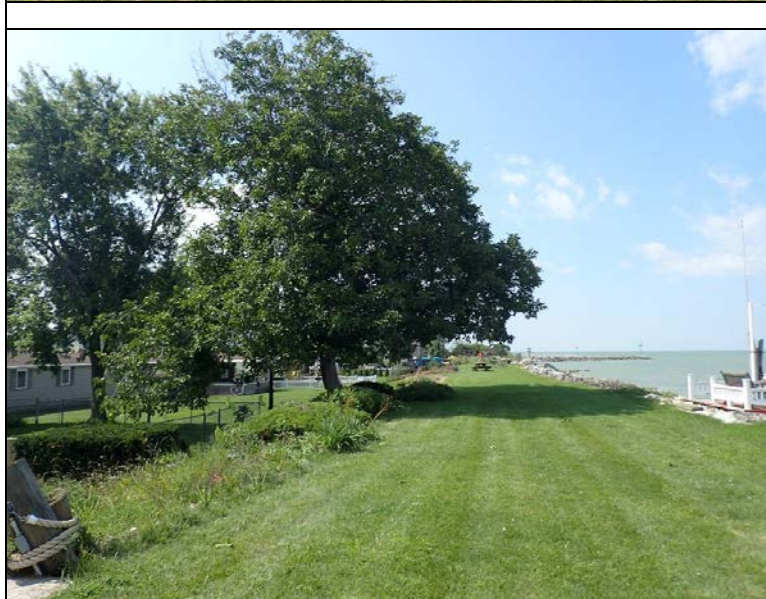
<p>Inspect ID: OH29_2018_p_0071 Title: USACE_CELRB_OH29_2018_p_0071_8.jpg Rated Item: 1. Unwanted Vegetation Growth Caption: Rating: Unacceptable; Remarks: Significant trees, unwanted vegetation, and gardens on levee landside slope along Dyke Road.; Action: Remove unwanted vegetation within the vegetation free zone and reestablish levee prism with adequate sod cover. Perform regular mowing to prevent further unwanted vegetation development.</p>

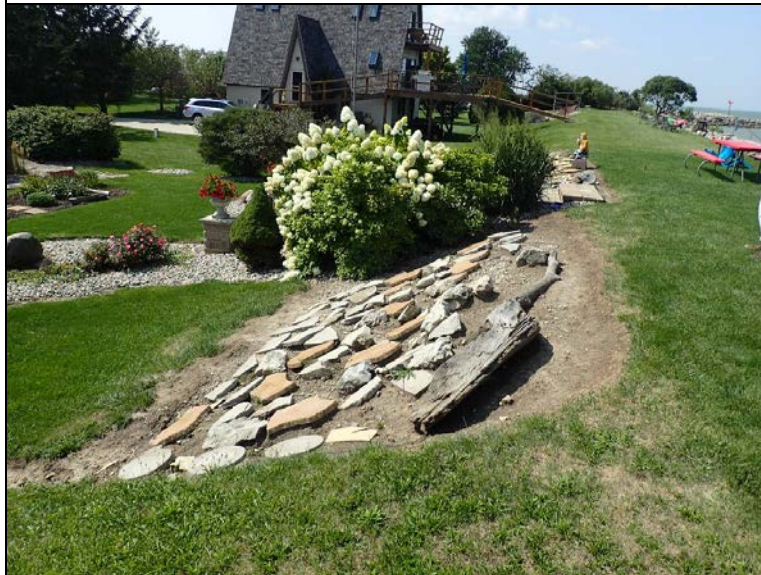
Inspect ID: OH29_2018_p_0106 **Title:** USACE_CELRB_OH29_2018_p_0106_1.jpg
Rated Item: 2. Sod Cover **Caption:** Rating: Unacceptable; Remarks: Inadequate sod cover on levee landside slope due to unauthorized alterations and unwanted vegetation.; Action: Remove unauthorized alterations and unwanted vegetation. Repair sod cover and maintain in accordance with USACE requirements.

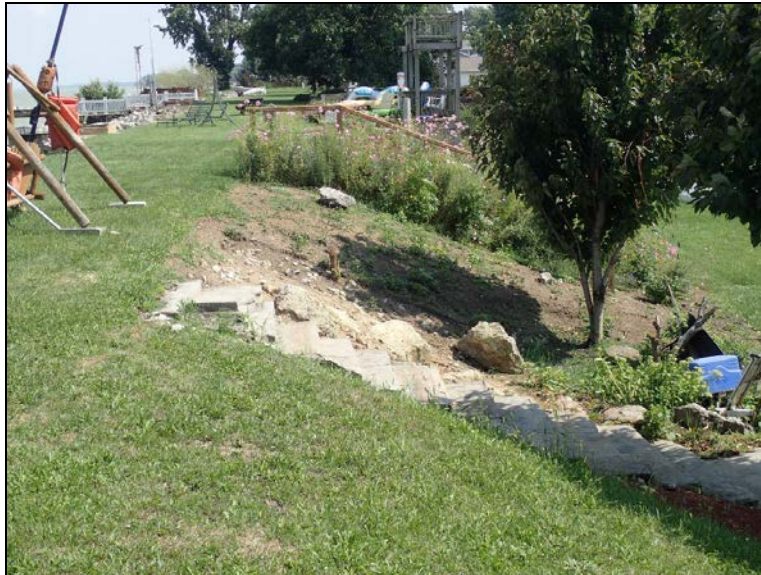
Inspect ID: OH29_2018_p_0106 **Title:** USACE_CELRB_OH29_2018_p_0106_2.jpg
Rated Item: 2. Sod Cover **Caption:** Rating: Unacceptable; Remarks: Inadequate sod cover on levee landside slope due to unauthorized alterations and unwanted vegetation.; Action: Remove unauthorized alterations and unwanted vegetation. Repair sod cover and maintain in accordance with USACE requirements.

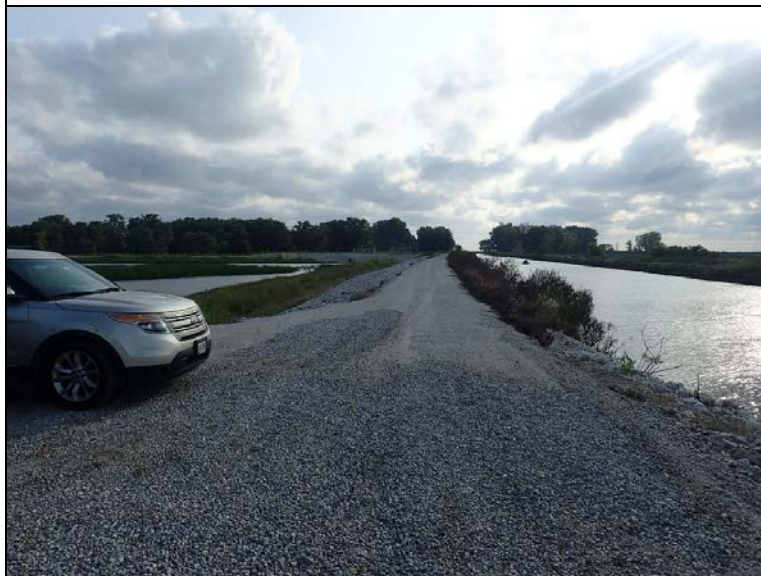
Inspect ID: OH29_2018_p_0001 **Title:** USACE_CELRB_OH29_2018_p_0001_1.jpg
Rated Item: 3. Encroachments **Caption:** Rating: Minimally Acceptable; Remarks: Toledo Metropark Alteration includes sub-agreement for transfer of maintenance on crown and landside slope of Wards Canal levee from Conservancy District to Metroparks. Requires inspection and guidance from USACE.; Action: Coordinate sub-agreement for O&M of Wards Canal levee with USACE.

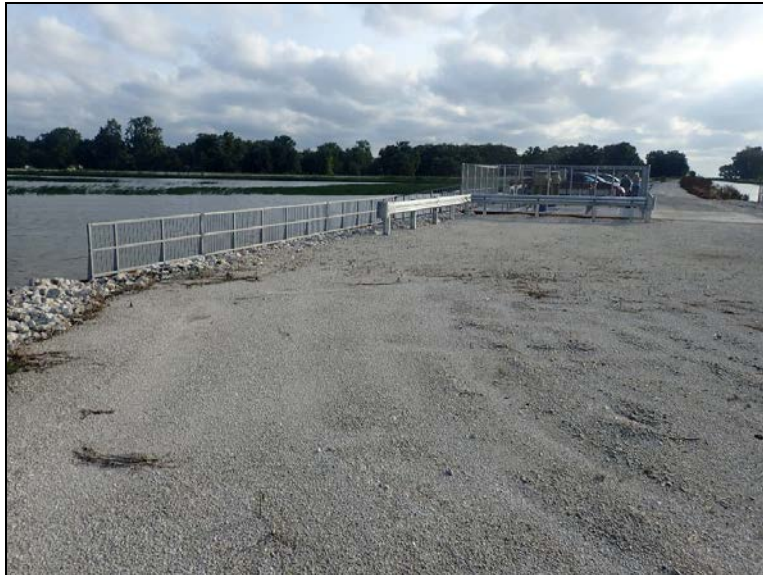
Inspect ID: OH29_2018_p_0001 **Title:** USACE_CELRB_OH29_2018_p_0001_6.jpg
Rated Item: 3. Encroachments **Caption:** Rating: Minimally Acceptable; Remarks:
 Toledo Metropark Alteration includes sub-agreement for transfer of maintenance on
 crown and landside slope of Wards Canal levee from Conservancy District to Metroparks.
 Requires inspection and guidance from USACE.; Action: Coordinate sub-agreement for
 O&M of Wards Canal levee with USACE.

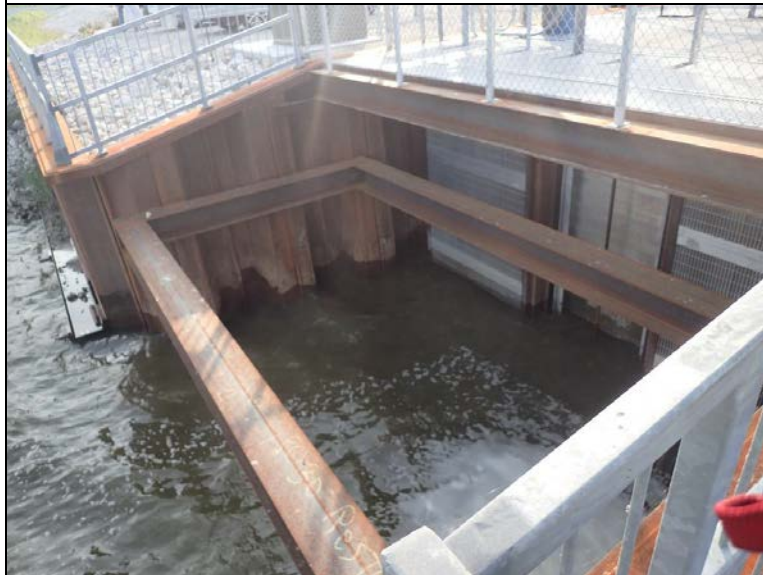
Inspect ID: OH29_2018_p_0001 **Title:** USACE_CELRB_OH29_2018_p_0001_7.jpg
Rated Item: 3. Encroachments **Caption:** Rating: Minimally Acceptable; Remarks:
 Toledo Metropark Alteration includes sub-agreement for transfer of maintenance on
 crown and landside slope of Wards Canal levee from Conservancy District to Metroparks.
 Requires inspection and guidance from USACE.; Action: Coordinate sub-agreement for
 O&M of Wards Canal levee with USACE.

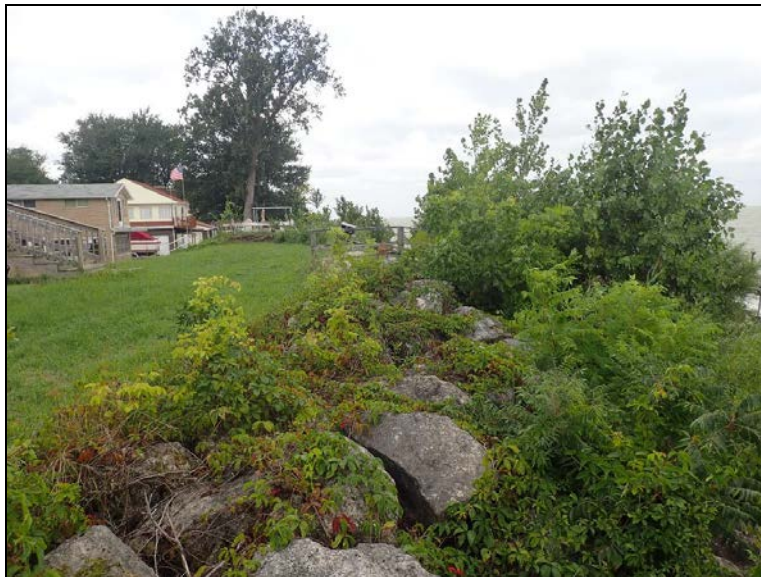
Inspect ID: OH29_2018_p_0013 **Title:** USACE_CELRB_OH29_2018_p_0013_1.jpg
Rated Item: 3. Encroachments **Caption:** Rating: Minimally Acceptable; Remarks:
Encroachments on both slopes and crown along Lagoon Drive. Examples include: decks,
docks, stairs, retaining walls, wooden and brick walkways, and a patio.; Action: Submit
Section 408 Alteration Request to USACE or remove encroachments.

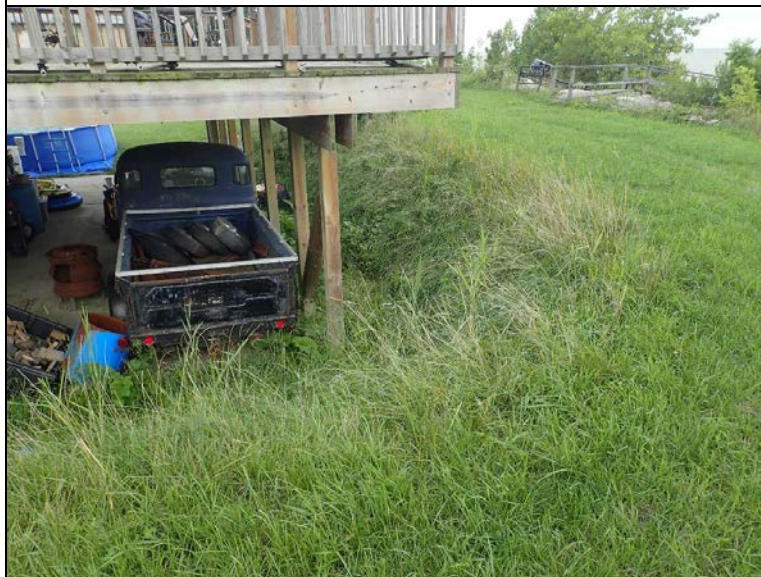
Inspect ID: OH29_2018_p_0013 **Title:** USACE_CELRB_OH29_2018_p_0013_2.jpg
Rated Item: 3. Encroachments **Caption:** Rating: Minimally Acceptable; Remarks:
Encroachments on both slopes and crown along Lagoon Drive. Examples include: decks,
docks, stairs, retaining walls, wooden and brick walkways, and a patio.; Action: Submit
Section 408 Alteration Request to USACE or remove encroachments.

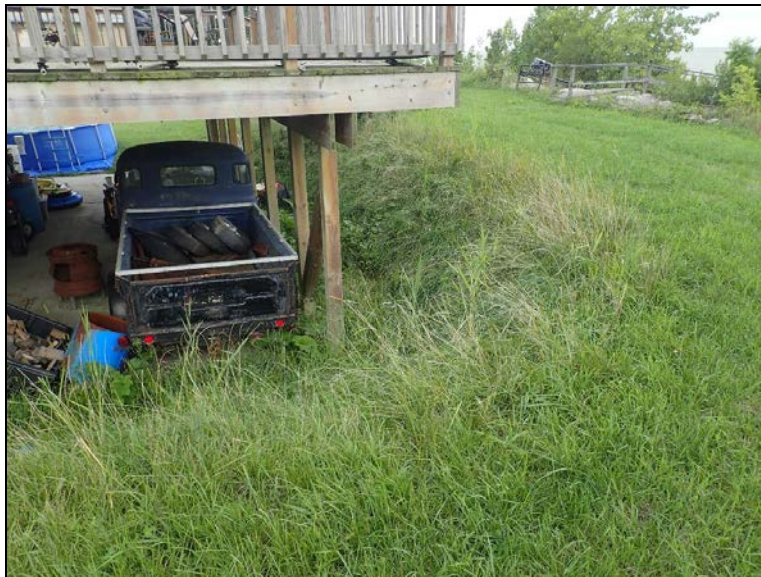
Inspect ID: OH29_2018_p_0014 **Title:** USACE_CELRB_OH29_2018_p_0014_1.jpg
Rated Item: 3. Encroachments **Caption:** Rating: Acceptable; Remarks: 12763 Lagoon Drive levee repair of toe and slope deemed acceptable by USACE per FY17 RI Report.; Action: NA

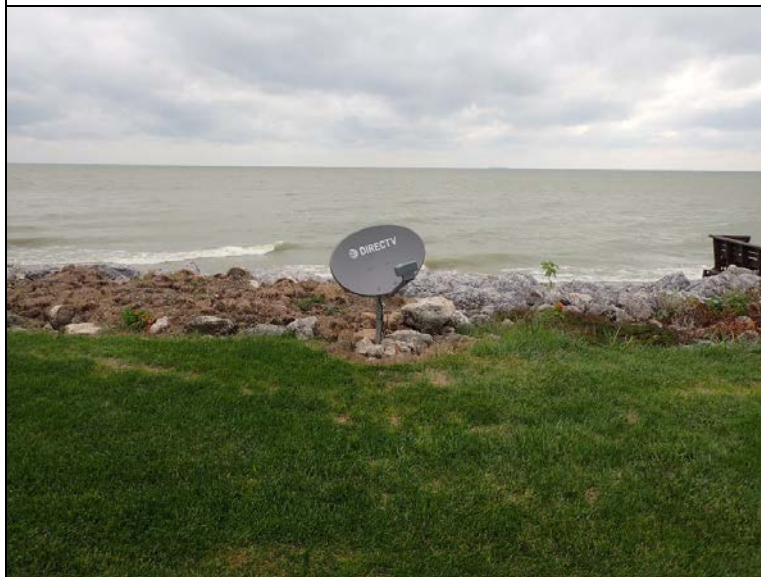
Inspect ID: OH29_2018_p_0024 **Title:** USACE_CELRB_OH29_2018_p_0024_1.jpg
Rated Item: 3. Encroachments **Caption:** Rating: Minimally Acceptable; Remarks: Unauthorized alteration - satellite dish encroachment w conduit running through levee crown.; Action: Submit Section 408 Alteration Request to USACE or remove encroachment.

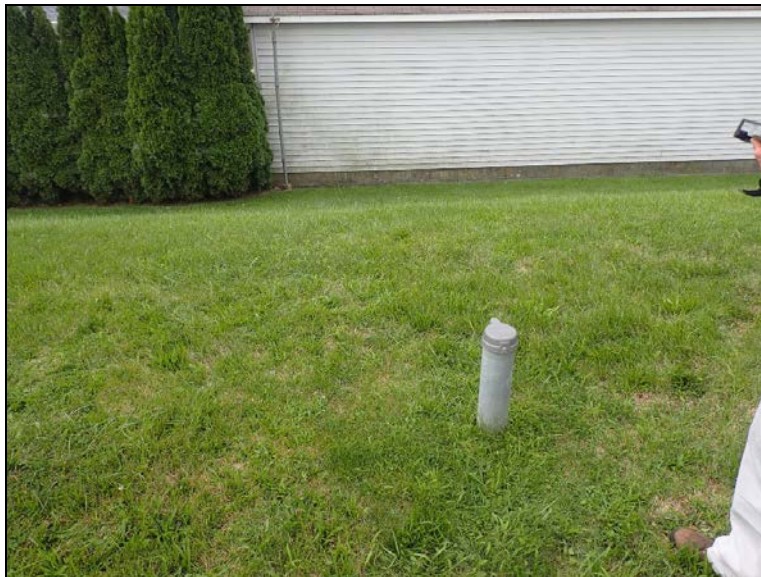
Inspect ID: OH29_2018_p_0033 **Title:** USACE_CELRB_OH29_2018_p_0033_2.jpg
Rated Item: 3. Encroachments **Caption:** Rating: Minimally Acceptable; Remarks: Unauthorized alteration - encroachments on both slopes and crown along La Course Drive.; Action: Submit Section 408 Alteration Request to USACE or remove encroachments.

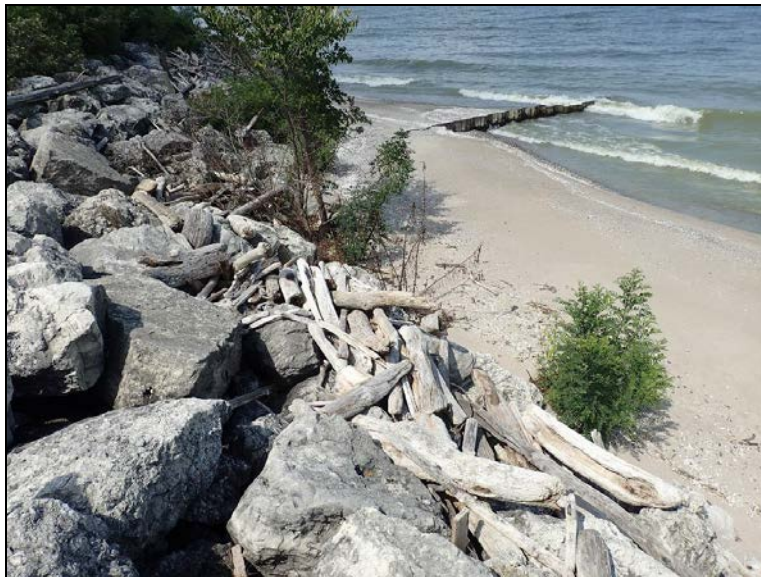
Inspect ID: OH29_2018_p_0061 **Title:** USACE_CELRB_OH29_2018_p_0061_1.jpg
Rated Item: 3. Encroachments **Caption:** Rating: Minimally Acceptable; Remarks:
 Debris on riprap at east-most property on Dyke Road.; Action: Remove debris.

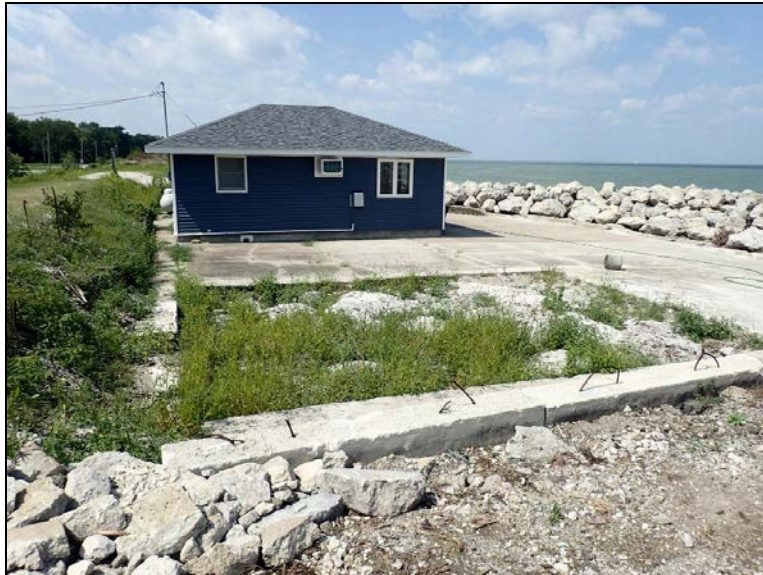
Inspect ID: OH29_2018_p_0065 **Title:** USACE_CELRB_OH29_2018_p_0065_1.jpg
Rated Item: 3. Encroachments **Caption:** Rating: Acceptable; Remarks: Pre-project cottages along Lakeway Drive at end of Waterway Road; one remains, one removed (foundation remains).; Action: NA

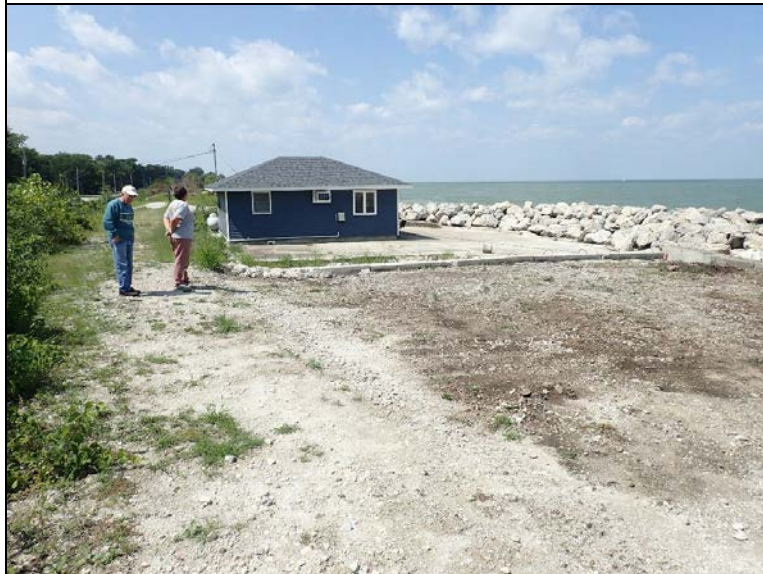
Inspect ID: OH29_2018_p_0065 **Title:** USACE_CELRB_OH29_2018_p_0065_2.jpg
Rated Item: 3. Encroachments **Caption:** Rating: Acceptable; Remarks: Pre-project cottages along Lakeway Drive at end of Waterway Road; one remains, one removed (foundation remains).; Action: NA

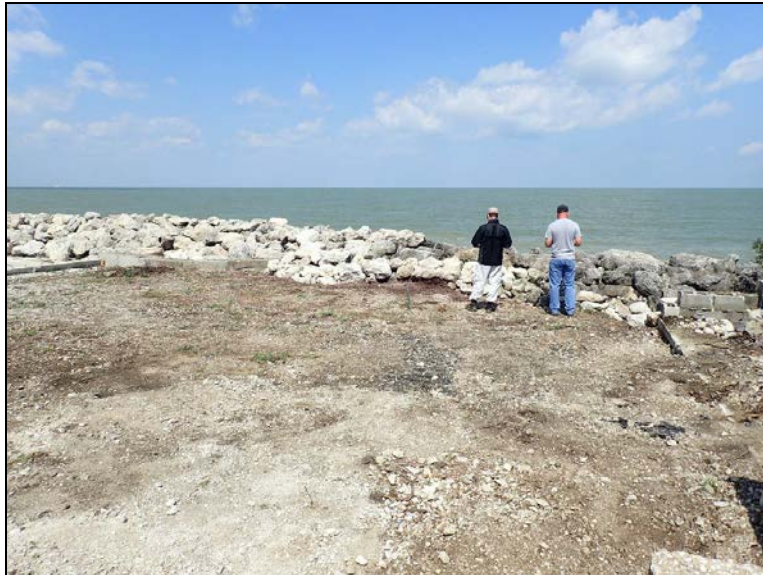
Inspect ID: OH29_2018_p_0065 **Title:** USACE_CELRB_OH29_2018_p_0065_3.jpg
Rated Item: 3. Encroachments **Caption:** Rating: Acceptable; Remarks: Pre-project cottages along Lakeway Drive at end of Waterway Road; one remains, one removed (foundation remains).; Action: NA

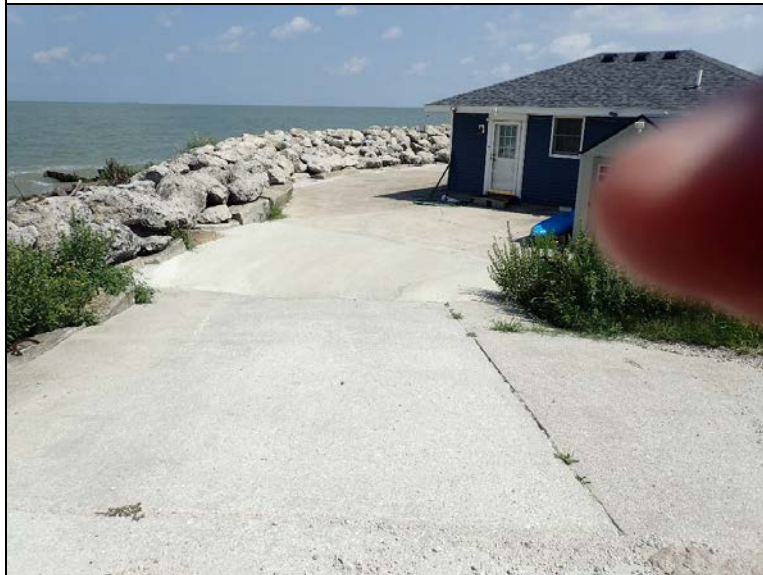
Inspect ID: OH29_2018_p_0065 **Title:** USACE_CELRB_OH29_2018_p_0065_4.jpg
Rated Item: 3. Encroachments **Caption:** Rating: Acceptable; Remarks: Pre-project cottages along Lakeway Drive at end of Waterway Road; one remains, one removed (foundation remains).; Action: NA

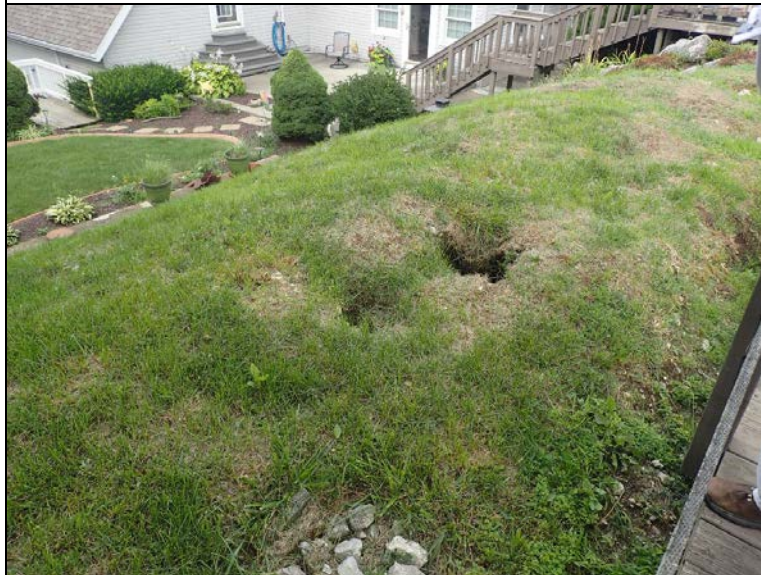
Inspect ID: OH29_2018_p_0020 **Title:** USACE_CELRB_OH29_2018_p_0020_1.jpg
Rated Item: 7. Settlement **Caption:** Rating: Minimally Acceptable; Remarks: Crown settling into levee and sporadic holes near transition from stone levee to soil levee 750' west of Wards Canal along Lagoon Drive.; Action: Repair settlement and fill holes with suitable material using compaction methods according to original plans and specifications.

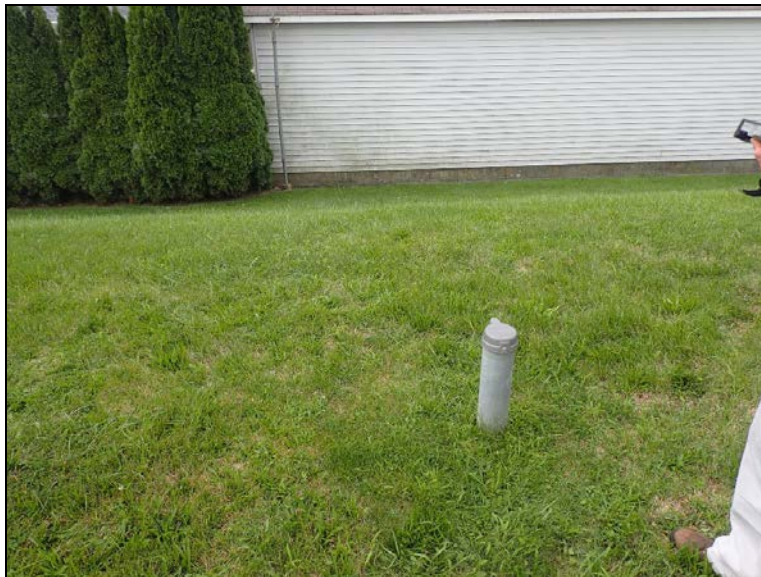
Inspect ID: OH29_2018_p_0036 **Title:** USACE_CELRB_OH29_2018_p_0036_1.jpg
Rated Item: 7. Settlement **Caption:** Rating: Minimally Acceptable; Remarks: Minor 2" settlement ring with 5' radius around well standpipe encroachment on crown.; Action: Repair settlement.

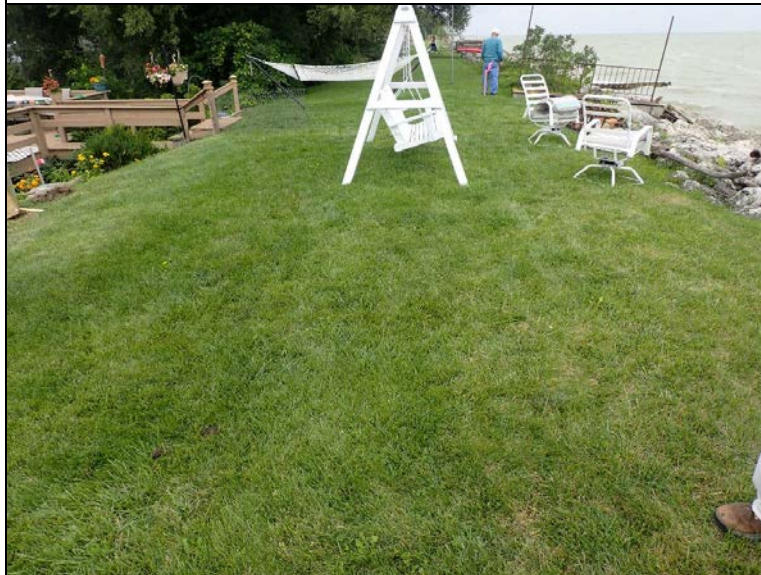
Inspect ID: OH29_2018_p_0048 **Title:** USACE_CELRB_OH29_2018_p_0048_1.jpg
Rated Item: 8. Depressions/ Rutting **Caption:** Rating: Minimally Acceptable; Remarks: Minor 6" depression on crown with 3'-4' circumference 650' west of Dyke Road Pump Station.; Action: Repair depression.

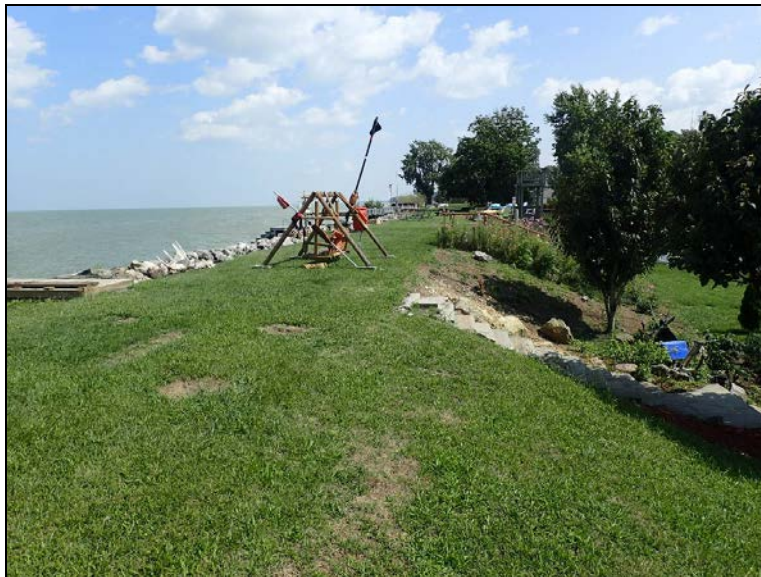
Inspect ID: OH29_2018_p_0086 **Title:** USACE_CELRB_OH29_2018_p_0086_1.jpg
Rated Item: 8. Depressions/ Rutting **Caption:** Rating: Minimally Acceptable; Remarks:
Minor depression on levee crown across from Riceland Road.; Action: Fill depression.

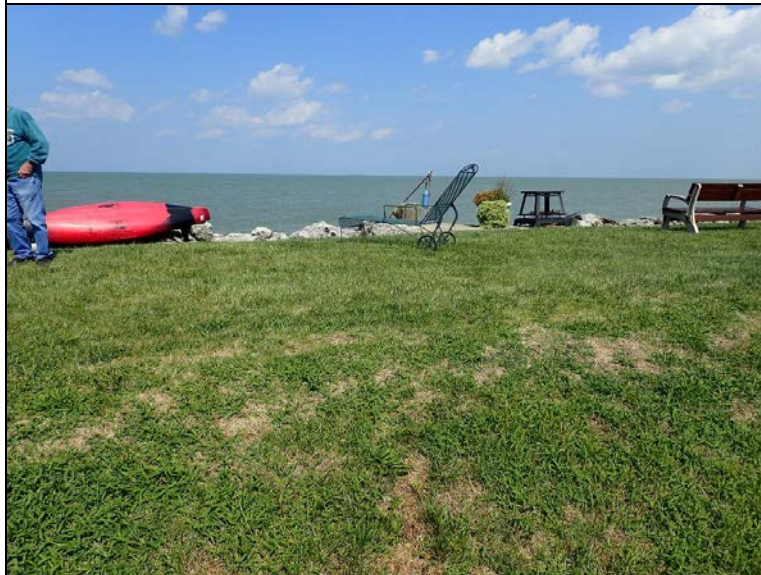
Inspect ID: OH29_2018_p_0090 **Title:** USACE_CELRB_OH29_2018_p_0090_1.jpg
Rated Item: 8. Depressions/ Rutting **Caption:** Rating: Minimally Acceptable; Remarks:
Minor depression in levee crown 300' east of Cooley Canal.; Action: Repair depression.

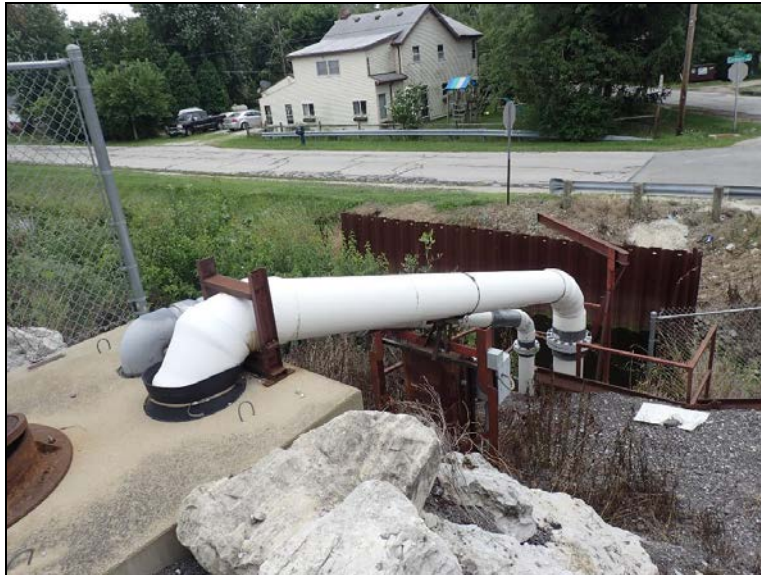
Inspect ID: OH29_2018_p_0107 **Title:** USACE_CELRB_OH29_2018_p_0107_1.jpg
Rated Item: 11. Culverts/ Discharge Pipes (This item includes both concrete and corrugated metal pipes.) **Caption:** Rating: Unacceptable; Remarks: Drainage ditch pump station discharge at intersection of Dyke Road and Corduroy penetrates through the levee system and has not been videotape inspected within last 5-years.; Action: Videotape inspect condition of discharge pipe and submit, with engineering evaluation and ratings, to USACE.

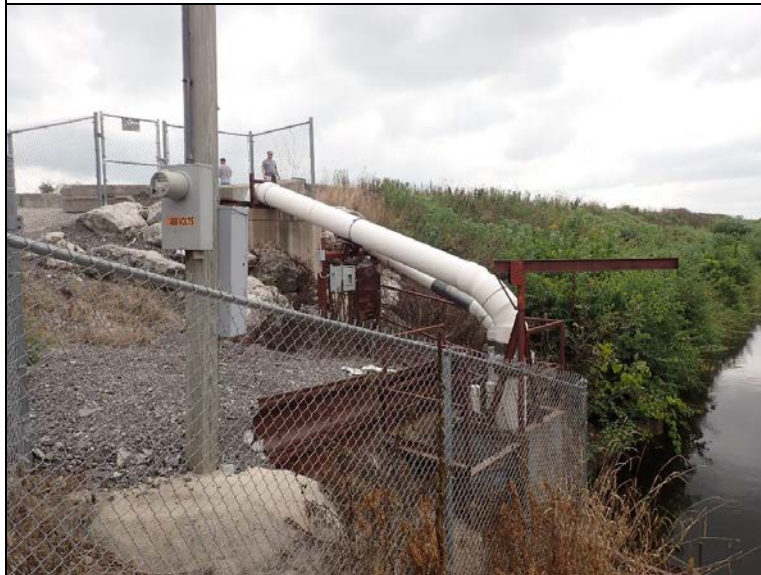
Inspect ID: OH29_2018_p_0107 **Title:** USACE_CELRB_OH29_2018_p_0107_2.jpg
Rated Item: 11. Culverts/ Discharge Pipes (This item includes both concrete and corrugated metal pipes.) **Caption:** Rating: Unacceptable; Remarks: Drainage ditch pump station discharge at intersection of Dyke Road and Corduroy penetrates through the levee system and has not been videotape inspected within last 5-years.; Action: Videotape inspect condition of discharge pipe and submit, with engineering evaluation and ratings, to USACE.

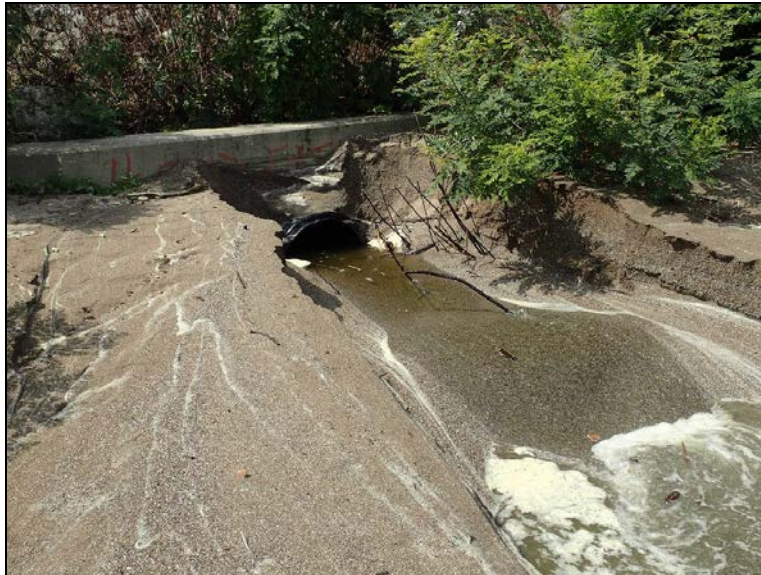
Inspect ID: OH29_2018_p_0107 **Title:** USACE_CELRB_OH29_2018_p_0107_3.jpg
Rated Item: 11. Culverts/ Discharge Pipes (This item includes both concrete and corrugated metal pipes.) **Caption:** Rating: Unacceptable; Remarks: Drainage ditch pump station discharge at intersection of Dyke Road and Corduroy penetrates through the levee system and has not been videotape inspected within last 5-years.; Action: Videotape inspect condition of discharge pipe and submit, with engineering evaluation and ratings, to USACE.

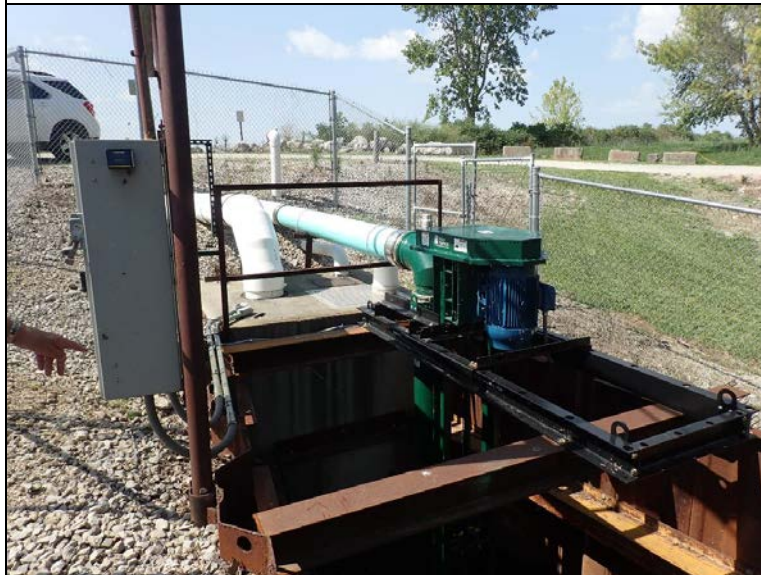
Inspect ID: OH29_2018_p_0108 **Title:** USACE_CELRB_OH29_2018_p_0108_1.jpg
Rated Item: 11. Culverts/ Discharge Pipes (This item includes both concrete and corrugated metal pipes.) **Caption:** Rating: Unacceptable; Remarks: Drainage ditch pump station discharge to Cooley Canal penetrates through the levee system and has not been videotape inspected within last 5-years.; Action: Videotape inspect condition of discharge pipe and submit, with engineering evaluation and ratings, to USACE.

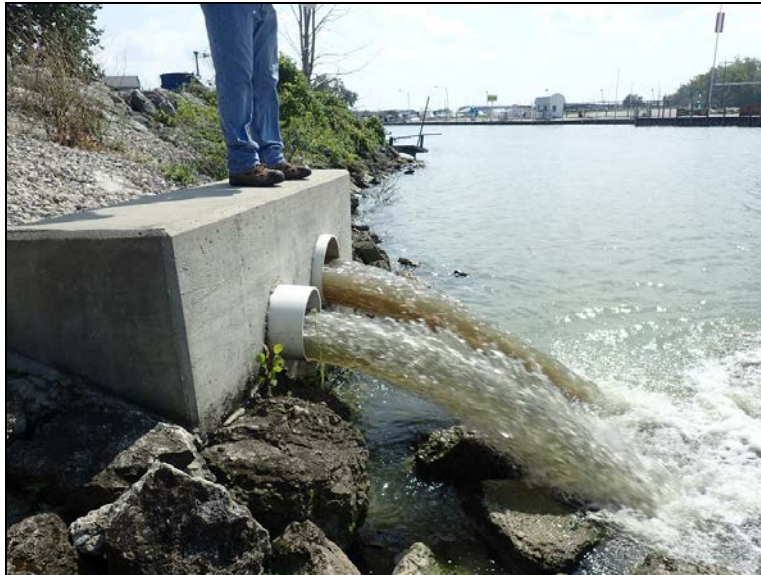
Inspect ID: OH29_2018_p_0108 **Title:** USACE_CELRB_OH29_2018_p_0108_2.jpg
Rated Item: 11. Culverts/ Discharge Pipes (This item includes both concrete and corrugated metal pipes.) **Caption:** Rating: Unacceptable; Remarks: Drainage ditch pump station discharge to Cooley Canal penetrates through the levee system and has not been videotape inspected within last 5-years.; Action: Videotape inspect condition of discharge pipe and submit, with engineering evaluation and ratings, to USACE.
