SUBJECT: FY18 Periodic Inspection, Flood Risk Management Project, Reno Beach-Howard Farms, Lucas County, Ohio (08/22/18)

Lake Erie – Reno Beach

FY 2018 PERIODIC INSPECTION REPORT

INSPECTED 22 AUGUST 2018

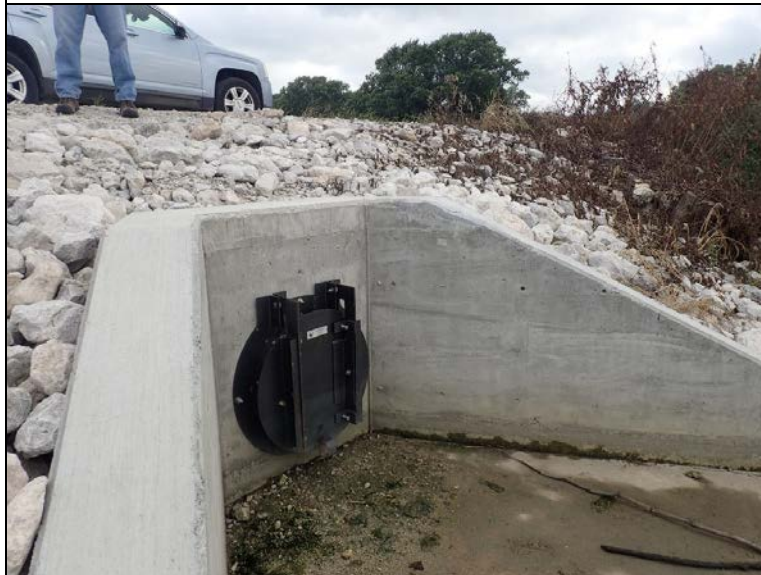
Inspect ID: OH29_2018_p_0109 **Title:** USACE_CELRB_OH29_2018_p_0109_1.jpg
Rated Item: 11. Culverts/ Discharge Pipes (This item includes both concrete and corrugated metal pipes.) **Caption:** Rating: Acceptable; Remarks: Toledo Metropark Alteration pump station discharge pipe to Wards Canal penetrates through the levee system. Therefore, it will require videotape inspection every 5-years.; Action: NA

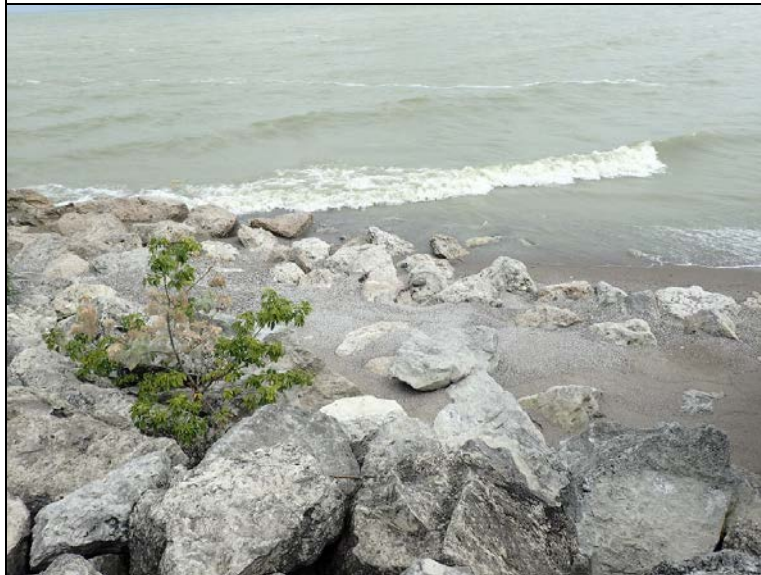
Inspect ID: OH29_2018_p_0044 **Title:** USACE_CELRB_OH29_2018_p_0044_1.jpg
Rated Item: 12. Riprap Revetments & Bank Protection **Caption:** Rating: Unacceptable; Remarks: Missing 150' of underlayer and armor stone along top of waterside slope east of Corduroy.; Action: Replace missing stone.

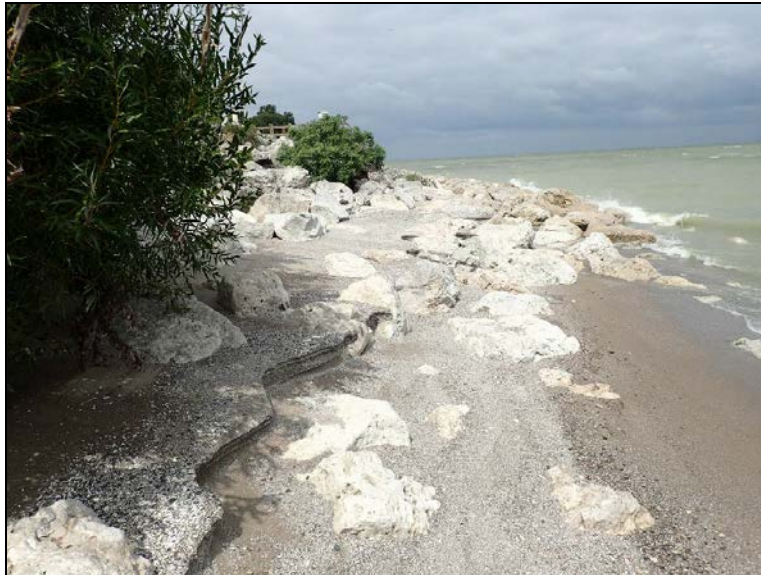
Inspect ID: OH29_2018_p_0044 **Title:** USACE_CELRB_OH29_2018_p_0044_2.jpg
Rated Item: 12. Riprap Revetments & Bank Protection **Caption:** Rating: Unacceptable;
Remarks: Missing 150' of underlayer and armor stone along top of waterside slope east of
Corduroy.; **Action:** Replace missing stone.

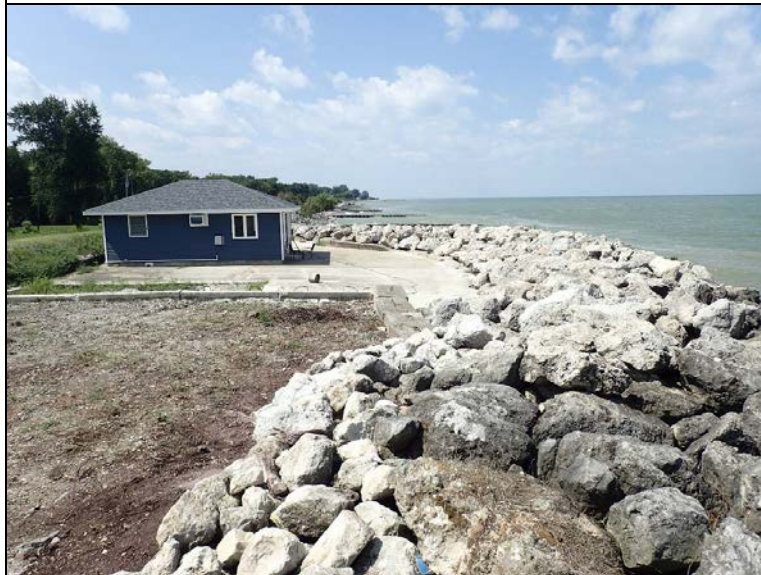
Inspect ID: OH29_2018_p_0066 **Title:** USACE_CELRB_OH29_2018_p_0066_1.jpg
Rated Item: 12. Riprap Revetments & Bank Protection **Caption:** Rating: Acceptable;
Remarks: Stone revetment recharged and potentially raised to a higher elevation of
protection round cottage on levee crown at Lakeway Drive, considered acceptable
maintenance.; **Action:** NA

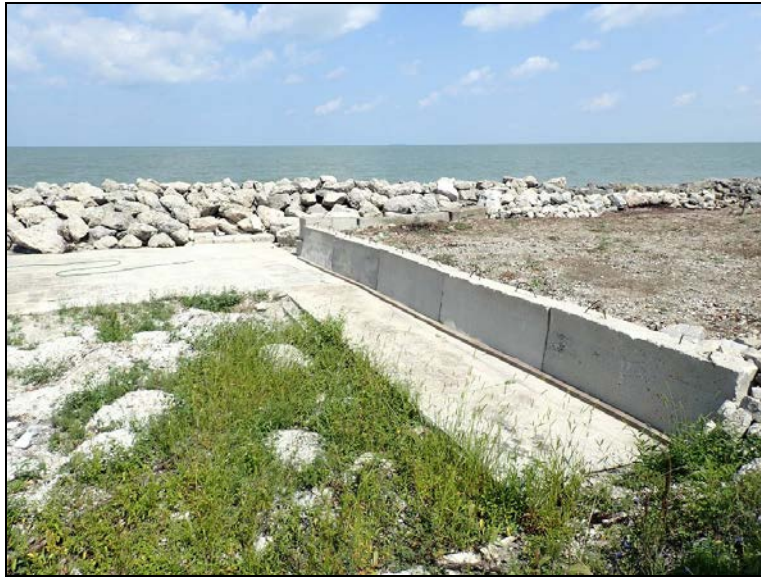
Inspect ID: OH29_2018_p_0066 **Title:** USACE_CELRB_OH29_2018_p_0066_2.jpg
Rated Item: 12. Riprap Revetments & Bank Protection **Caption:** Rating: Acceptable;
Remarks: Stone revetment recharged and potentially raised to a higher elevation of protection round cottage on levee crown at Lakeway Drive, considered acceptable maintenance.; **Action:** NA

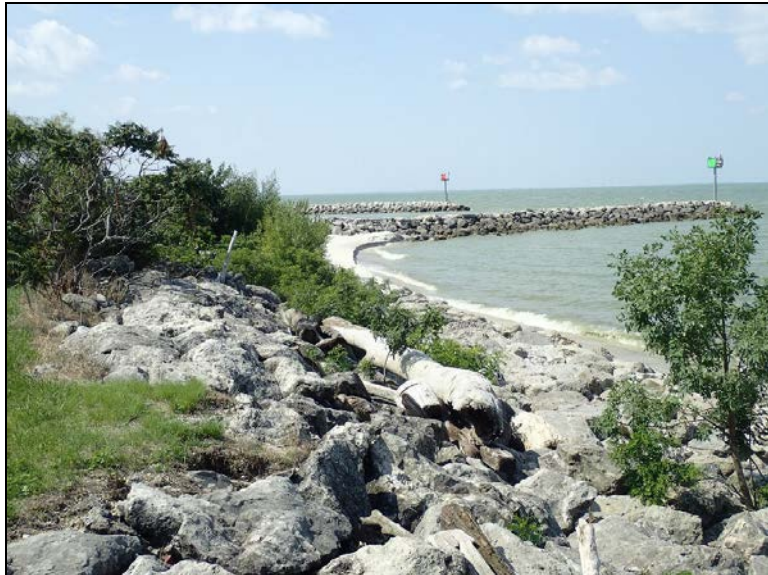
<p>Inspect ID: OH29_2018_p_0093 Title: USACE_CELRB_OH29_2018_p_0093_1.jpg Rated Item: 12. Riprap Revetments & Bank Protection Caption: Rating: Unacceptable; Remarks: Vegetation in on riprap at levee tie into Cooley Canal east jetty.; Action: Remove unwanted vegetation within the vegetation free zone and reestablish levee prism with adequate sod cover. Perform regular mowing to prevent further unwanted vegetation development.</p>
