DEPARTMENT OF THE ARMY
BUFFALO DISTRICT, U.S. ARMY CORPS OF ENGINEERS
1776 NIAGARA STREET
BUFFALO, NEW YORK 14207-3199

October 26, 2020

SUBJECT: FY20 Joint Routine Inspection of Completed Works, Flood Risk Management Project, Reno Beach-Howard Farms, Lucas County, Ohio (08/27/20)

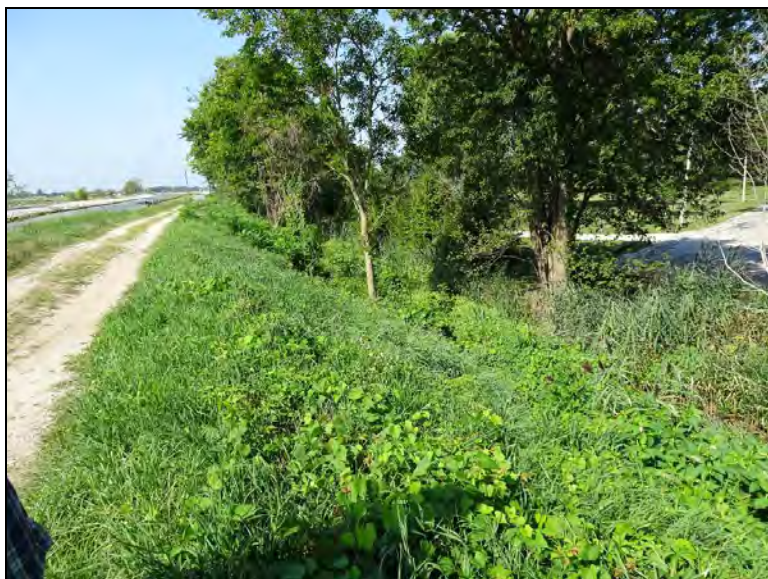
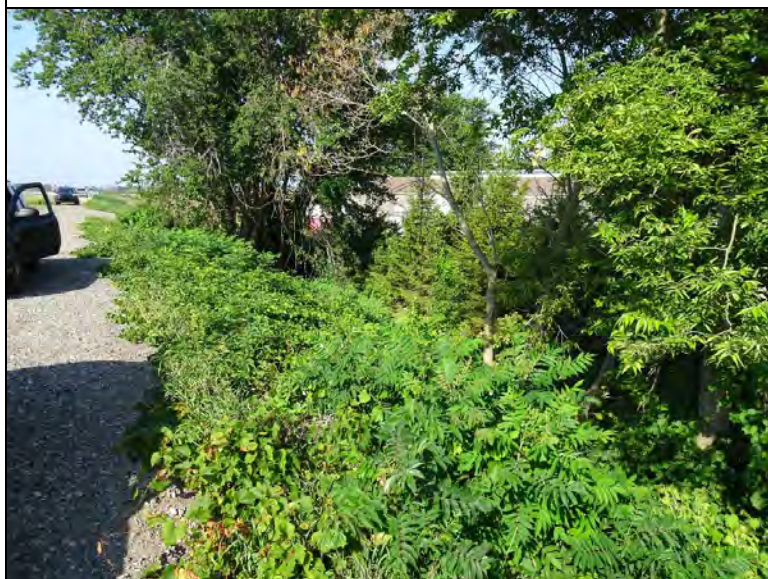
Inspect ID: OH29_2020_r_0010 **Title:** USACE_CELRB_OH29_2020_r_0010_1.jpg
Rated Item: 1. Unwanted Vegetation Growth **Caption:** Rating: Unacceptable; Remarks: Trees along levee landside slope and toe from Toulon Drive to La Fontaine Drive.; Action: Remove trees from levee slope and toe.; Station_1: -1+53; Station_2: -11+00

Inspect ID: OH29_2020_r_0010 **Title:** USACE_CELRB_OH29_2020_r_0010_2.jpg
Rated Item: 1. Unwanted Vegetation Growth **Caption:** Rating: Unacceptable; Remarks: Trees along levee landside slope and toe from Toulon Drive to La Fontaine Drive.; Action: Remove trees from levee slope and toe.; Station_1: -1+53; Station_2: -11+00

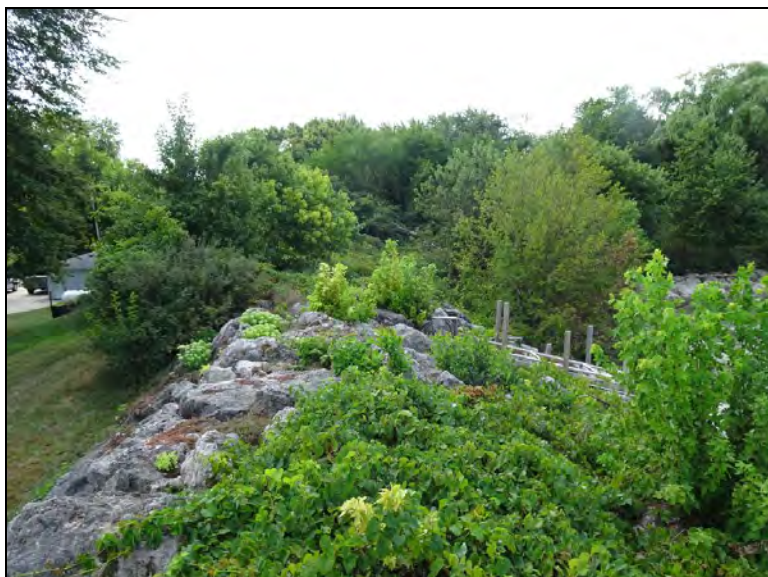
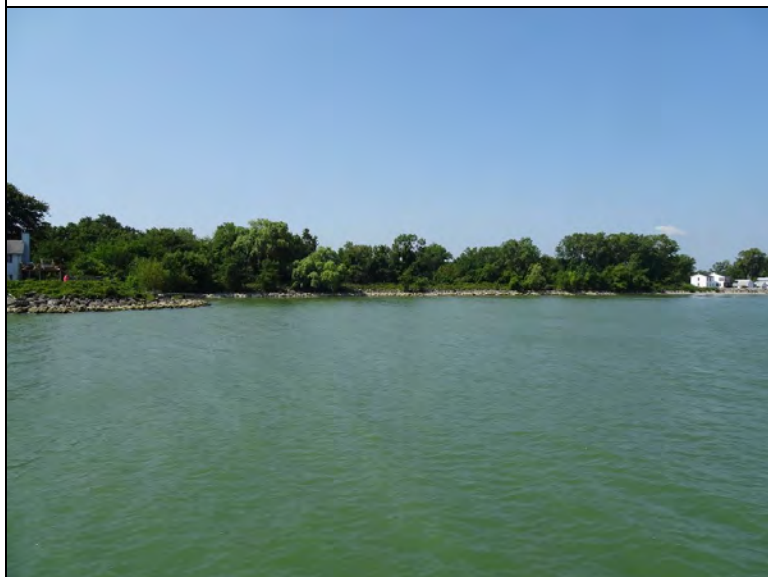
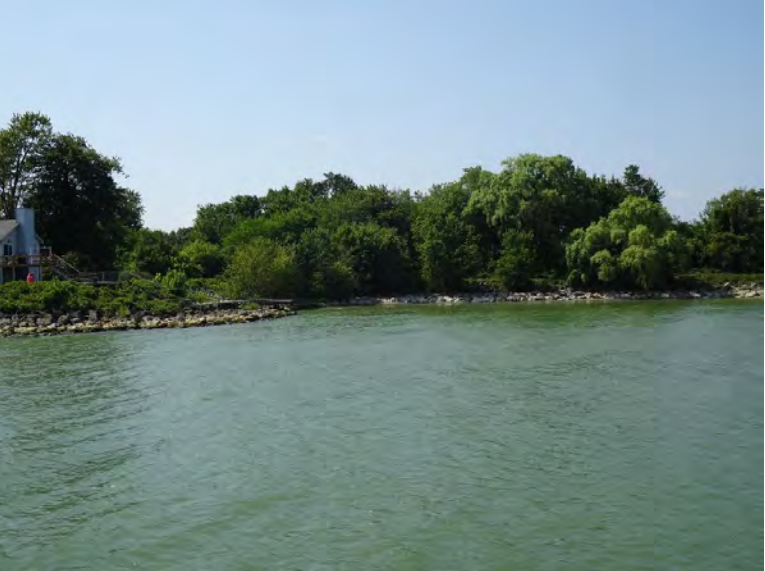
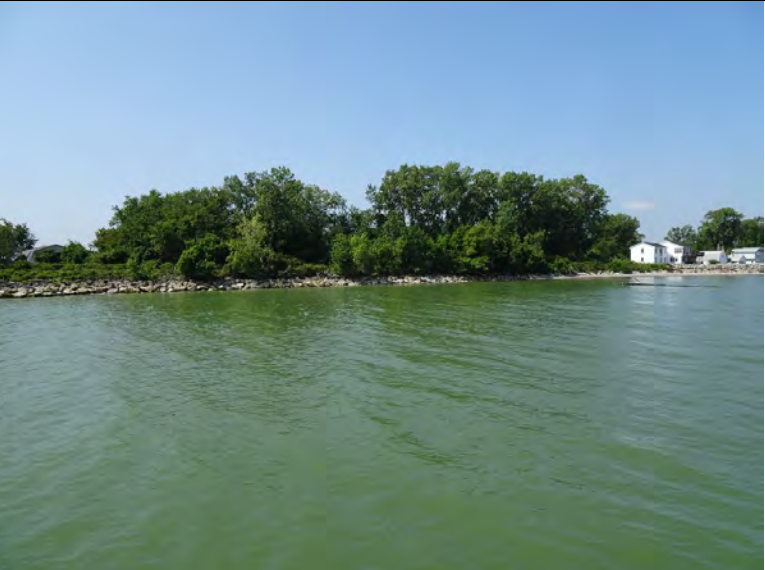
Inspect ID: OH29_2020_r_0022 **Title:** USACE_CELRB_OH29_2020_r_0022_1.jpg
Rated Item: 1. Unwanted Vegetation Growth **Caption:** Rating: Unacceptable; Remarks: Trees and heavy vegetation on crown and both slopes from west end of Lagoon Drive to La Course Drive.; Action: Remove trees and heavy vegetation from levee (toe to toe). Perform regular maintenance to prevent further unwanted vegetation development.; Station_1: 38+88; Station_2: 30+00

Inspect ID: OH29_2020_r_0022 **Title:** USACE_CELRB_OH29_2020_r_0022_2.jpg
Rated Item: 1. Unwanted Vegetation Growth **Caption:** Rating: Unacceptable; Remarks: Trees and heavy vegetation on crown and both slopes from west end of Lagoon Drive to La Course Drive.; Action: Remove trees and heavy vegetation from levee (toe to toe). Perform regular maintenance to prevent further unwanted vegetation development.; Station_1: 38+88; Station_2: 30+00

<p>Inspect ID: OH29_2020_r_0022 Title: USACE_CELRB_OH29_2020_r_0022_3.jpg Rated Item: 1. Unwanted Vegetation Growth Caption: Rating: Unacceptable; Remarks: Trees and heavy vegetation on crown and both slopes from west end of Lagoon Drive to La Course Drive.; Action: Remove trees and heavy vegetation from levee (toe to toe). Perform regular maintenance to prevent further unwanted vegetation development.; Station_1: 38+88; Station_2: 30+00</p>

<p>Inspect ID: OH29_2020_r_0022 Title: USACE_CELRB_OH29_2020_r_0022_4.jpg Rated Item: 1. Unwanted Vegetation Growth Caption: Rating: Unacceptable; Remarks: Trees and heavy vegetation on crown and both slopes from west end of Lagoon Drive to La Course Drive.; Action: Remove trees and heavy vegetation from levee (toe to toe). Perform regular maintenance to prevent further unwanted vegetation development.; Station_1: 38+88; Station_2: 30+00</p>

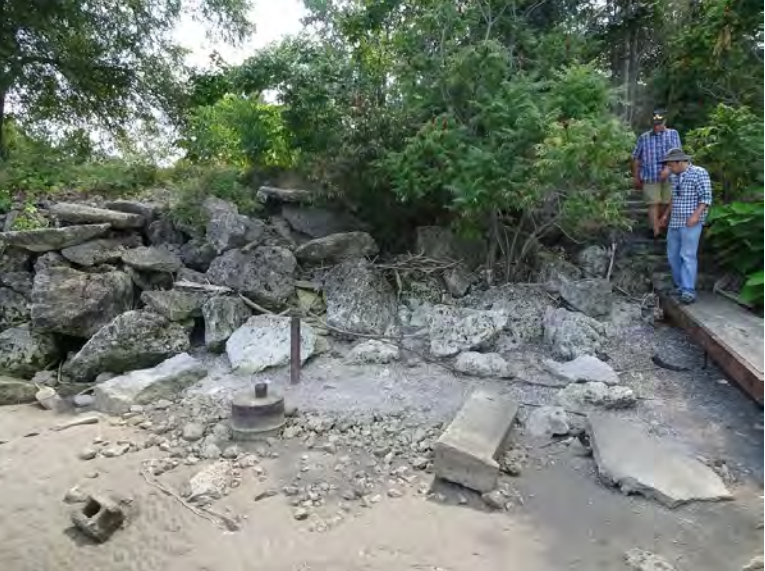
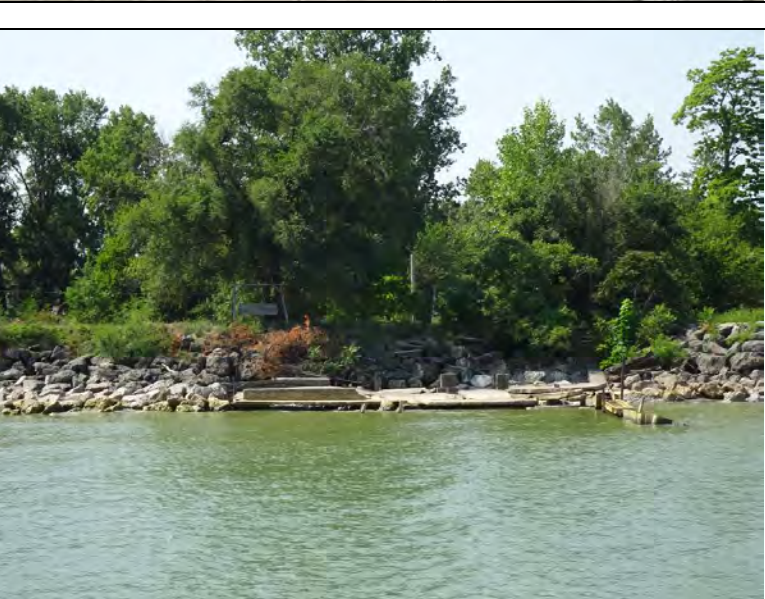
<p>Inspect ID: OH29_2020_r_0023 Title: USACE_CELRB_OH29_2020_r_0023_1.jpg Rated Item: 1. Unwanted Vegetation Growth Caption: Rating: Unacceptable; Remarks: Trees and woody vegetation on levee landside slope and crown at concrete slab, just west of 12153 Corduroy Road.; Action: Remove trees and woody vegetation. Perform regular maintenance to prevent further unwanted vegetation development.; Station_1: 50+60</p>

<p>Inspect ID: OH29_2020_r_0023 Title: USACE_CELRB_OH29_2020_r_0023_2.jpg Rated Item: 1. Unwanted Vegetation Growth Caption: Rating: Unacceptable; Remarks: Trees and woody vegetation on levee landside slope and crown at concrete slab, just west of 12153 Corduroy Road.; Action: Remove trees and woody vegetation. Perform regular maintenance to prevent further unwanted vegetation development.; Station_1: 50+60</p>

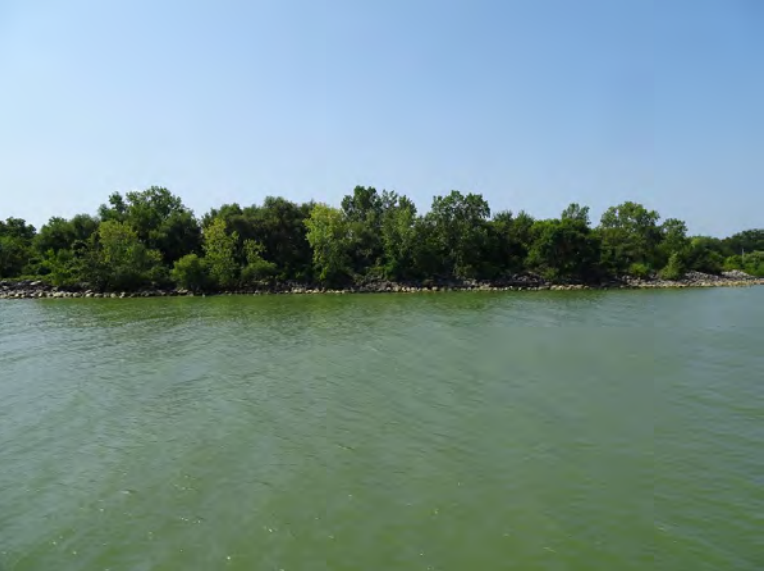
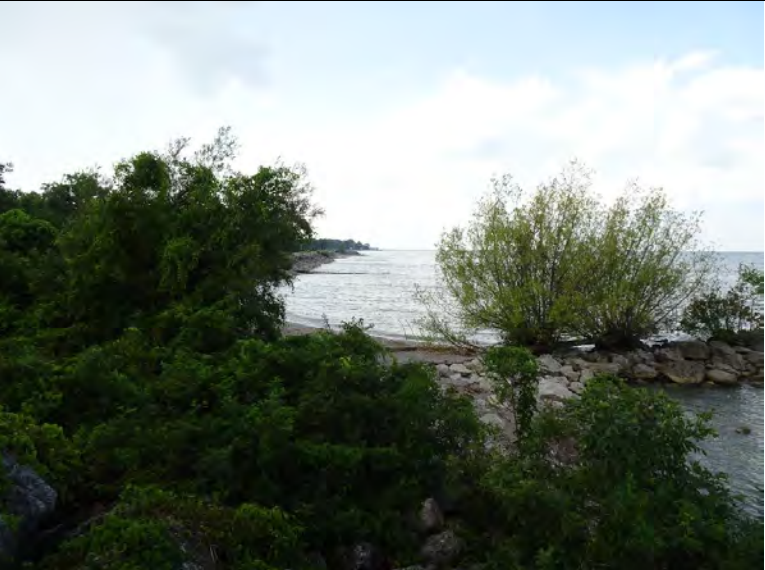
<p>Inspect ID: OH29_2020_r_0032 Title: USACE_CELRB_OH29_2020_r_0032_1.jpg Rated Item: 1. Unwanted Vegetation Growth Caption: Rating: Unacceptable; Remarks: Trees and woody vegetation on both levee side slopes and crown starting at Rialto Drive and continuing 700' east.; Action: Remove trees and woody vegetation.; Station_1: 84+58; Station_2: 78+81</p>

<p>Inspect ID: OH29_2020_r_0032 Title: USACE_CELRB_OH29_2020_r_0032_2.jpg Rated Item: 1. Unwanted Vegetation Growth Caption: Rating: Unacceptable; Remarks: Trees and woody vegetation on both levee side slopes and crown starting at Rialto Drive and continuing 700' east.; Action: Remove trees and woody vegetation.; Station_1: 84+58; Station_2: 78+81</p>

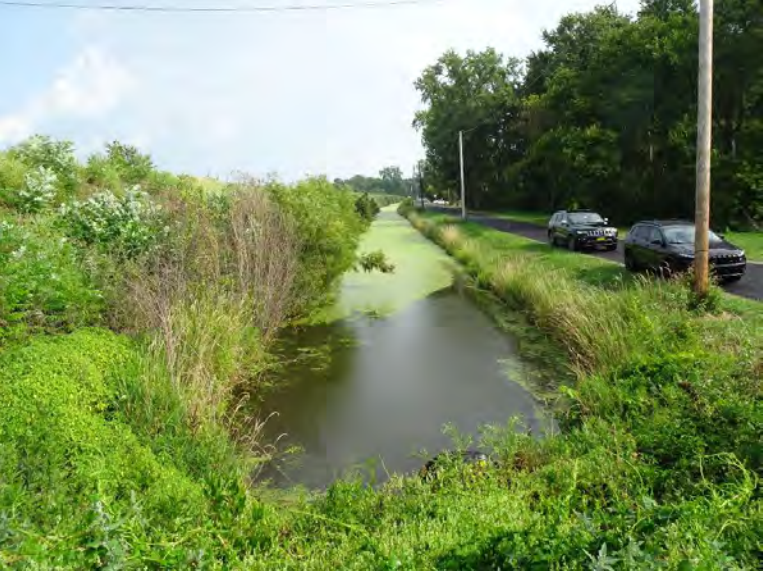
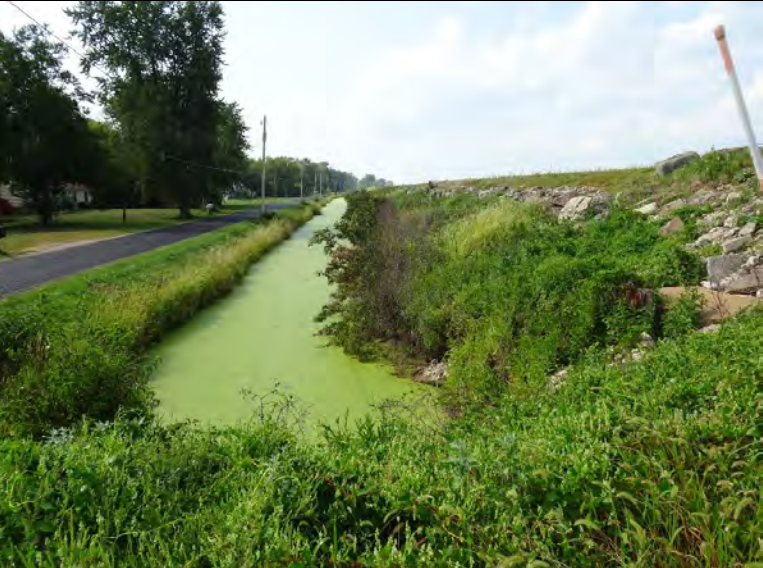
<p>Inspect ID: OH29_2020_r_0033 Title: USACE_CELRB_OH29_2020_r_0033_1.jpg Rated Item: 1. Unwanted Vegetation Growth Caption: Rating: Acceptable; Remarks: Levee landside slope is in acceptable condition along Lakeway Drive between Rialto Drive and Park Colony Boulevard. USACE agreed with sponsor to keep native small growing bush along landside toe.; Action: NA; Station_1: 100+00; Station_2: 96+73</p>

<p>Inspect ID: OH29_2020_r_0033 Title: USACE_CELRB_OH29_2020_r_0033_2.jpg Rated Item: 1. Unwanted Vegetation Growth Caption: Rating: Acceptable; Remarks: Levee landside slope is in acceptable condition along Lakeway Drive between Rialto Drive and Park Colony Boulevard. USACE agreed with sponsor to keep native small growing bush along landside toe.; Action: NA; Station_1: 100+00; Station_2: 96+73</p>

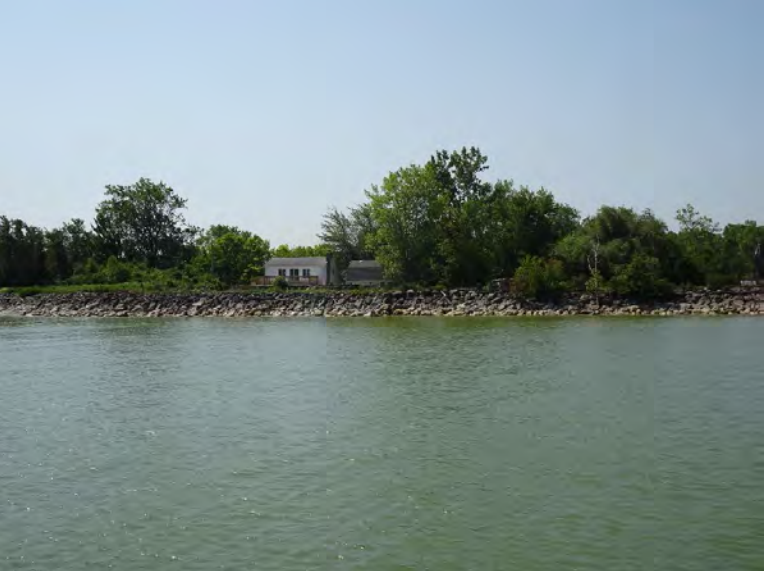
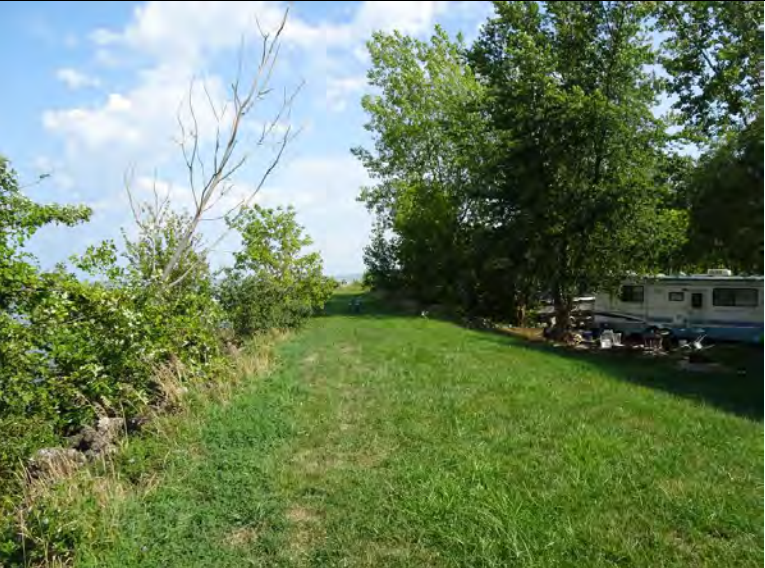
36	U	Trees and woody vegetation on both levee side slopes at 11227 Dyke Road.	Remove trees and woody vegetation; establish proper sod cover.	36_1.jpg 36_2.jpg	Levee Embankments	Unwanted Vegetation Growth	NA	130+53	127+10
39	M	Conservancy District does not maintain flood-fighting supplies.	Maintain or have access to flood-fighting supplies in accordance with USACE requirements.		General Items for All Flood Damage Reduction Systems	Emergency Supplies and Equipment (A or M only)	NA	150+00	NA
40	M	Sponsor has an Emergency Action Plan (EAP) that is being further developed.	Continue to improve and develop the EAP.		General Items for All Flood Damage Reduction Systems	Flood Preparedness and Training (A or M only)	NA	150+00	NA
46	U	Drainage ditch pump station two discharge pipes to Cooley Canal penetrates through the levee system and has not been videotape inspected within last 5-years.	Perform pipe videotape inspection and submit pipe assessment to USACE.		Levee Embankments	Culverts/ Discharge Pipes (This item includes both concrete and corrugated metal pipes.)	NA	154+44	NA

<p>Inspect ID: OH29_2020_r_0036 Title: USACE_CELRB_OH29_2020_r_0036_1.jpg Rated Item: 1. Unwanted Vegetation Growth Caption: Rating: Unacceptable; Remarks: Trees and woody vegetation on both levee side slopes at 11227 Dyke Road.; Action: Remove trees and woody vegetation; establish proper sod cover.; Station_1: 130+53; Station_2: 127+10</p>

<p>Inspect ID: OH29_2020_r_0036 Title: USACE_CELRB_OH29_2020_r_0036_2.jpg Rated Item: 1. Unwanted Vegetation Growth Caption: Rating: Unacceptable; Remarks: Trees and woody vegetation on both levee side slopes at 11227 Dyke Road.; Action: Remove trees and woody vegetation; establish proper sod cover.; Station_1: 130+53; Station_2: 127+10</p>

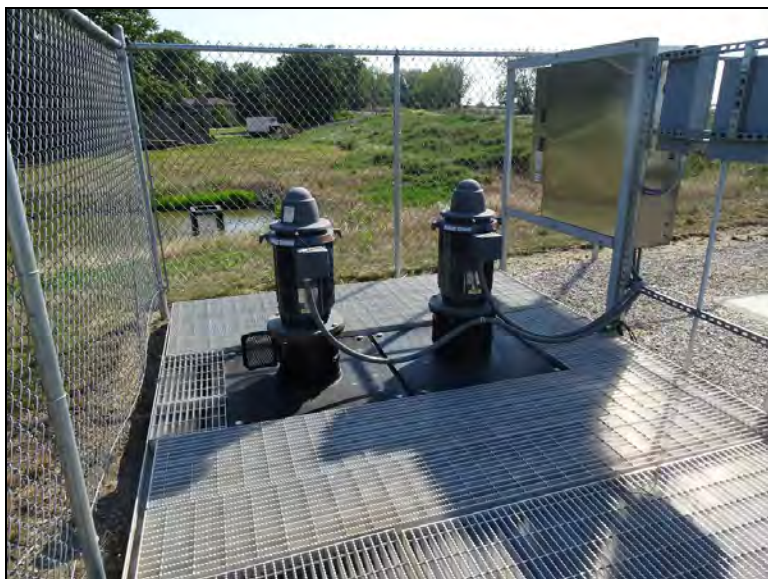
Inspect ID: OH29_2020_r_0003 **Title:** USACE_CELRB_OH29_2020_r_0003_1.jpg
Rated Item: 3. Encroachments **Caption:** Rating: Acceptable; Remarks: Toledo Metroparks pump station operated and maintained by Conservancy District per sub-agreement.; Action: NA; Station_1: -14+00

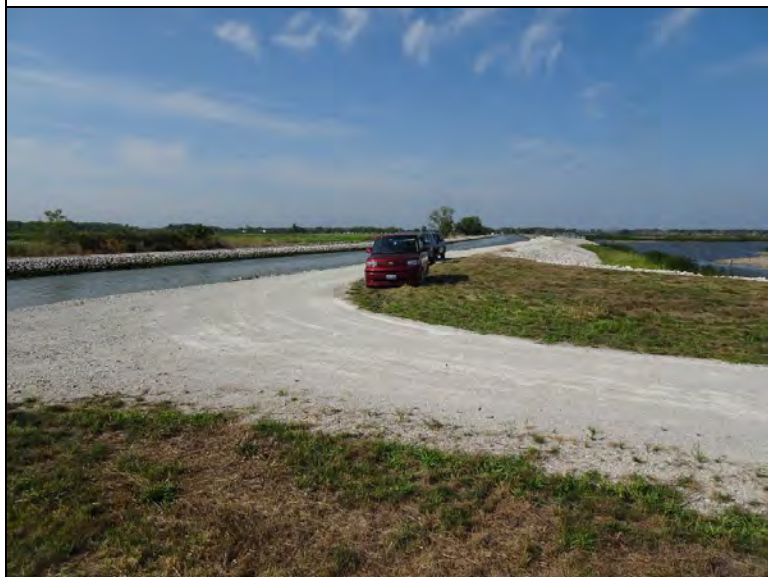
Inspect ID: OH29_2020_r_0004 **Title:** USACE_CELRB_OH29_2020_r_0004_1.jpg
Rated Item: 3. Encroachments **Caption:** Rating: Acceptable; Remarks: Authorized alteration: Toledo Metroparks levee ties into Wards Canal levee.; Action: NA; Station_1: -14+00

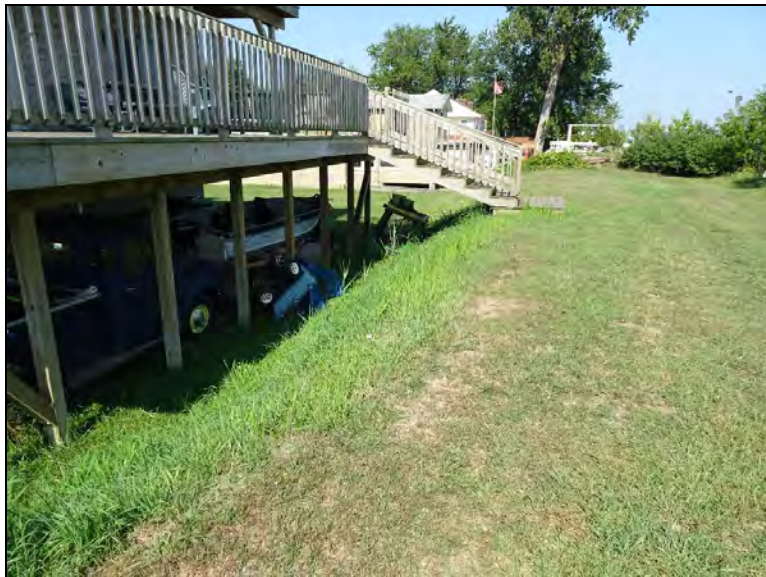
Inspect ID: OH29_2020_r_0012 **Title:** USACE_CELRB_OH29_2020_r_0012_1.jpg
Rated Item: 3. Encroachments **Caption:** Rating: Acceptable; Remarks: 12763 Lagoon Drive levee repair of toe and slope deemed acceptable by USACE per FY17 RI Report.; Action: NA; Station_1: -1+53

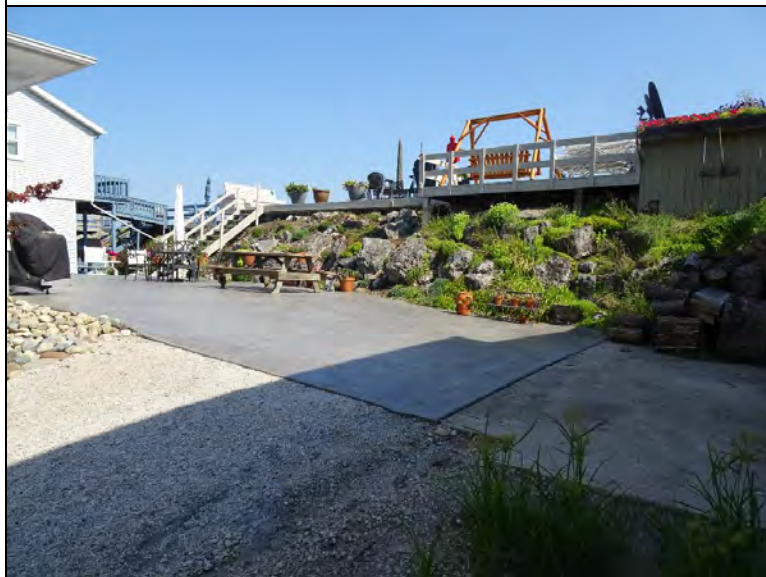
Inspect ID: OH29_2020_r_0020 **Title:** USACE_CELRB_OH29_2020_r_0020_1.jpg
Rated Item: 3. Encroachments **Caption:** Rating: Unacceptable; Remarks: Unauthorized alteration: multiple decks and stairs along both levee side slopes and crown from 12659 to 12743 Lagoon Drive. Riprap has been removed or displaced for decks and stairs. Proper operations and maintenance is impeded.; Action: Remove or Submit Section 408 Alteration Request to USACE.; Station_1: 0+10; Station_2: 5+07

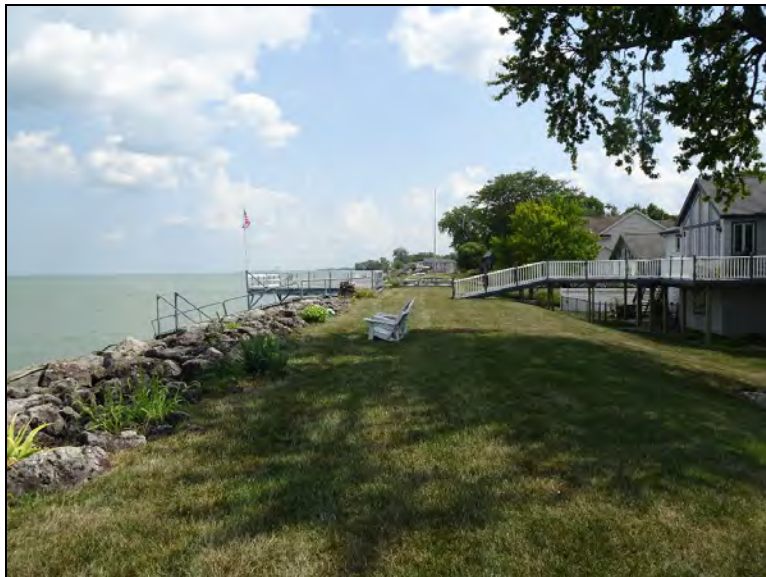
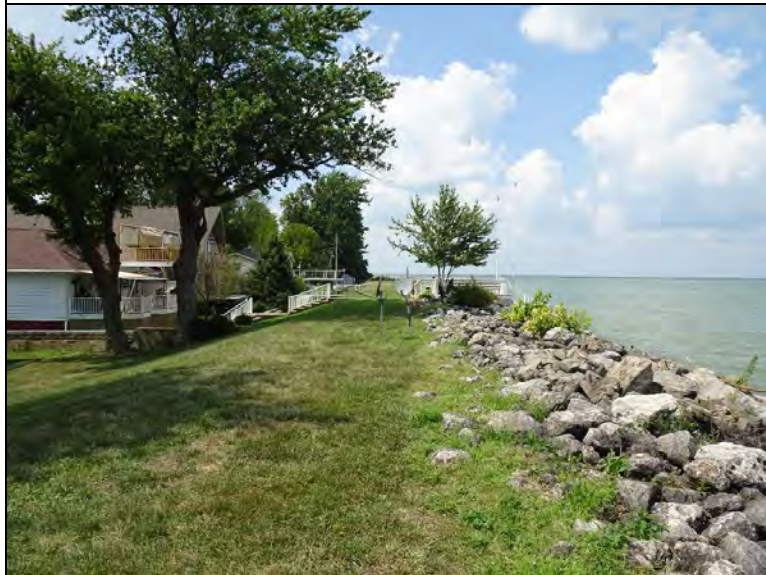
Inspect ID: OH29_2020_r_0047 **Title:** USACE_CELRB_OH29_2020_r_0047_1.jpg
Rated Item: 3. Encroachments **Caption:** Rating: Minimally Acceptable; Remarks: Unauthorized encroachments on both side slopes and crown of levee along multiple reaches of the project.; Action: Sponsor is coordinating with USACE to document and resolve encroachments.; Station_1: 152+90

Inspect ID: OH29_2020_r_0047 **Title:** USACE_CELRB_OH29_2020_r_0047_2.jpg
Rated Item: 3. Encroachments **Caption:** Rating: Minimally Acceptable; Remarks: Unauthorized encroachments on both side slopes and crown of levee along multiple reaches of the project.; Action: Sponsor is coordinating with USACE to document and resolve encroachments.; Station_1: 152+90

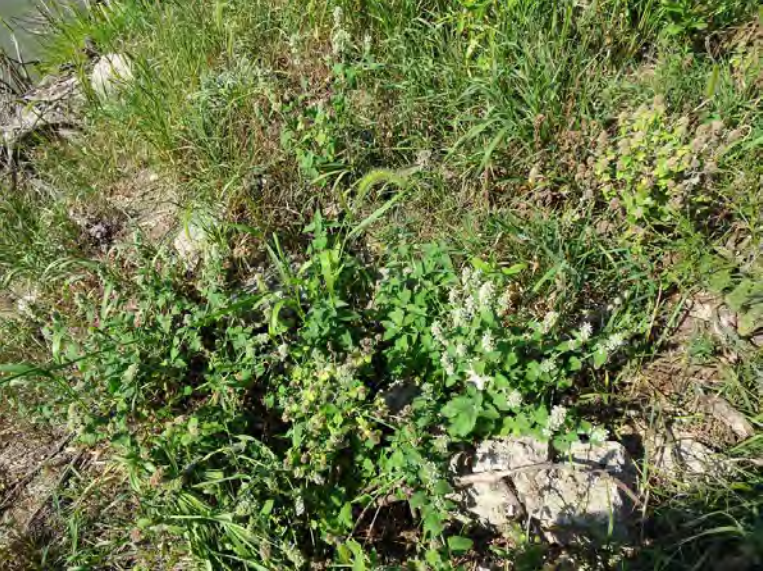
<p>Inspect ID: OH29_2020_r_0009 Title: USACE_CELRB_OH29_2020_r_0009_1.jpg Rated Item: 10. Animal Control Caption: Rating: Minimally Acceptable; Remarks: Multiple animal burrows on levee waterside slope at the end of La Fontaine Drive.; Action: Improve or create an animal control plan and fill burrow.; Station_1: -5+00</p>

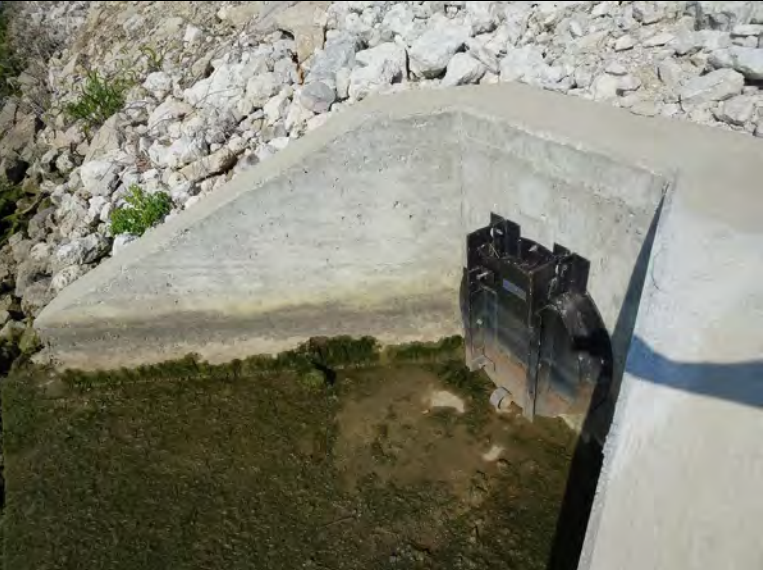
<p>Inspect ID: OH29_2020_r_0005 Title: USACE_CELRB_OH29_2020_r_0005_1.jpg Rated Item: 11. Culverts/ Discharge Pipes (This item includes both concrete and corrugated metal pipes.) Caption: Rating: Unacceptable; Remarks: Authorized alteration: Toledo Metropark alteration pump station 24" discharge pipe to Wards Canal penetrates through the levee system. Therefore, it will require videotape inspection every 5-years.; Action: Perform pipe videotape inspection and submit pipe assessment to USACE.; Station_1: -14+00</p>

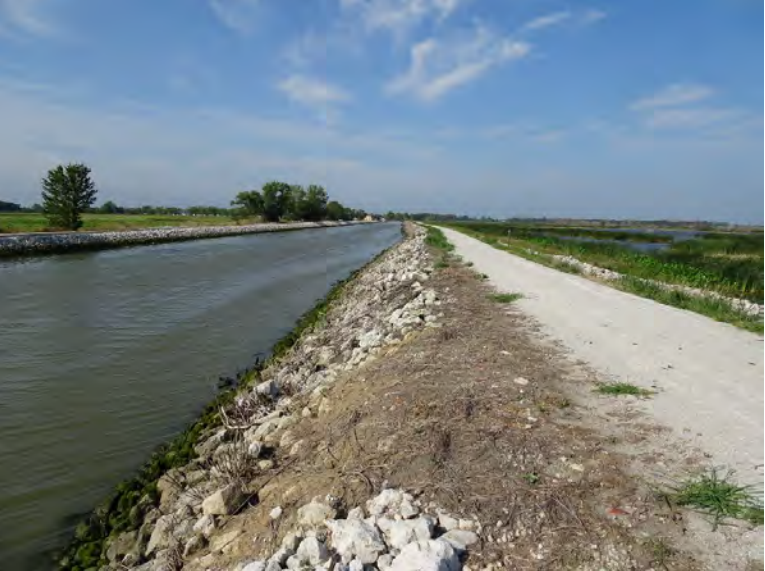
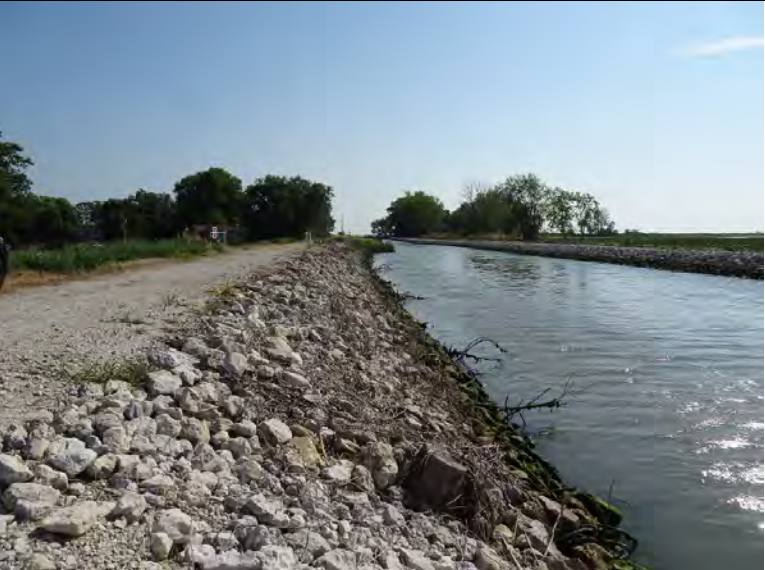
<p>Inspect ID: OH29_2020_r_0002 Title: USACE_CELRB_OH29_2020_r_0002_1.jpg Rated Item: 12. Riprap Revetments & Bank Protection Caption: Rating: Acceptable; Remarks: Riprap on levee waterside slope from Toulon Drive to project limit.; Action: NA; Station_1: -47+80; Station_2: -11+00</p>

<p>Inspect ID: OH29_2020_r_0002 Title: USACE_CELRB_OH29_2020_r_0002_2.jpg Rated Item: 12. Riprap Revetments & Bank Protection Caption: Rating: Acceptable; Remarks: Riprap on levee waterside slope from Toulon Drive to project limit.; Action: NA; Station_1: -47+80; Station_2: -11+00</p>

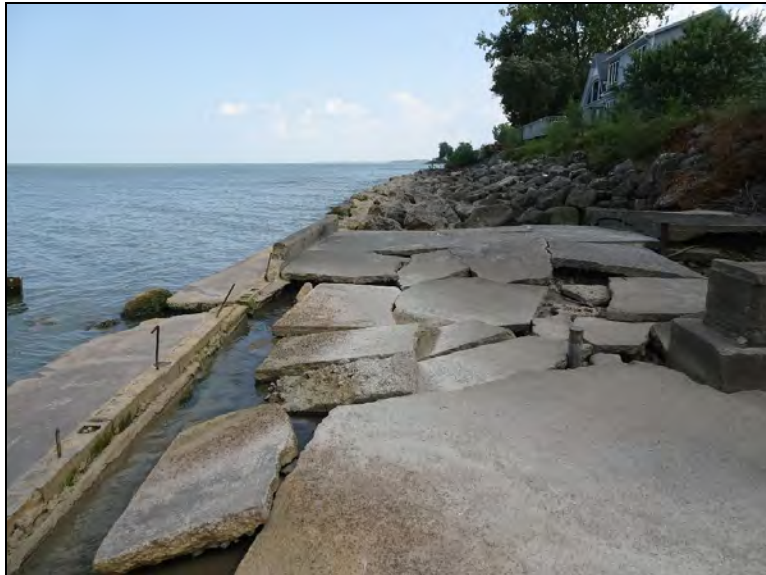
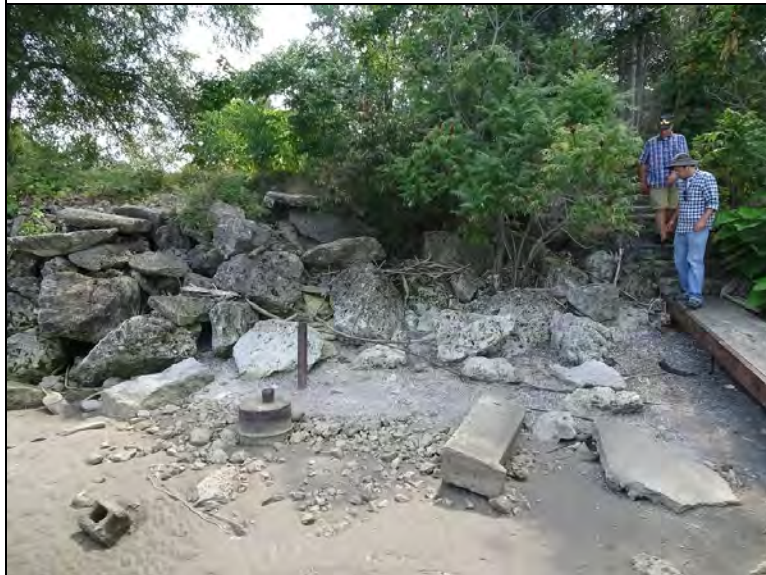
Inspect ID: OH29_2020_r_0024 **Title:** USACE_CELRB_OH29_2020_r_0024_1.jpg
Rated Item: 12. Riprap Revetments & Bank Protection **Caption:** Rating: Unacceptable;
 Remarks: Riprap has been removed from levee waterside slope over the distance of approx. 120' near concrete slab, just west of 12153 Corduroy Road.; Action: Replace borken up concrete slab with proper riprap. Should be placed from waterside toe to top of crest.; Station_1: 50+60

Inspect ID: OH29_2020_r_0024 **Title:** USACE_CELRB_OH29_2020_r_0024_2.jpg
Rated Item: 12. Riprap Revetments & Bank Protection **Caption:** Rating: Unacceptable;
 Remarks: Riprap has been removed from levee waterside slope over the distance of approx. 120' near concrete slab, just west of 12153 Corduroy Road.; Action: Replace borken up concrete slab with proper riprap. Should be placed from waterside toe to top of crest.; Station_1: 50+60

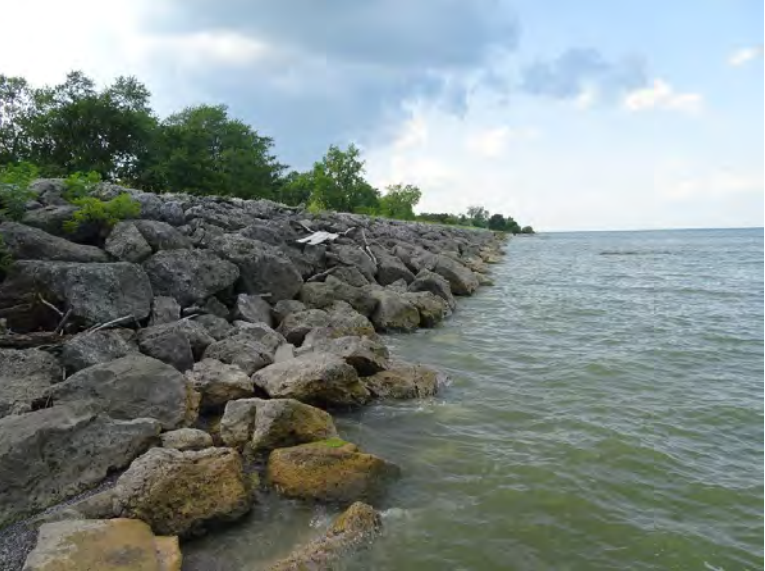
<p>Inspect ID: OH29_2020_r_0027 Title: USACE_CELRB_OH29_2020_r_0027_1.jpg Rated Item: 12. Riprap Revetments & Bank Protection Caption: Rating: Acceptable; Remarks: Riprap on levee waterside slope along Corduroy Road is in acceptable condition.; Action: NA; Station_1: 52+53</p>

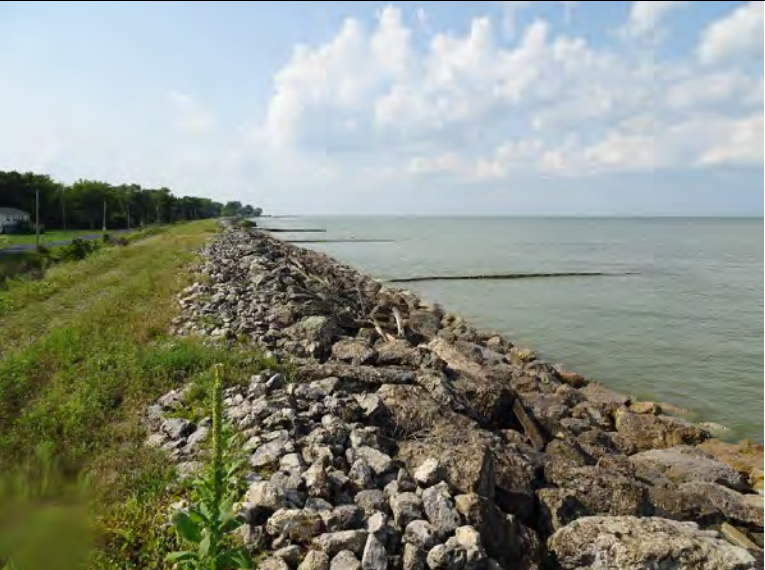
<p>Inspect ID: OH29_2020_r_0034 Title: USACE_CELRB_OH29_2020_r_0034_1.jpg Rated Item: 12. Riprap Revetments & Bank Protection Caption: Rating: Acceptable; Remarks: Riprap on levee waterside slope is in acceptable condition along Lakeway Drive between Rialto Drive and Park Colony Boulevard.; Action: NA; Station_1: 96+73; Station_2: 100+00</p>

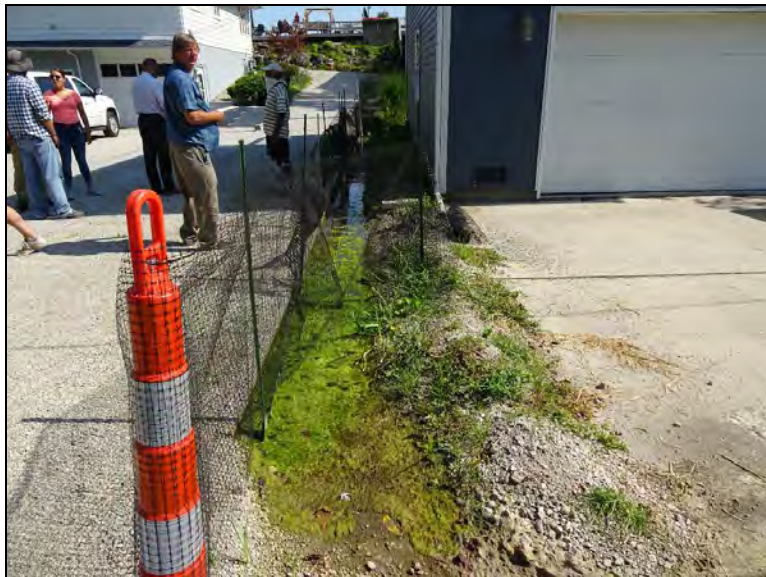
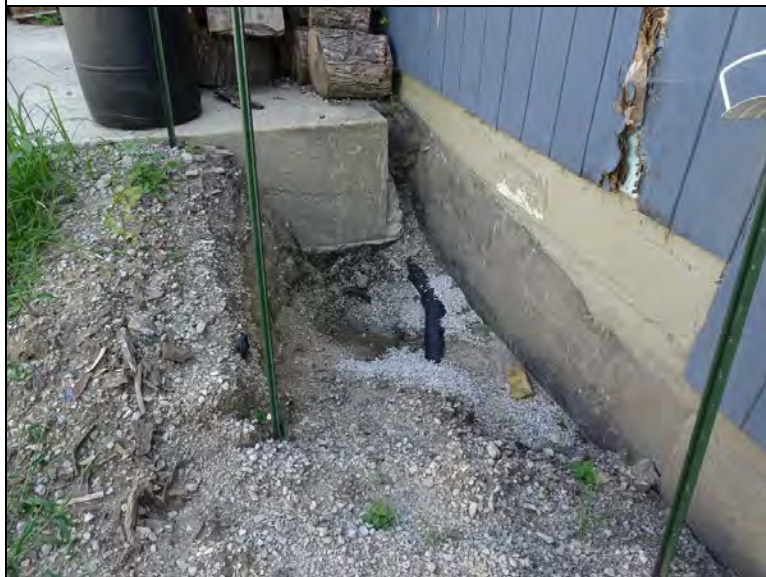
Inspect ID: OH29_2020_r_0015 **Title:** USACE_CELRB_OH29_2020_r_0015_2.jpg
Rated Item: 15. Seepage **Caption:** Rating: Minimally Acceptable; Remarks: Residents and Conservancy District indicate seepage for group of residential homes along Lagoon Drive, near 12727 Lagoon Drive.; Action: Coordinate with USACE to mitigate seepage.; Station_1: 3+62

Inspect ID: OH29_2020_r_0015 **Title:** USACE_CELRB_OH29_2020_r_0015_3.jpg
Rated Item: 15. Seepage **Caption:** Rating: Minimally Acceptable; Remarks: Residents and Conservancy District indicate seepage for group of residential homes along Lagoon Drive, near 12727 Lagoon Drive.; Action: Coordinate with USACE to mitigate seepage.; Station_1: 3+62

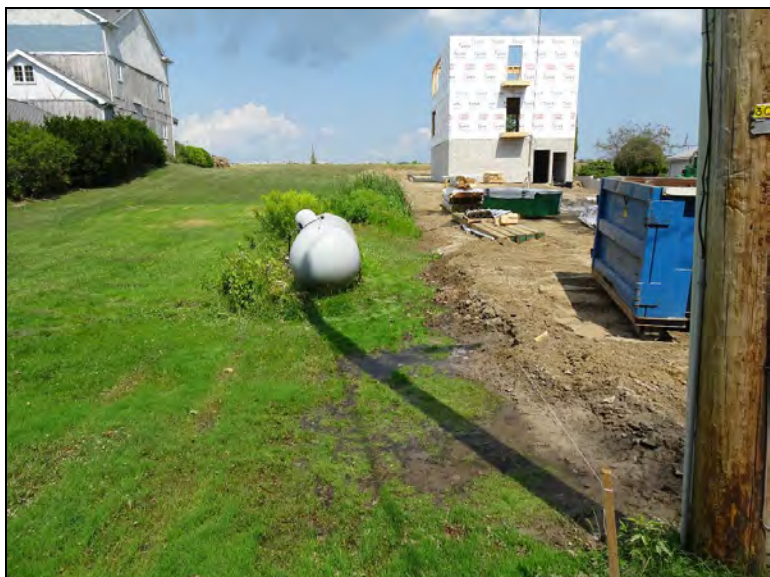
Inspect ID: OH29_2020_r_0021 **Title:** USACE_CELRB_OH29_2020_r_0021_1.jpg
Rated Item: 15. Seepage **Caption:** Rating: Minimally Acceptable; Remarks: Residents and Conservancy District indicate seepage between two residential homes along Lagoon Drive, between 12545 and 12615 Lagoon Drive.; Action: Coordinate with USACE to mitigate seepage.; Station_1: 9+57

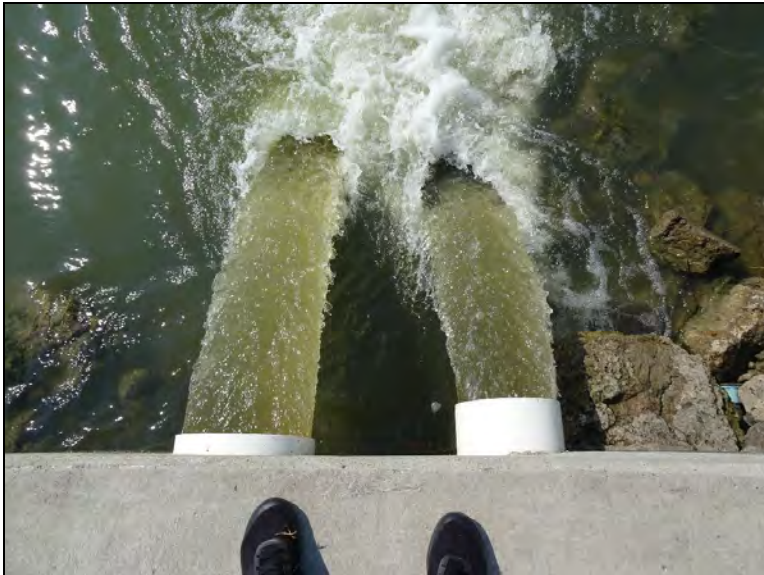
Inspect ID: OH29_2020_r_0045 **Title:** USACE_CELRB_OH29_2020_r_0045_1.jpg
Rated Item: 5. Concrete Surfaces (Such as gate wells, outfalls, intakes, or culverts)
Caption: Rating: Acceptable; Remarks: Cooley Canal Pump Station Outfall headwall in acceptable condition.; Action: NA; Station_1: 154+44

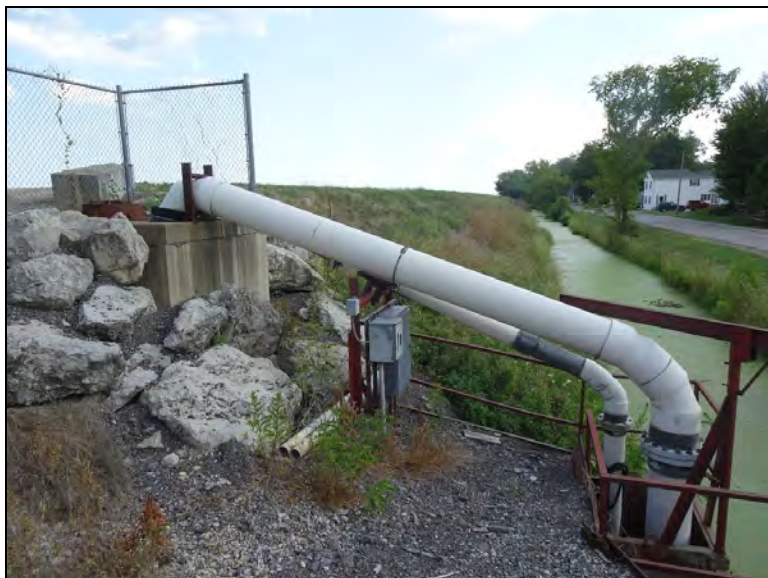
Inspect ID: OH29_2020_r_0030 **Title:** USACE_CELRB_OH29_2020_r_0030_1.jpg
Rated Item: 1. Pump Stations Operating, Maintenance, Training, & Inspection Records
Caption: Rating: Acceptable; Remarks: Project Pump Station at east end of Dyke Road at Corduroy. Records of operation are tracked hourly.; Action: NA; Station_1: 63+54

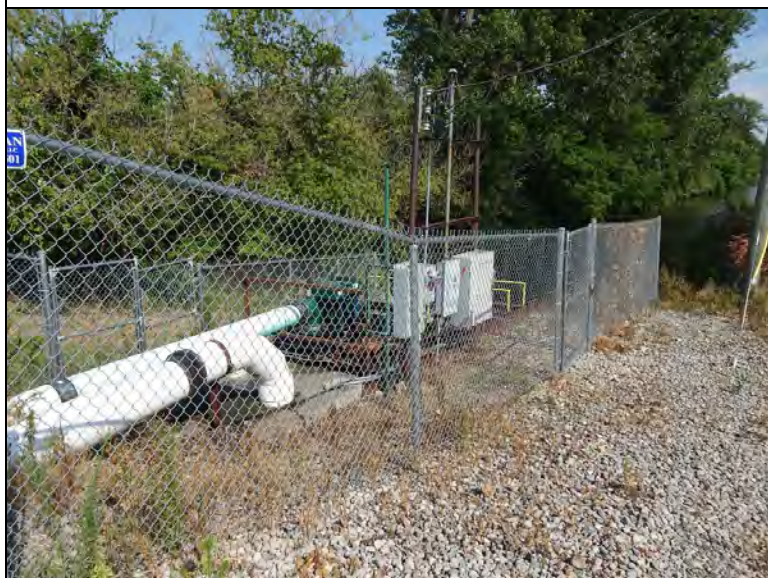
Inspect ID: OH29_2020_r_0043 **Title:** USACE_CELRB_OH29_2020_r_0043_1.jpg
Rated Item: 7. Pumps **Caption:** Rating: Acceptable; Remarks: Cooley Canal Pump Station in acceptable condition.; Action: NA; Station_1: 154+44

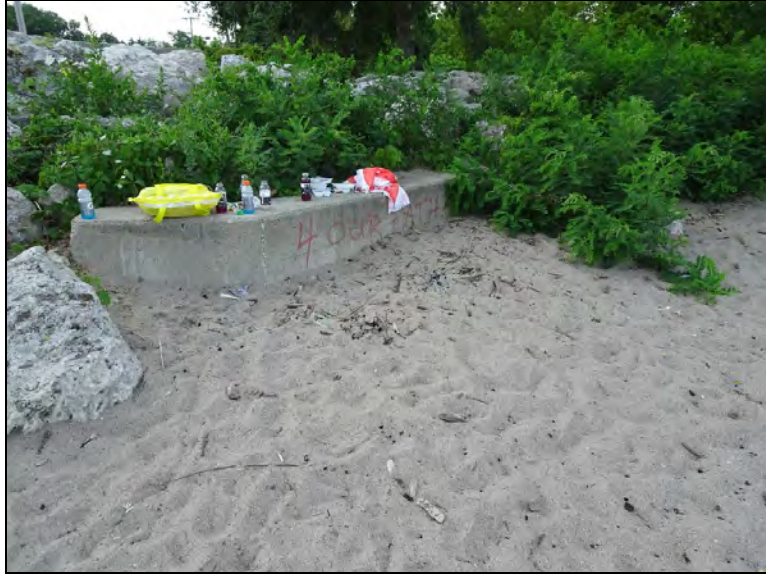
Inspect ID: OH29_2020_r_0029 **Title:** USACE_CELRB_OH29_2020_r_0029_1.jpg
Rated Item: 17. Intake and Discharge Pipelines **Caption:** Rating: Unacceptable;
Remarks: 24" discharge pipe for Dyke Road/Corduoy pump station completely shoaled in. Sponsor digs out sand with shovel. Typically clears out during operation but could be serious issue.; **Action:** Clear sediments from outfall; consider measures to keep outfall clear of sediments.; **Station_1:** 63+15

- (4) Sponsor should consider measures to keep Dyke Road/Corduroy pump station outfall discharge from being blocked by each sand which washes up against the headwall. This causes a blockage of the outfall and impedes proper pump station discharge.
- (5) Although project is "Inactive" in the USACE Rehabilitation Program. The project sponsor is encouraged to continue maintaining the project in accordance with the project O&M manual to the practical extent possible in order to maximize benefits provided by the project and to maximize public safety. The sponsor has made excellent progress in this regard over the past two years.

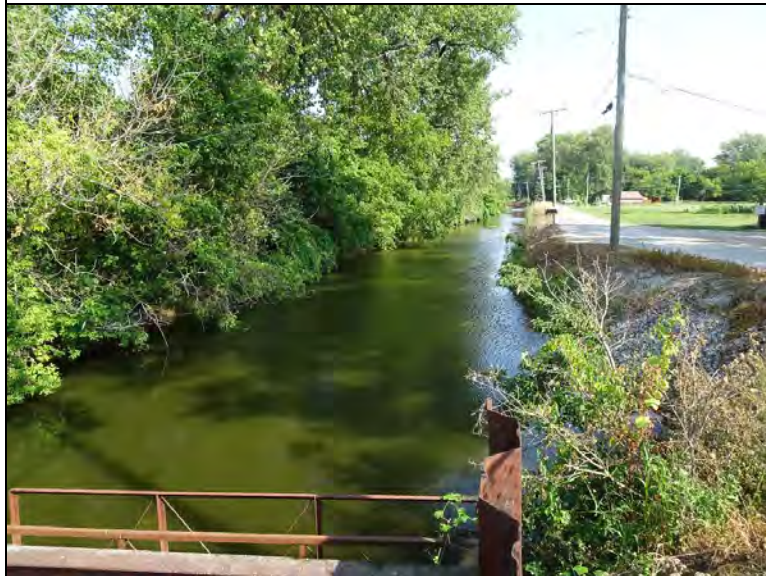
Inspect ID: OH29_2020_r_0044 **Title:** USACE_CELRB_OH29_2020_r_0044_1.jpg
Rated Item: 17. Intake and Discharge Pipelines **Caption:** Rating: Acceptable; **Remarks:** Cooley Canal Pump Station intake channel in acceptable condition.; **Action:** NA;
Station_1: 154+44
