DEPARTMENT OF THE ARMY  
CORPS OF ENGINEERS, BUFFALO DISTRICT  
1776 NIAGARA STREET  
BUFFALO, NEW YORK 14207-3111

Transmitted herewith is the FY22 Inspection of Completed Works inspection report for the Flood Risk Management Project at Reno Beach-Howard Farms, Lucas County, Ohio. Thank you for your agency's participation in this inspection. The rating for this project as determined by the current inspection is **MINIMALLY ACCEPTABLE**. This project is currently **ACTIVE** in the USACE Rehabilitation Program.

FY22 Joint Routine Inspection of Completed Works  
Reno Beach-Howard Farms, Lucas County, Ohio  
Flood Risk Management Project

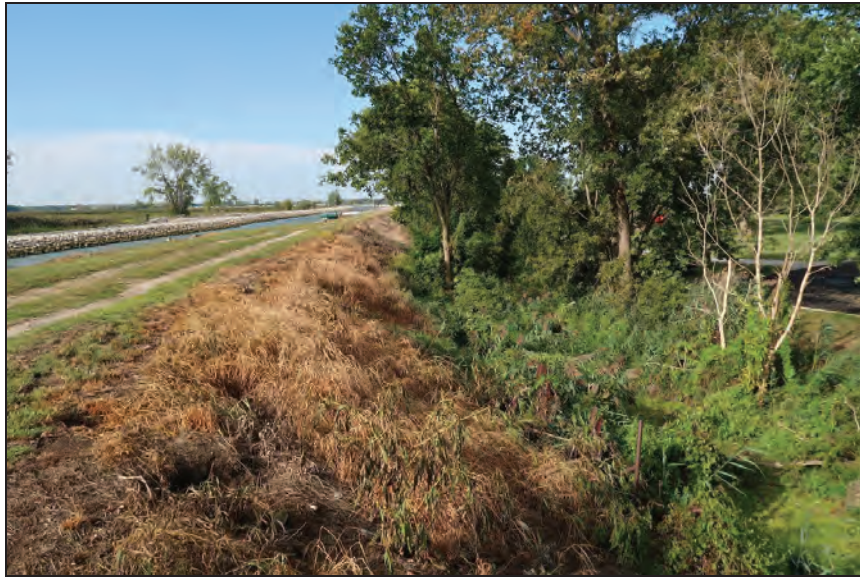
Rated Item	Rating	Rating Guidelines	Location/Remarks/Recommendations	
1. Unwanted Vegetation Growth <sup>1</sup>	U	A	The levee has little or no unwanted vegetation (trees, bush, or undesirable weeds), except for vegetation that is properly contained and/or situated on overbuilt sections, such that the mandatory 3-foot root-free zone is preserved around the levee profile. The levee has been recently mowed. The vegetation-free zone extends 15 feet from both the landside and riverside toes of the levee to the centerline of the tree. If the levee access easement doesn't extend to the described limits, then the vegetation-free zone must be maintained to the easement limits. Reference EM 1110-2-301 or Corps policy for regional vegetation variance.	OH29_2022_r_0008: Station_1 -1+53: Station_2 -11+00: Trees along levee landside toe from Toulon Drive to La Fontaine Drive.: Remove trees from levee slope and toe. (U) OH29_2022_r_0016: Station_1 38+88: Station_2 30+00: Trees and vegetation on the levee landside slope from the west end of Lagoon Drive to La Course Drive.: Remove trees and vegetation from the landside slope. (U)

**Inspect ID:** OH29\_2022\_r\_0008 **Title:** USACE\_CELRB\_OH29\_2022\_r\_0008\_1.jpg  
**Rated Item:** 1. Unwanted Vegetation Growth **Caption:** Rating: Unacceptable; Remarks: Trees along levee landside toe from Toulon Drive to La Fontaine Drive.; Action: Remove trees from levee slope and toe.; Station\_1: -1+53; Station\_2: -11+00

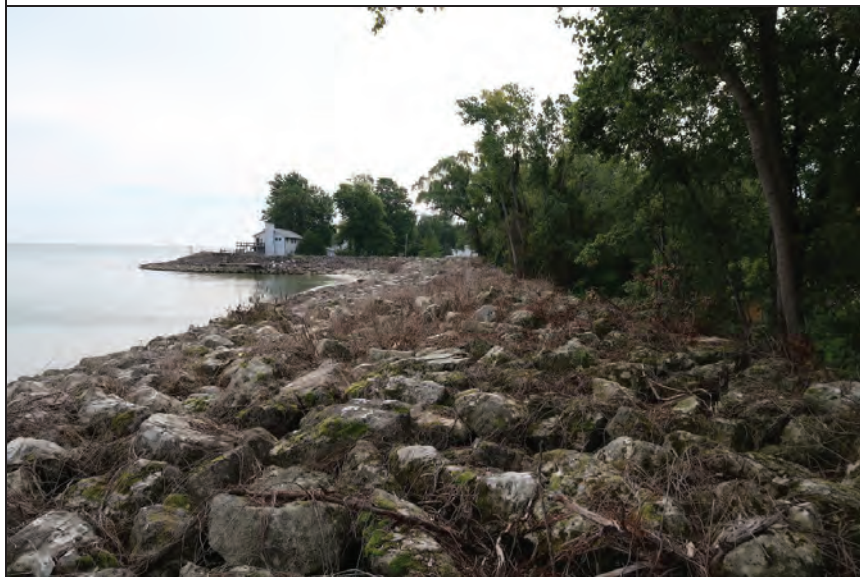
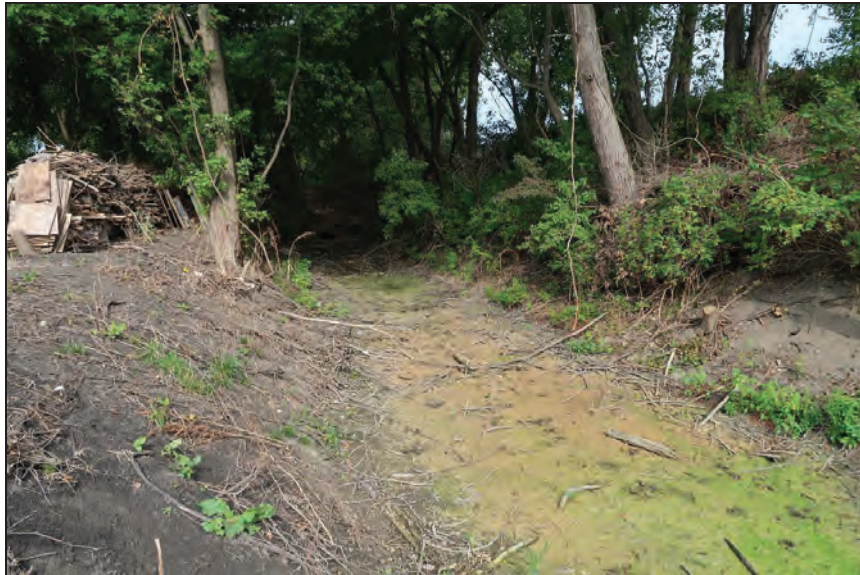
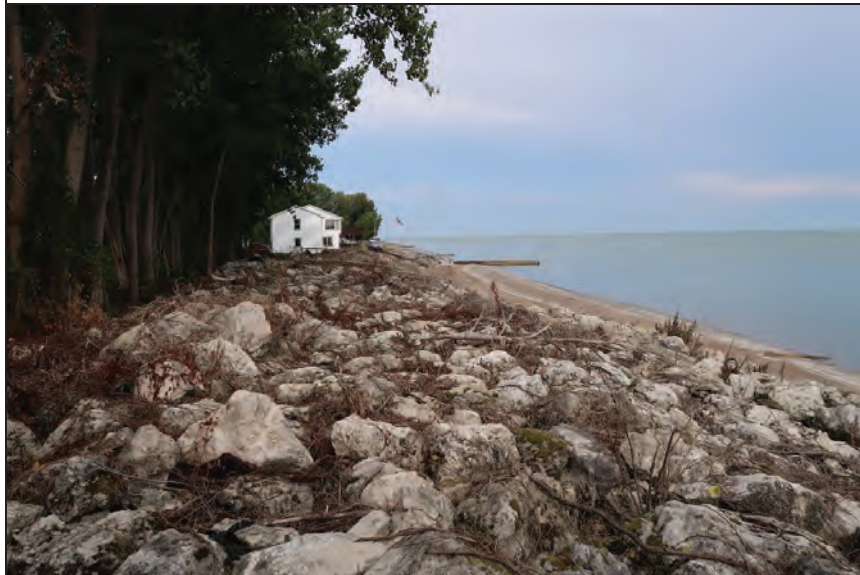
**Inspect ID:** OH29\_2022\_r\_0016 **Title:** USACE\_CELRB\_OH29\_2022\_r\_0016\_1.jpg  
**Rated Item:** 1. Unwanted Vegetation Growth **Caption:** Rating: Unacceptable; Remarks: Trees and vegetation on the levee landside slope from the west end of Lagoon Drive to La Course Drive.; Action: Remove trees and vegetation from the landside slope.; Station\_1: 38+88; Station\_2: 30+00

**Inspect ID:** OH29\_2022\_r\_0016 **Title:** USACE\_CELRB\_OH29\_2022\_r\_0016\_2.jpg  
**Rated Item:** 1. Unwanted Vegetation Growth **Caption:** Rating: Unacceptable; Remarks: Trees and vegetation on the levee landside slope from the west end of Lagoon Drive to La Course Drive.; Action: Remove trees and vegetation from the landside slope.; Station\_1: 38+88; Station\_2: 30+00

**Inspect ID:** OH29\_2022\_r\_0016 **Title:** USACE\_CELRB\_OH29\_2022\_r\_0016\_3.jpg  
**Rated Item:** 1. Unwanted Vegetation Growth **Caption:** Rating: Unacceptable; Remarks: Trees and vegetation on the levee landside slope from the west end of Lagoon Drive to La Course Drive.; Action: Remove trees and vegetation from the landside slope.; Station\_1: 38+88; Station\_2: 30+00

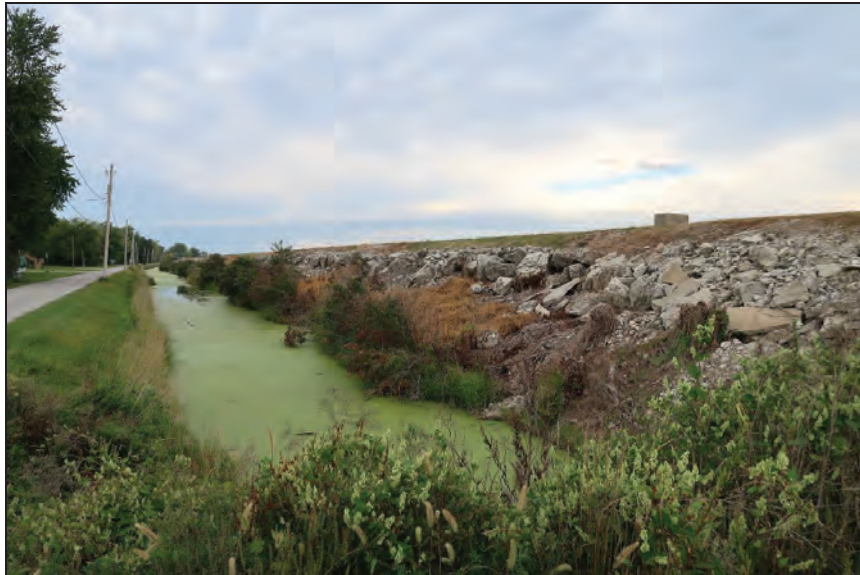
**Inspect ID:** OH29\_2022\_r\_0019 **Title:** USACE\_CELRB\_OH29\_2022\_r\_0019\_1.jpg  
**Rated Item:** 1. Unwanted Vegetation Growth **Caption:** Rating: Minimally Acceptable;  
Remarks: Vegetation and woody growth along the landside toe between Rialto Drive and Park Colony Boulevard. USACE agreed with sponsor to keep native small growing bush along landside toe.; Action: NA; Station\_1: 100+00; Station\_2: 96+73

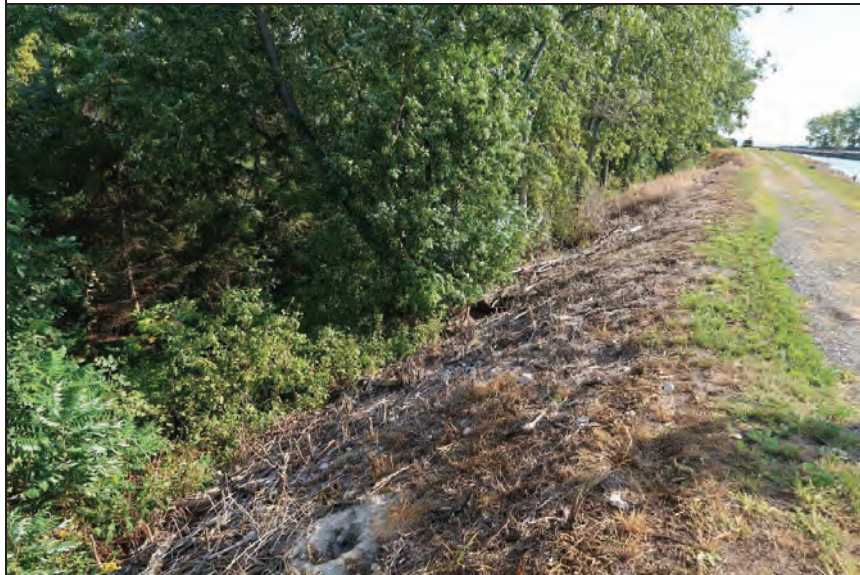
29	M	Sod cover missing on the landside slope of the Wards Canal levee after vegetation removal.	Coordinate with USACE to reestablish sod cover on landside slope.	29_1.jpg	Levee Embankments	Sod Cover	-9+00	-6+00
30	M	Miscellaneous debris on the landside slope of the Wards Canal levee.	Clear debris from the landside slope.	30_1.jpg	Levee Embankments	Encroachments	-9+00	NA

2. Sod Cover	M	A	There is good coverage of sod over the levee.	OH29_2022_r_0029: Station_1 -9+00: Station_2 -6+00: Sod cover missing on the landside slope of the Wards Canal levee after vegetation removal.: Coordinate with USACE to reestablish sod cover on landside slope. (M)
		M	Approximately 25% of the sod cover is missing or damaged over a significant portion or over significant portions of the levee embankment. This may be the result of over-grazing or feeding on the levee, unauthorized vehicular traffic, chemical or insect problems, or burning during inappropriate seasons.	OH29_2022_r_0036: Station_1 54+46: Station_2 58+32: Levee landside slope along Corduroy Road.: NA (A)
		U	Over 50% of the sod cover is missing or damaged over a significant portion or portions of the levee embankment.	
		N/A	Surface protection is provided by other means.

**Inspect ID:** OH29\_2022\_r\_0029 **Title:** USACE\_CELRB\_OH29\_2022\_r\_0029\_1.jpg  
**Rated Item:** 2. Sod Cover **Caption:** Rating: Minimally Acceptable; Remarks: Sod cover missing on the landside slope of the Wards Canal levee after vegetation removal.; Action: Coordinate with USACE to reestablish sod cover on landside slope.; Station\_1: -9+00; Station\_2: -6+00

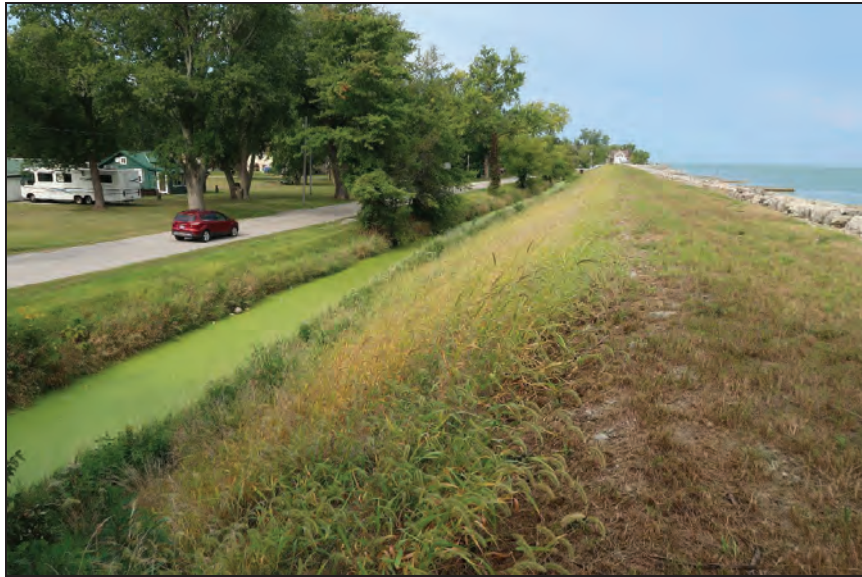
**Inspect ID:** OH29\_2022\_r\_0036 **Title:** USACE\_CELRB\_OH29\_2022\_r\_0036\_1.jpg  
**Rated Item:** 2. Sod Cover **Caption:** Rating: Acceptable; Remarks: Levee landside slope along Corduroy Road.; Action: NA; Station\_1: 54+46; Station\_2: 58+32

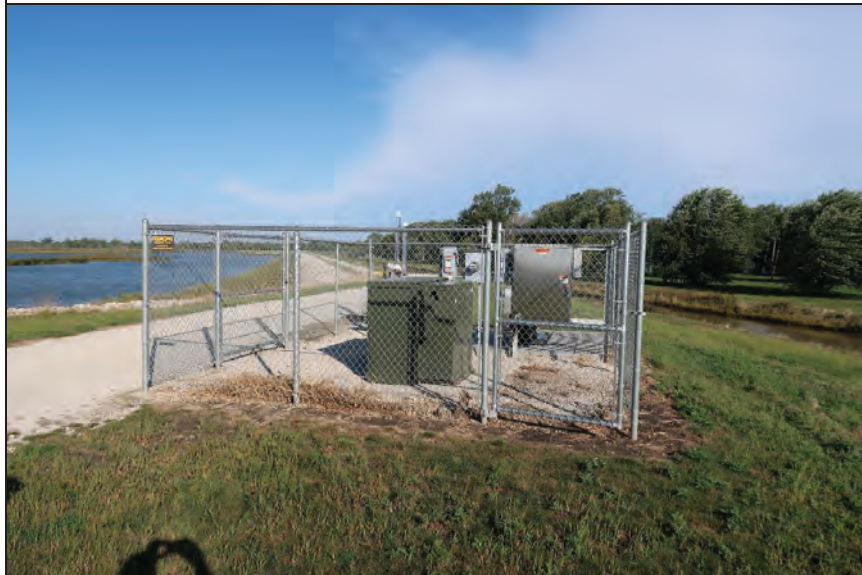
**Inspect ID:** OH29\_2022\_r\_0007 **Title:** USACE\_CELRB\_OH29\_2022\_r\_0007\_1.jpg  
**Rated Item:** 3. Encroachments **Caption:** Rating: Acceptable; Remarks: Toledo Metroparks pump station operated and maintained by Conservancy District per sub-agreement.; Action: NA; Station\_1: -14+00

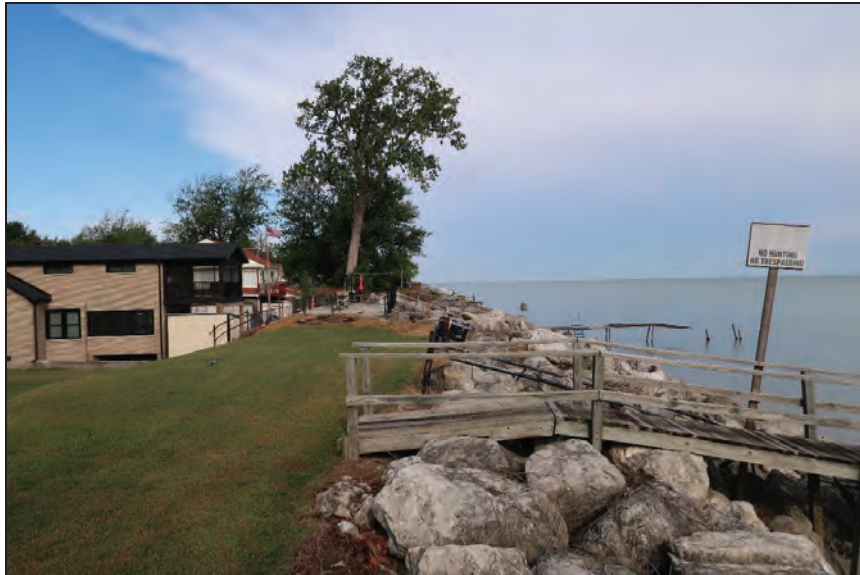
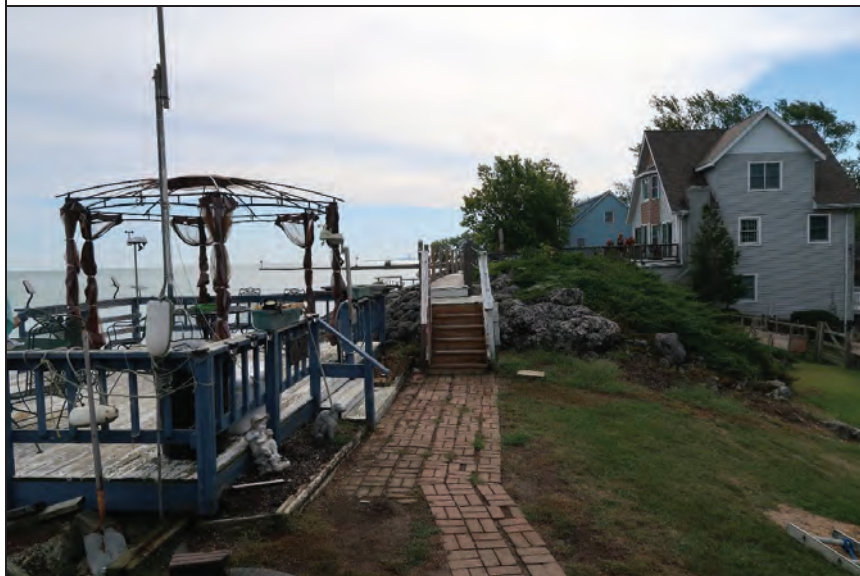
U	Unauthorized encroachments or inappropriate activities noted are likely to inhibit operations and maintenance, emergency operations, or negatively impact the integrity of the levee.	OH29_2022_r_0014: Station_1 0+10: Station_2 5+07: Unauthorized alteration: multiple decks and stairs along both levee side slopes and crown from 12659 to 12743 Lagoon Drive. Riprap has been removed or displaced for decks and stairs. Proper operations and maintenance is impeded.: Remove or Submit Section 408 Alteration Request to USACE. (U) OH29_2022_r_0017: Station_1 98+64: Pre-project cottages along Lakeway Drive at end of Waterway Road; one

**Inspect ID:** OH29\_2022\_r\_0014 **Title:** USACE\_CELRB\_OH29\_2022\_r\_0014\_1.jpg  
**Rated Item:** 3. Encroachments **Caption:** Rating: Unacceptable; Remarks: Unauthorized alteration: multiple decks and stairs along both levee side slopes and crown from 12659 to 12743 Lagoon Drive. Riprap has been removed or displaced for decks and stairs. Proper operations and maintenance is impeded.; Action: Remove or Submit Section 408 Alteration Request to USACE.; Station\_1: 0+10; Station\_2: 5+07

**Inspect ID:** OH29\_2022\_r\_0014 **Title:** USACE\_CELRB\_OH29\_2022\_r\_0014\_2.jpg  
**Rated Item:** 3. Encroachments **Caption:** Rating: Unacceptable; Remarks: Unauthorized alteration: multiple decks and stairs along both levee side slopes and crown from 12659 to 12743 Lagoon Drive. Riprap has been removed or displaced for decks and stairs. Proper operations and maintenance is impeded.; Action: Remove or Submit Section 408 Alteration Request to USACE.; Station\_1: 0+10; Station\_2: 5+07

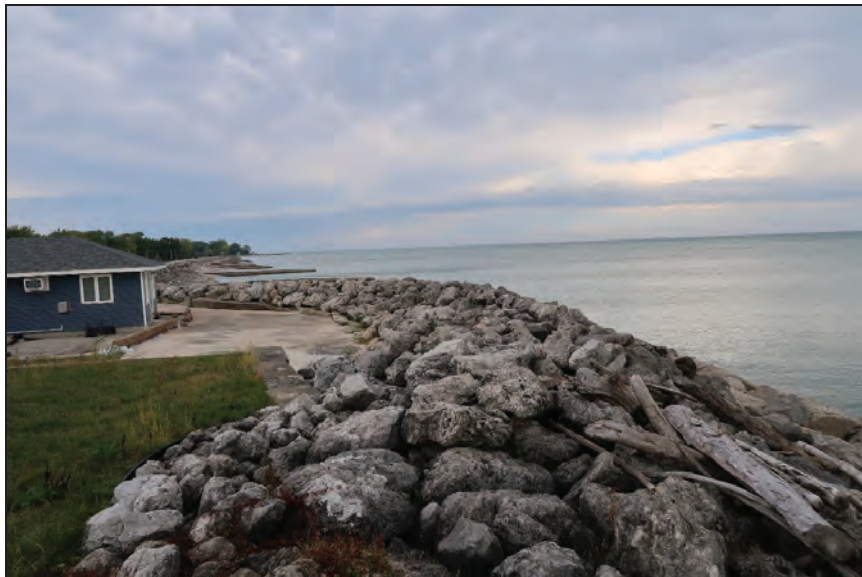
**Inspect ID:** OH29\_2022\_r\_0017 **Title:** USACE\_CELRB\_OH29\_2022\_r\_0017\_1.jpg  
**Rated Item:** 3. Encroachments **Caption:** Rating: Acceptable; Remarks: Pre-project cottages along Lakeway Drive at end of Waterway Road; one remains, one removed (foundation remains).; Action: NA; Station\_1: 98+64

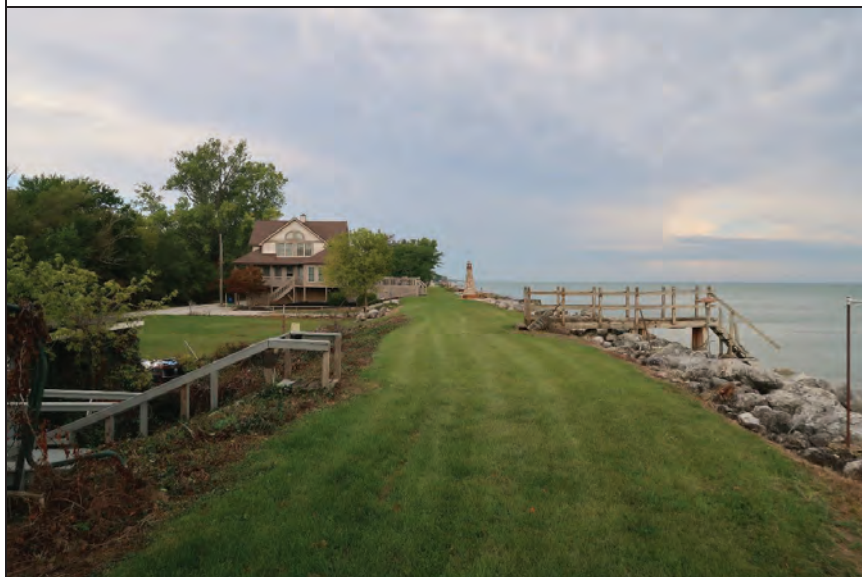
Rated Item	Rating	Rating Guidelines		Location/Remarks/Recommendations
				remains, one removed (foundation remains).: NA (A) OH29_2022_r_0023; Station_1 152+90: Unauthorized encroachments on both levee side slopes and crest along multiple reaches of the project.: Sponsor is coordinating with USACE to document and resolve encroachments. (M) OH29_2022_r_0030; Station_1 -9+00: Miscellaneous debris on the landside slope of the Wards Canal levee.: Clear debris from the landside slope. (M)

**Inspect ID:** OH29\_2022\_r\_0023 **Title:** USACE\_CELRB\_OH29\_2022\_r\_0023\_1.jpg  
**Rated Item:** 3. Encroachments **Caption:** Rating: Minimally Acceptable; Remarks: Unauthorized encroachments on both levee side slopes and crest along multiple reaches of the project.; Action: Sponsor is coordinating with USACE to document and resolve encroachments.; Station\_1: 152+90

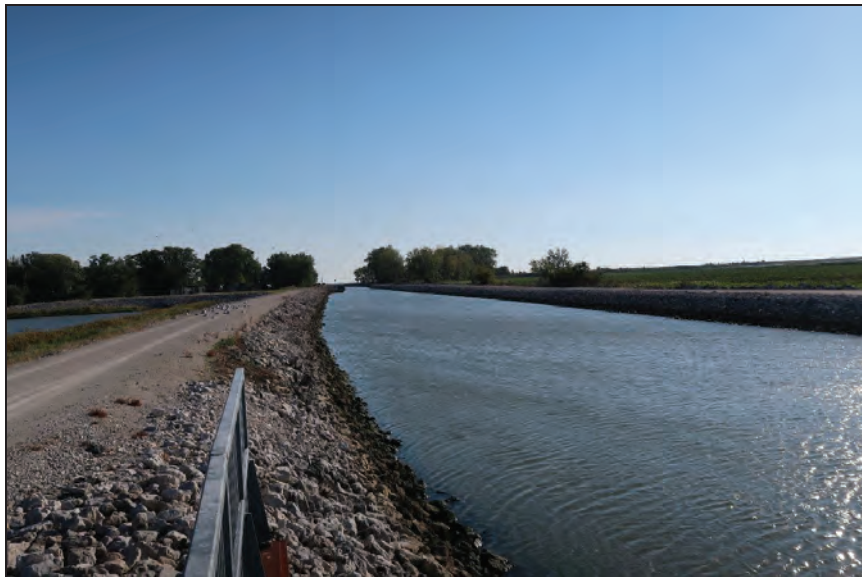
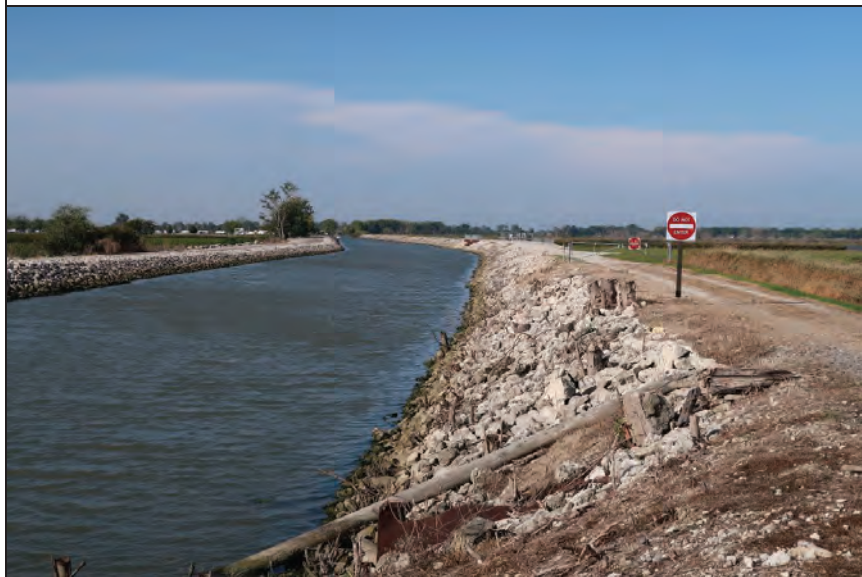
**Inspect ID:** OH29\_2022\_r\_0002 **Title:** USACE\_CELRB\_OH29\_2022\_r\_0002\_1.jpg  
**Rated Item:** 12. Riprap Revetments & Bank Protection **Caption:** Rating: Acceptable;  
**Remarks:** Riprap on levee waterside slope from Toulon Drive to Wards Canal.; **Action:** NA; **Station\_1:** -47+80; **Station\_2:** -11+00

**Inspect ID:** OH29\_2022\_r\_0002 **Title:** USACE\_CELRB\_OH29\_2022\_r\_0002\_2.jpg  
**Rated Item:** 12. Riprap Revetments & Bank Protection **Caption:** Rating: Acceptable;  
**Remarks:** Riprap on levee waterside slope from Toulon Drive to Wards Canal.; **Action:** NA; **Station\_1:** -47+80; **Station\_2:** -11+00

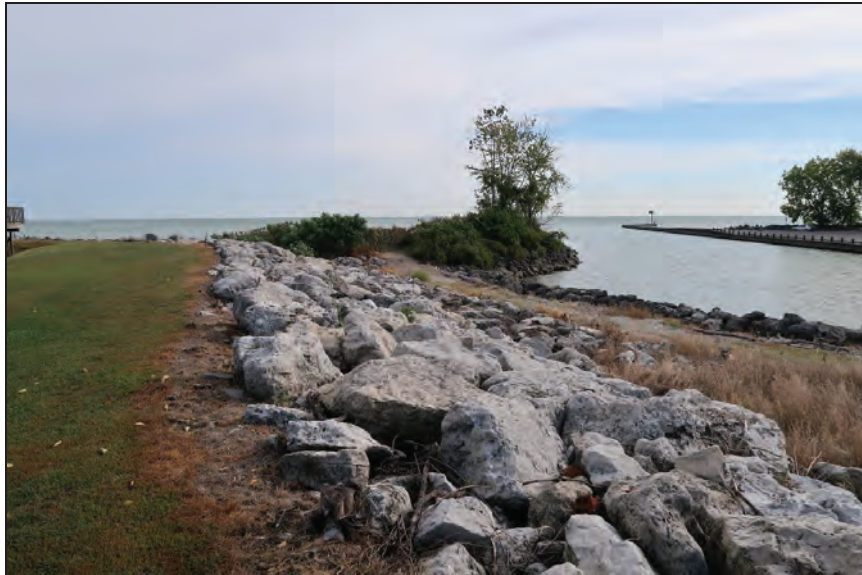
**Inspect ID:** OH29\_2022\_r\_0012 **Title:** USACE\_CELRB\_OH29\_2022\_r\_0012\_1.jpg  
**Rated Item:** 12. Riprap Revetments & Bank Protection **Caption:** Rating: Acceptable;  
**Remarks:** Riprap on the levee waterside slope at 12763 Lagoon Drive is clear of vegetation.; **Action:** NA; **Station\_1:** -1+53; **Station\_2:** 0+10

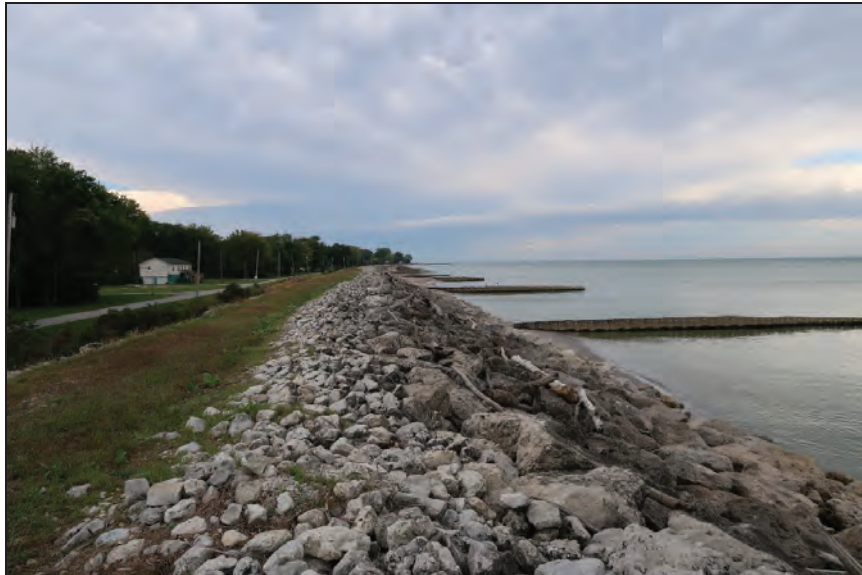
**Inspect ID:** OH29\_2022\_r\_0018 **Title:** USACE\_CELRB\_OH29\_2022\_r\_0018\_1.jpg  
**Rated Item:** 12. Riprap Revetments & Bank Protection **Caption:** Rating: Acceptable;  
**Remarks:** Riprap on the levee waterside slope between Rialto Drive and Park Colony Boulevard is clear of vegetation.; **Action:** NA; **Station\_1:** 96+73; **Station\_2:** 100+00

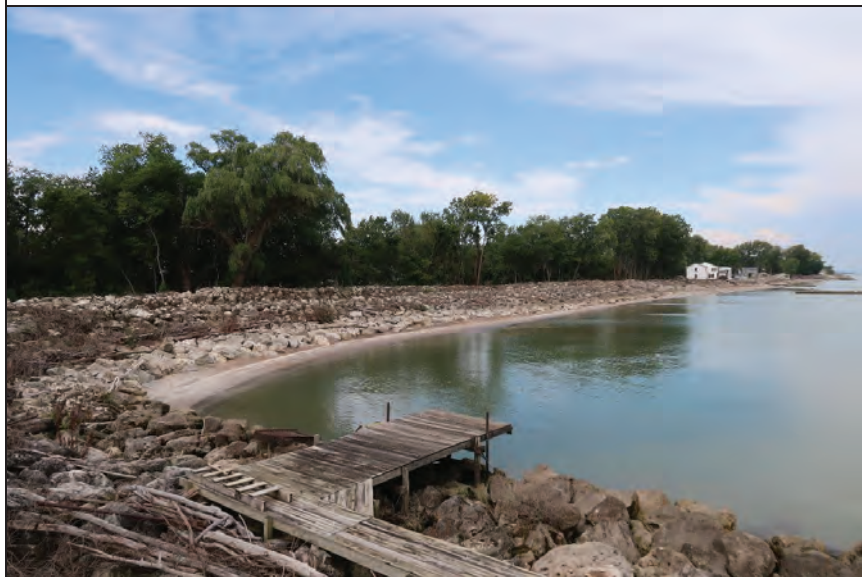
**Inspect ID:** OH29\_2022\_r\_0031 **Title:** USACE\_CELRB\_OH29\_2022\_r\_0031\_1.jpg  
**Rated Item:** 12. Riprap Revetments & Bank Protection **Caption:** Rating: Acceptable;  
**Remarks:** Riprap on the levee waterside slope from the west end of Lagoon Drive to La Course Drive.; **Action:** NA; **Station\_1:** 37+69; **Station\_2:** 30+43

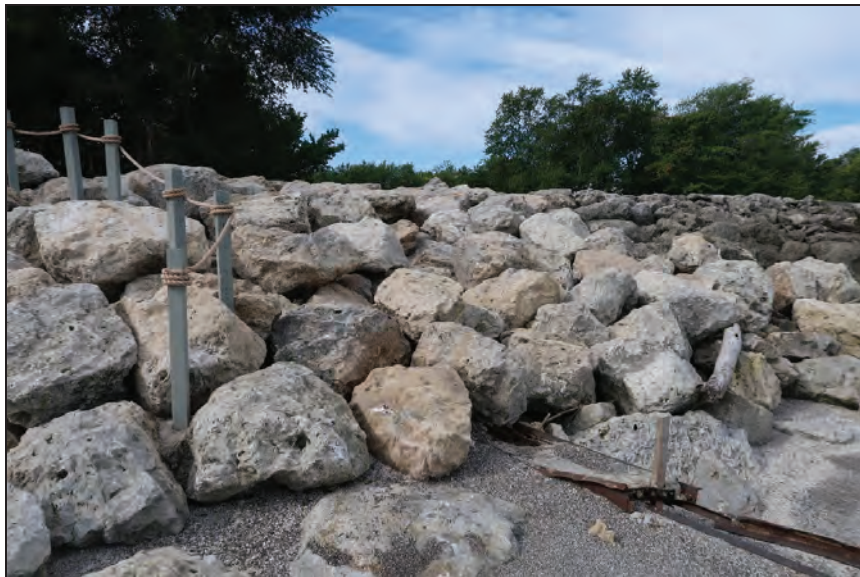
**Inspect ID:** OH29\_2022\_r\_0034 **Title:** USACE\_CELRB\_OH29\_2022\_r\_0034\_1.jpg  
**Rated Item:** 12. Riprap Revetments & Bank Protection **Caption:** Rating: Acceptable;  
**Remarks:** The sponsor has removed the concrete slab and replaced the removed riprap at 12153 Corduroy Road.; **Action:** NA; **Station\_1:** 50+60

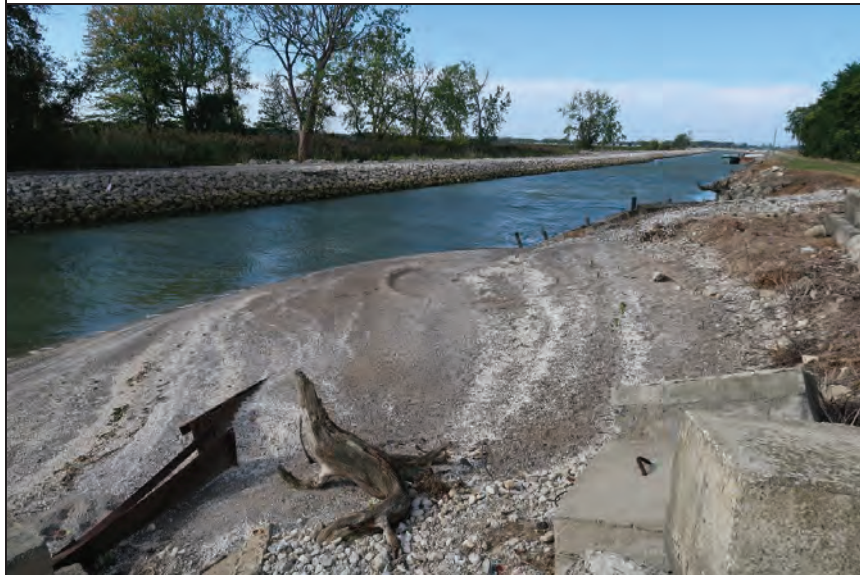
13. Revetments other than Riprap	<b>NA</b>	<b>A</b> Existing revetment protection is properly maintained, undamaged, and clearly visible.	OH29_2022_r_0010: Station_1 -4+00: Observation: SSP wall failure at Wards Canal.: Recommendation: The SSP wall should be monitored for further failure. This area should remain clear of vegetation to allow for proper inspection of the levee. (NA)
		<b>M</b> Minor revetment displacement or deterioration that does not pose an immediate threat to the integrity of the levee. Unwanted vegetation must be cleared or sprayed with an appropriate herbicide.	
		<b>U</b> Significant revetment displacement, deterioration, or exposure of bedding observed. Scour activity is undercutting banks, eroding embankments, or impairing channel flows by causing turbulence or shoaling. Revetment protection is hidden by dense brush and trees.	
		<b>N/A</b> There are no such revetments protecting this feature of the segment / system.

**Inspect ID:** OH29\_2022\_r\_0010 **Title:** USACE\_CELRB\_OH29\_2022\_r\_0010\_1.jpg  
**Rated Item:** 13. Revetments other than Riprap **Caption:** Rating: Not Applicable;  
**Remarks:** Observation: SSP wall failure at Wards Canal.; **Action:** Recommendation: The SSP wall should be monitored for further failure. This area should remain clear of vegetation to allow for proper inspection of the levee.; **Station\_1:** -4+00

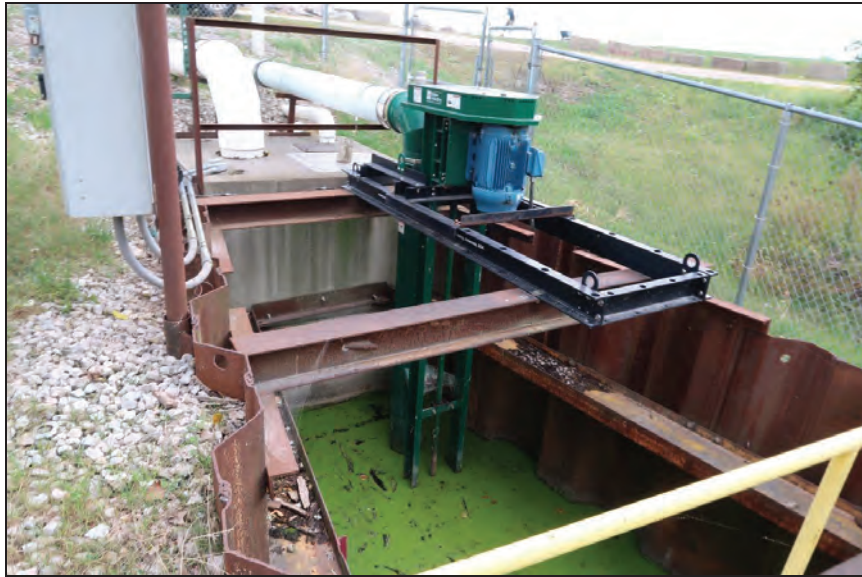
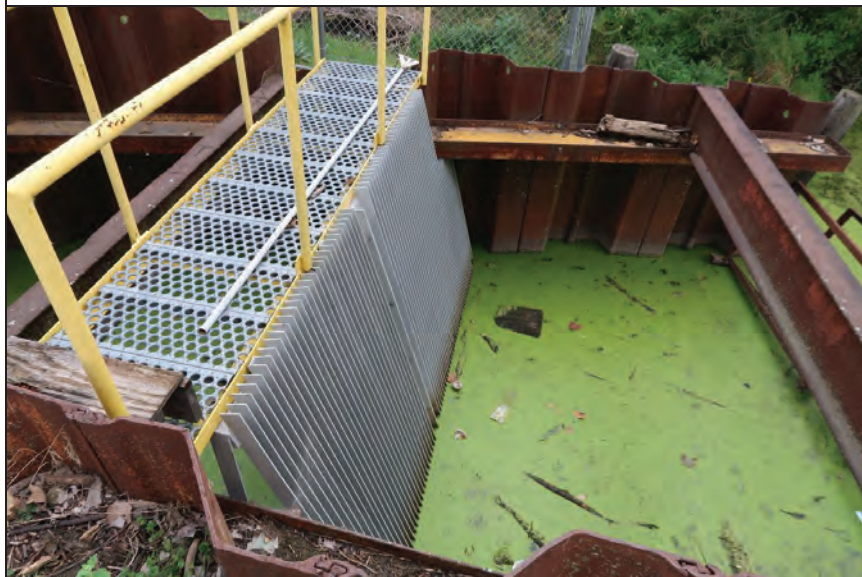
**Inspect ID:** OH29\_2022\_r\_0025 **Title:** USACE\_CELRB\_OH29\_2022\_r\_0025\_1.jpg  
**Rated Item:** 1. Pump Stations Operating, Maintenance, Training, & Inspection Records  
**Caption:** Rating: Acceptable; Remarks: Cooley Canal Pump Station.; Action: NA;  
Station\_1: 154+44

**Inspect ID:** OH29\_2022\_r\_0025 **Title:** USACE\_CELRB\_OH29\_2022\_r\_0025\_2.jpg  
**Rated Item:** 1. Pump Stations Operating, Maintenance, Training, & Inspection Records  
**Caption:** Rating: Acceptable; Remarks: Cooley Canal Pump Station.; Action: NA;  
Station\_1: 154+44
