DEPARTMENT OF THE ARMY
CORPS OF ENGINEERS, BUFFALO DISTRICT
1776 NIAGARA STREET
BUFFALO, NEW YORK 14207-3111

November 1, 2021

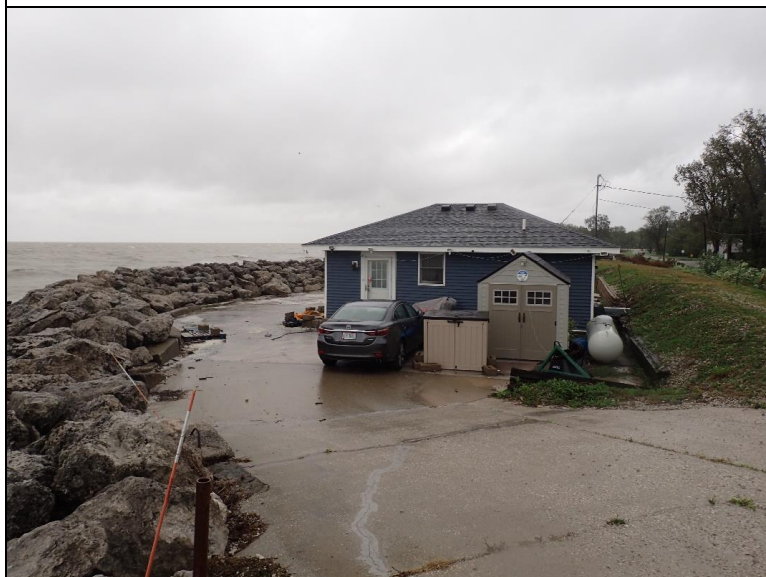
Inspect ID: OH29_2021_r_0013 **Title:** USACE_CELRB_OH29_2021_r_0013_1.jpg
Rated Item: 3. Encroachments **Caption:** Rating: Acceptable; **Remarks:** Pre-project cottages along Lakeway Drive at end of Waterway Road; one remains, one removed (foundation remains).; **Action:** NA; **Station_1:** 98+64

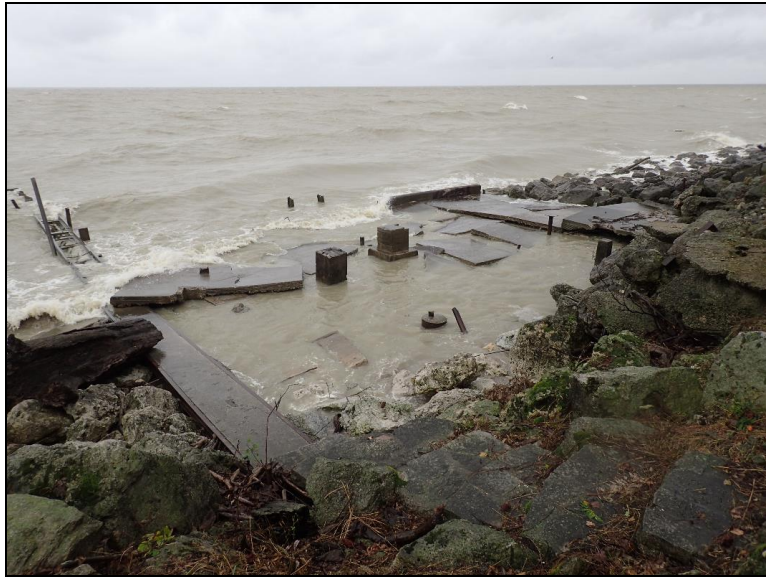
Inspect ID: OH29_2021_r_0007 **Title:** USACE_CELRB_OH29_2021_r_0007_1.jpg
Rated Item: 12. Riprap Revetments & Bank Protection **Caption:** Rating: Unacceptable;
Remarks: Riprap has been removed from levee waterside slope over the distance of approx. 55' near concrete slab, just west of 12153 Corduroy Road.; **Action:** Replace broken up concrete slab with proper riprap. Should be placed from waterside toe to top of crest.; **Station_1:** 50+60

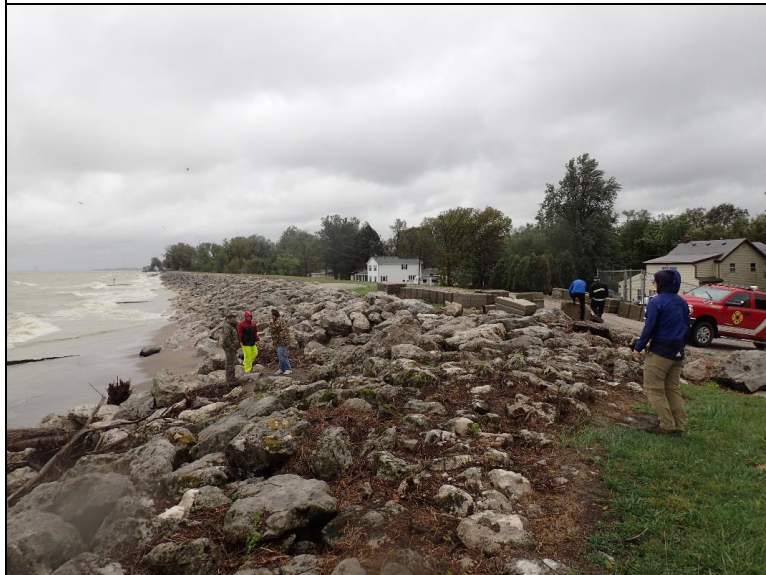
Inspect ID: OH29_2021_r_0008 **Title:** USACE_CELRB_OH29_2021_r_0008_1.jpg
Rated Item: 12. Riprap Revetments & Bank Protection **Caption:** Rating: Acceptable;
Remarks: Riprap on levee waterside slope along Corduroy Road is in acceptable condition.; **Action:** NA; **Station_1:** 52+53

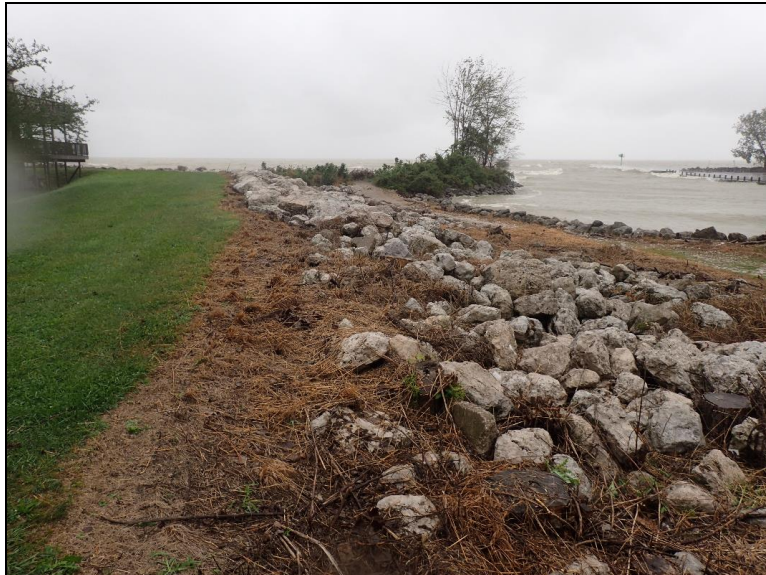
Inspect ID: OH29_2021_r_0027 **Title:** USACE_CELRB_OH29_2021_r_0027_1.jpg
Rated Item: 12. Riprap Revetments & Bank Protection **Caption:** Rating: Acceptable;
 Remarks: Riprap on levee waterside slope at 12763 Lagoon Drive, near Wards Canal, in acceptable condition.; Action: NA; Station_1: -1+53; Station_2: 0+10

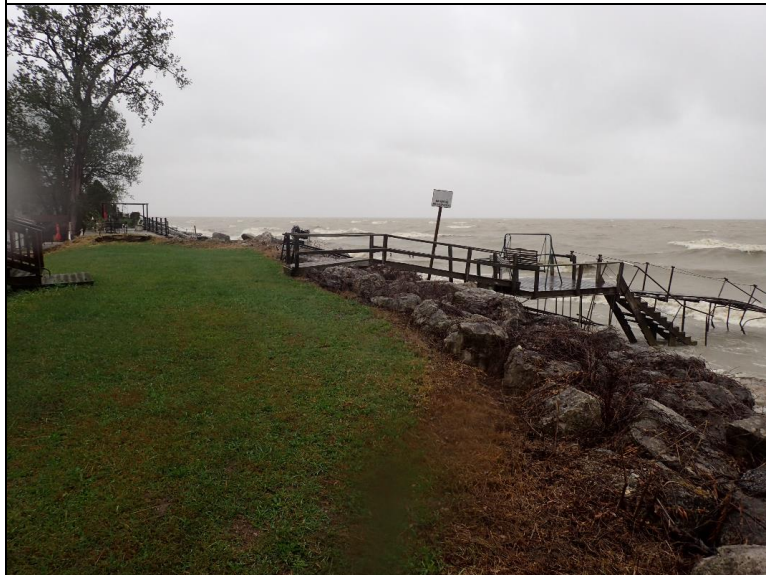
Inspect ID: OH29_2021_r_0027 **Title:** USACE_CELRB_OH29_2021_r_0027_2.jpg
Rated Item: 12. Riprap Revetments & Bank Protection **Caption:** Rating: Acceptable;
 Remarks: Riprap on levee waterside slope at 12763 Lagoon Drive, near Wards Canal, in acceptable condition.; Action: NA; Station_1: -1+53; Station_2: 0+10

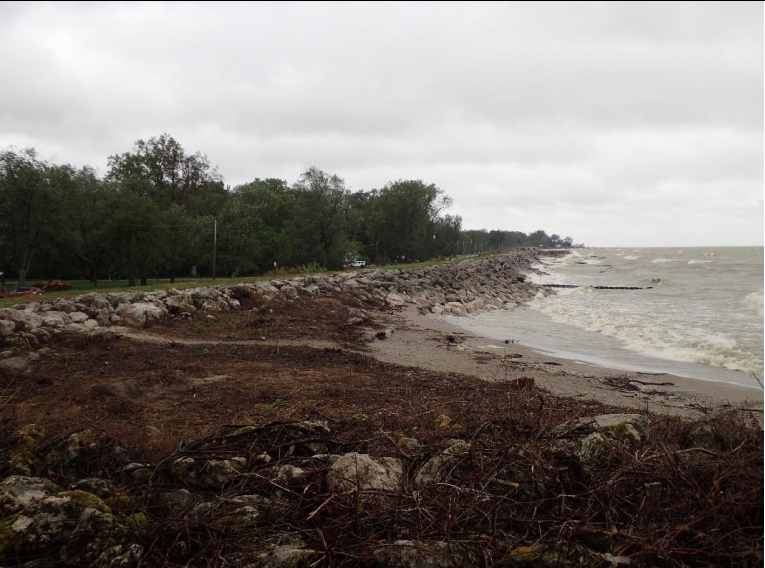
<p>Inspect ID: OH29_2021_r_0034 Title: USACE_CELRB_OH29_2021_r_0034_1.jpg Rated Item: 12. Riprap Revetments & Bank Protection Caption: Rating: Acceptable; Remarks: Riprap on levee waterside slope is in acceptable condition along Lakeway Drive between Rialto Drive and Park Colony Boulevard.; Action: NA; Station_1: 96+73; Station_2: 100+00</p>

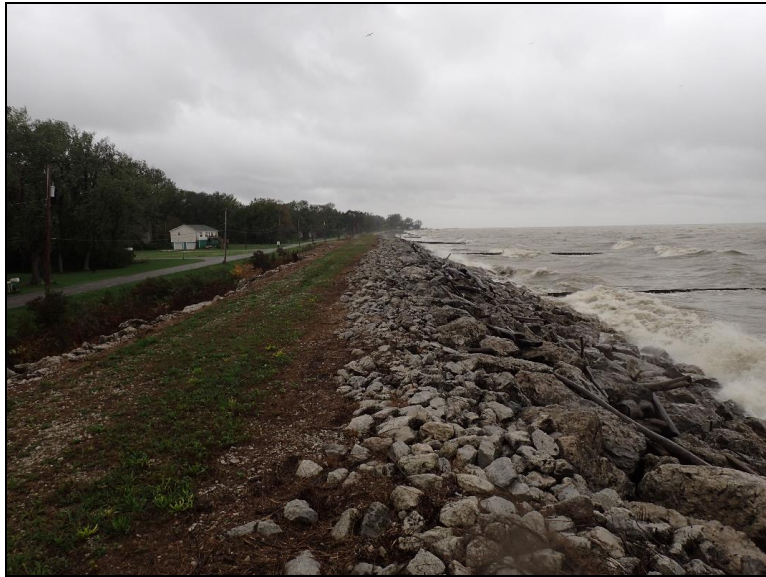
Inspect ID: OH29_2021_r_0034 **Title:** USACE_CELRB_OH29_2021_r_0034_2.jpg
Rated Item: 12. Riprap Revetments & Bank Protection **Caption:** Rating: Acceptable;
Remarks: Riprap on levee waterside slope is in acceptable condition along Lakeway Drive between Rialto Drive and Park Colony Boulevard.; **Action:** NA; **Station_1:** 96+73; **Station_2:** 100+00

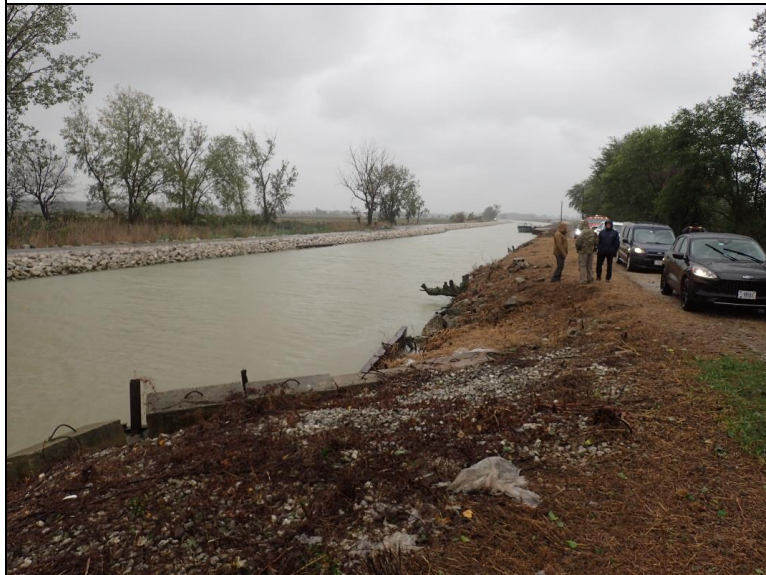
Inspect ID: OH29_2021_r_0025 **Title:** USACE_CELRB_OH29_2021_r_0025_1.jpg
Rated Item: 13. Revetments other than Riprap **Caption:** Rating: Unacceptable;
Remarks: SSP wall failure at Wards Canal levee waterside toe threatens dike integrity 300' upstream of canal entrance.; **Action:** Repair and/or stabilize SSP wall with toe stone.; **Station_1:** -4+00

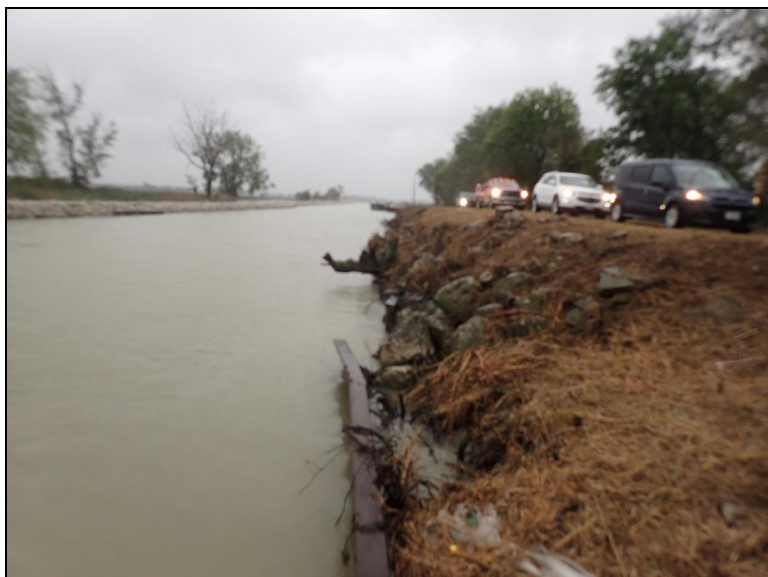
Inspect ID: OH29_2021_r_0025 **Title:** USACE_CELRB_OH29_2021_r_0025_2.jpg
Rated Item: 13. Revetments other than Riprap **Caption:** Rating: Unacceptable;
Remarks: SSP wall failure at Wards Canal levee waterside toe threatens dike integrity 300' upstream of canal entrance.; **Action:** Repair and/or stabilize SSP wall with toe stone.;
Station_1: -4+00
