Levee Segment
**Lake Erie - Reno
Beach-Howard
Farms**

Inspection Type
Site Visit

Start Date
26-Sept-2023

Site Visit Summary

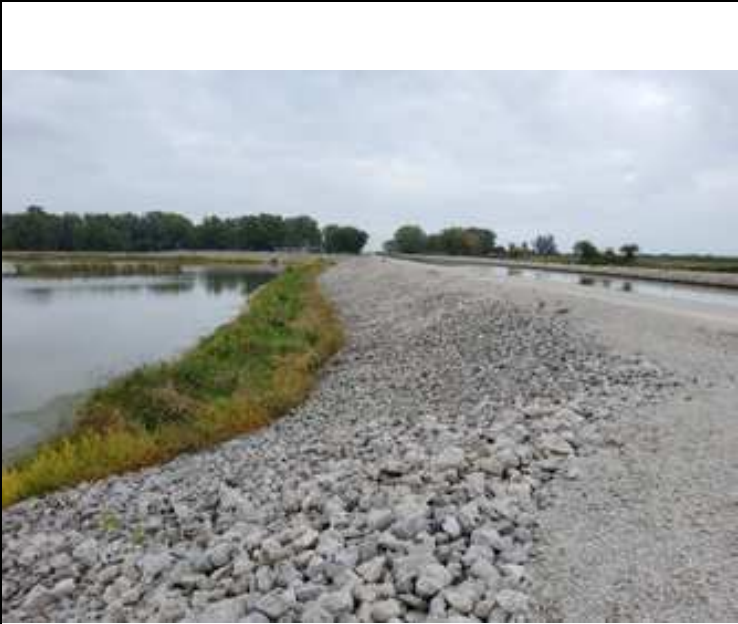
Category:	Levee Embankments	Item:	Unwanted Vegetation
Observation ID:	2023-0001		
Description:	Soft vegetation is growing along the landside toe of the levee adjacent to Wards Canal.		
Caption:	No User Rating (Site Visit) - Looking north from the fish ladder alteration.		
Lat/Long:	41.64925/-83.24365

Toledo Metroparks was present during for the fish ladder alteration inspection. Toledo Metroparks continues to satisfactorily maintain their structure in accordance with the 408 permission conditions. Soft vegetation was noted along the landside toe of the Wards Canal levee. Toledo Metroparks will include this work during the next maintenance cycle.

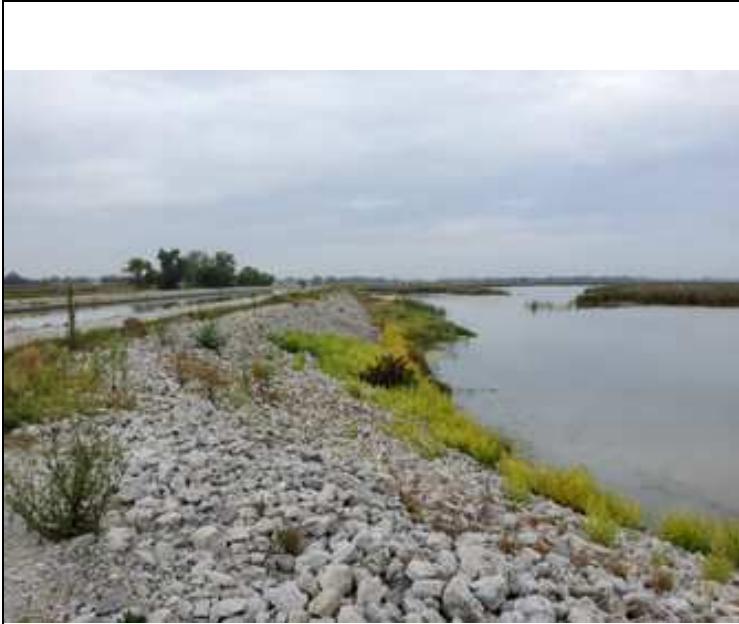
Category:	Levee Embankments	Item:	Unwanted Vegetation
Observation ID:	2023-0001		
Description:	Soft vegetation is growing along the landside toe of the levee adjacent to Wards Canal.		
Caption:	No User Rating (Site Visit) - Looking south from the fish ladder alteration.		
Lat/Long:	41.64925/-83.24365

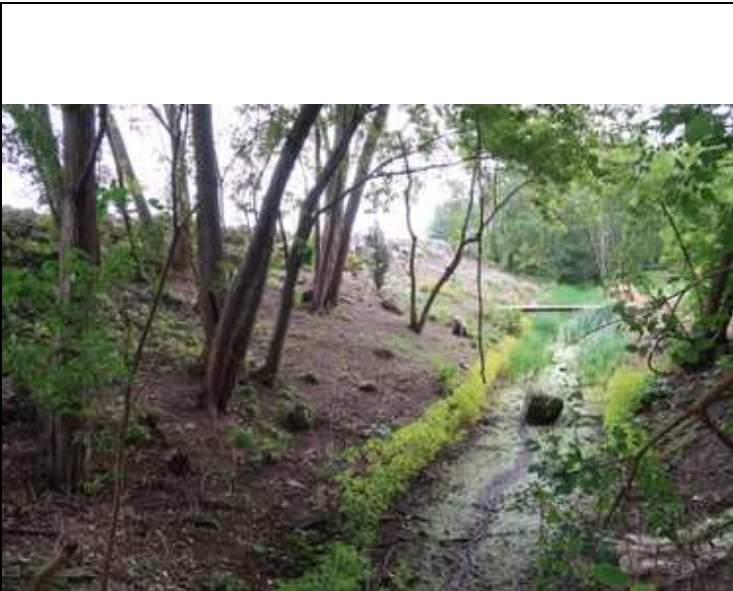
Category:	Levee Embankments	Item:	Unwanted Vegetation
Observation ID:	2023-0003		
Description:	Trees and woody vegetation on the levee landside slope between 12727 and 12743 Lagoon Drive.		
Caption:	No User Rating (Site Visit) - Looking from the end of Bayonne Drive.		
Lat/Long:	41.65738/-83.25070

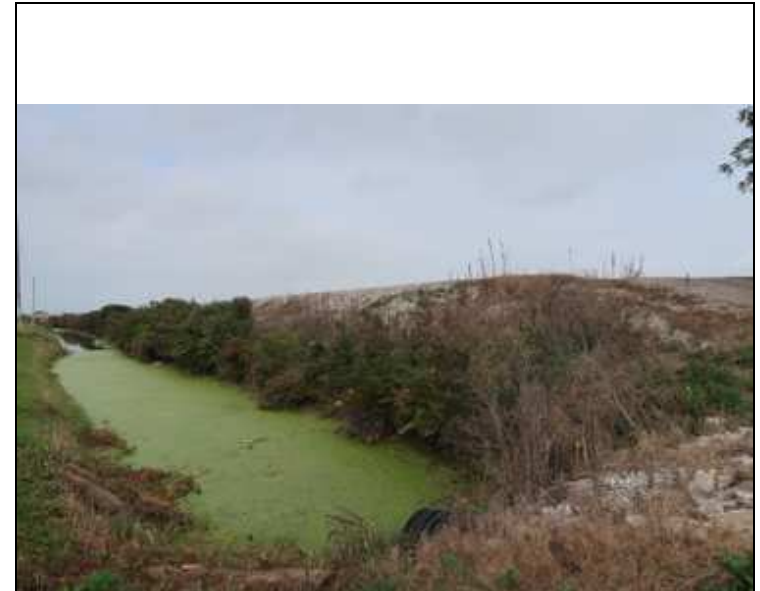
Category:	Levee Embankments	Item:	Unwanted Vegetation
Observation ID:	2023-0006		
Description:	Woody vegetation along the landside toe of the levee along Lakeway Drive, between Rialto Drive and Dyke Road.		
Caption:	No User Rating (Site Visit) - Looking west from Rialto Drive.		
Lat/Long:	41.66474/-83.26480

There are existing retaining walls along the landside of the levee between Rialto Drive and Dyke Road. These walls were existing prior to construction of the project and therefore are not considered part of the project's O&M. However, they have deteriorated and should be monitored. In the event of a failed wall, any subsequent slope degradation must be corrected.

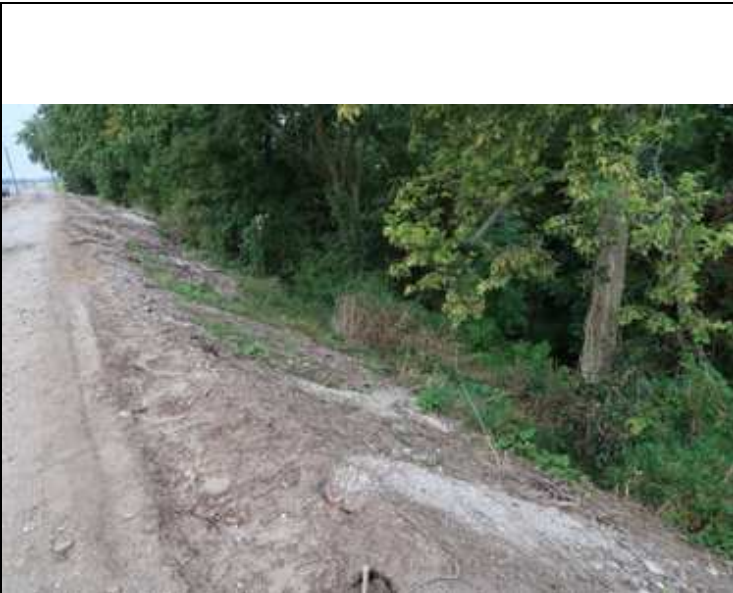
Category:	Levee Embankments	Item:	Sod Cover
Observation ID:	2023-0008		
Description:	The landside slope of the Wards Canal levee has degraded following the initial removal of the large trees. The steep side slopes have exposed soil, increasing the risk of erosion and sloughing.		
Caption:	No User Rating (Site Visit) - Looking south from the end of La Pointe Drive.		
Lat/Long:	41.65001/-83.24111

The Wards Canal levee landside slope is degraded after the initial removal of the large trees. The side slopes are steep, and the exposed soil may be susceptible to erosion and/or sloughing. Animal burrows are also present in this area and are being filled in accordance with the USACE Animal Burrow SOP. The Conservancy is working to secure funding to begin to address the deficiencies along the section of the levee. USACE will work with the Conservancy on an appropriate course of action.

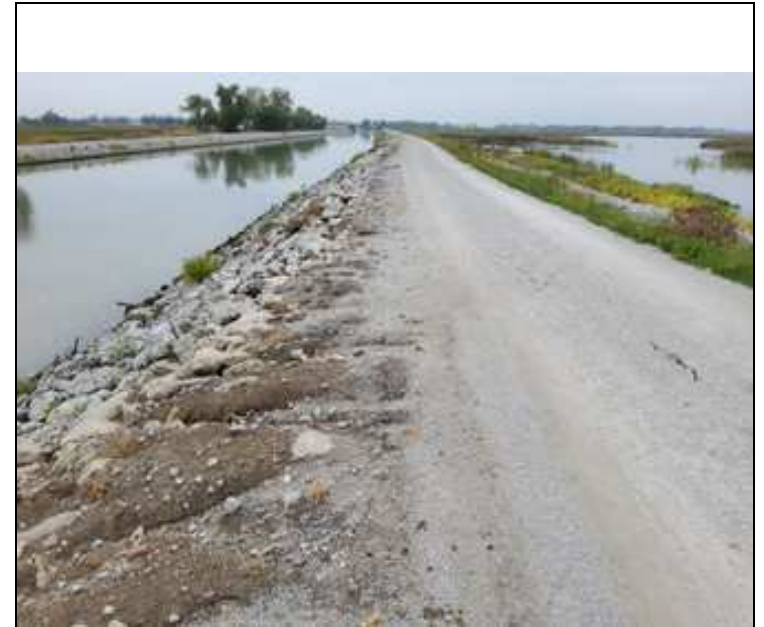
Category:	Levee Embankments	Item:	Erosion/ Bank Caving
Observation ID:	2023-0002		
Description:	Erosion along the crest of the Wards Canal levee should be monitored. If erosion progresses to a point where it threatens the stability of the side slope, corrective measures will be necessary.		
Caption:	No User Rating (Site Visit) - Looking south from the fish ladder alteration.		
Lat/Long:	41.64815/-83.24573

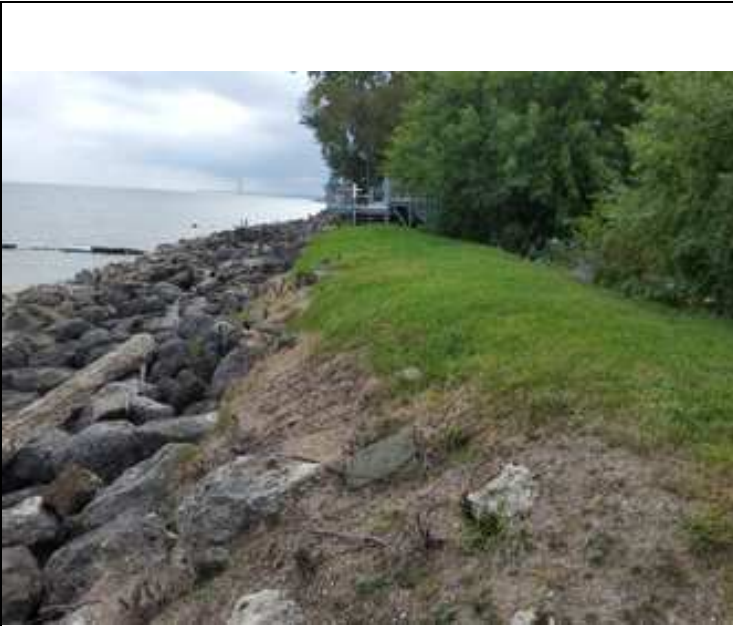
Category:	Levee Embankments	Item:	Erosion/ Bank Caving
Observation ID:	2023-0005		
Description:	Erosion along the levee crest at 12153 Corduroy Road.		
Caption:	No User Rating (Site Visit)		
Lat/Long:	41.65953/-83.25425

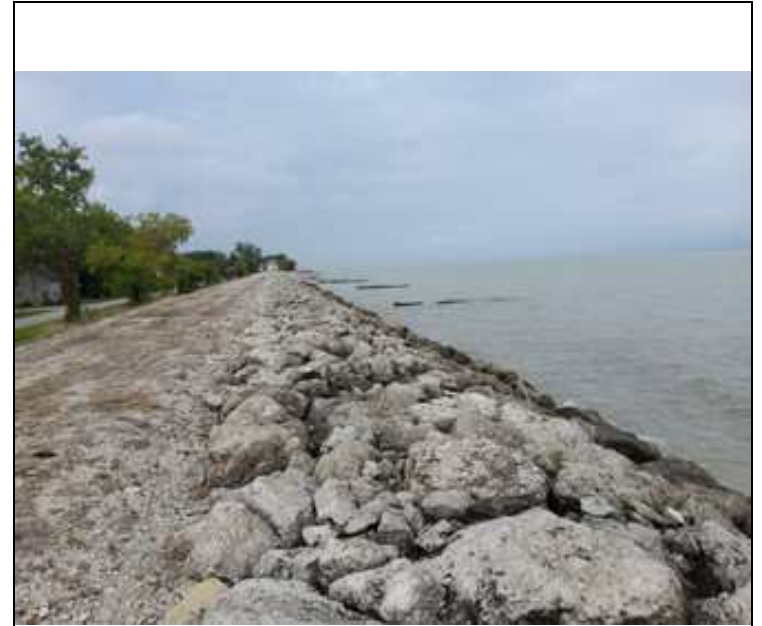
Category:	Levee Embankments	Item:	Riprap Revetments &
Observation ID:	2023-0004		
Description:	The armor stone on the waterside slope of the levee along Lakeway Drive is in satisfactory condition and is free of vegetation.		
Caption:	No User Rating (Site Visit) - Looking west from Rialto Drive.		
Lat/Long:	41.65967/-83.25454

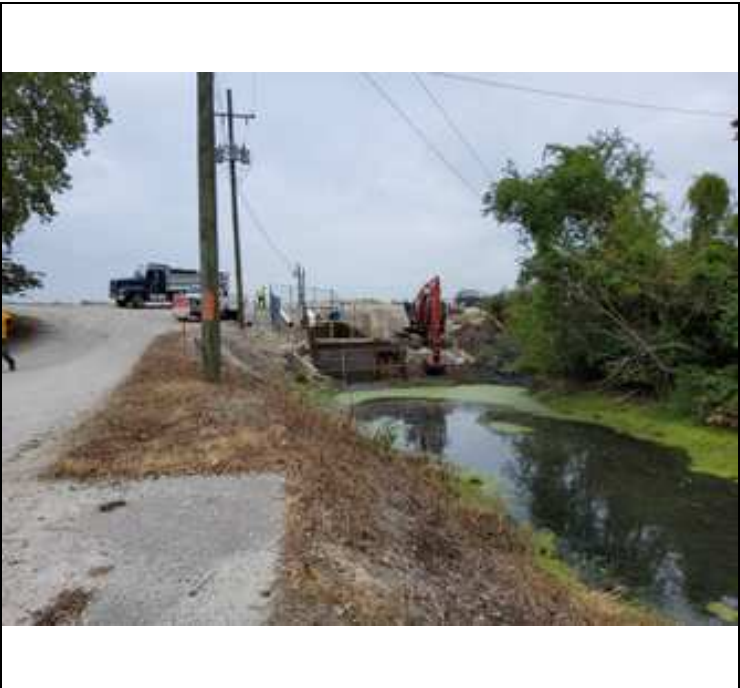
Category:	Pump Stations	Item:	Pumps
Observation ID:	2023-0007		
Description:	Debris removal operations are currently underway at the Cooley Canal Pump Station. Additionally, improvements are being made to the electrical control panel systems at the station.		
Caption:	No User Rating (Site Visit)		
Lat/Long:	41.67465/-83.28308

Work was underway at the Cooley Canal Pump Station. Scope of work included debris removal from the inlet as well as control panel improvements.

The power take-off driven (PTO) pump was exercised during the site visit. This pump should be exercised at least annually or in accordance with the manufacturer's recommendations. The inlet and outlet structures should be kept clear of vegetation and debris.
