SUBJECT: FY18 Periodic Inspection, Flood Risk Management Project, Reno Beach-Howard Farms, Lucas County, Ohio (08/22/18)

Lake Erie – Reno Beach

FY 2018 PERIODIC INSPECTION REPORT

INSPECTED 22 AUGUST 2018

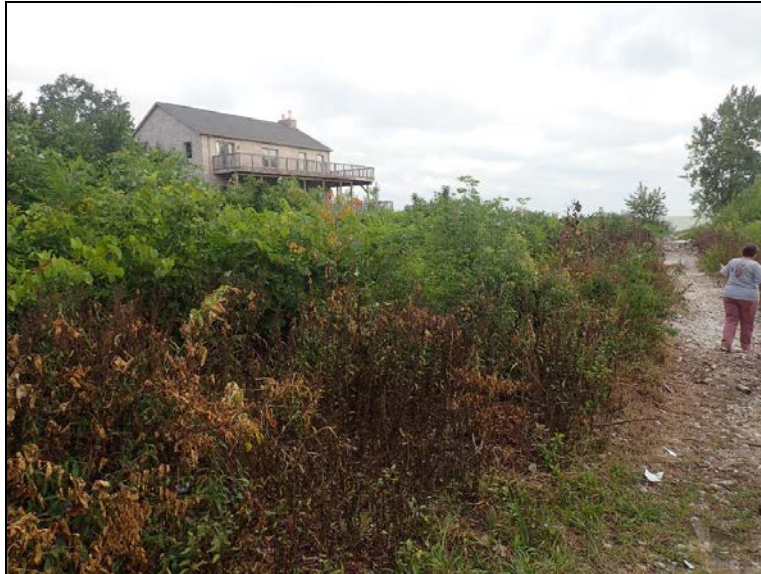
Inspect ID: OH29_2018_p_0010 **Title:** USACE_CELRB_OH29_2018_p_0010_4.jpg
Rated Item: 1. Unwanted Vegetation Growth **Caption:** Rating: Unacceptable; Remarks: Significant unwanted vegetation and trees on landside and waterside.; Action: Remove unwanted vegetation and trees.

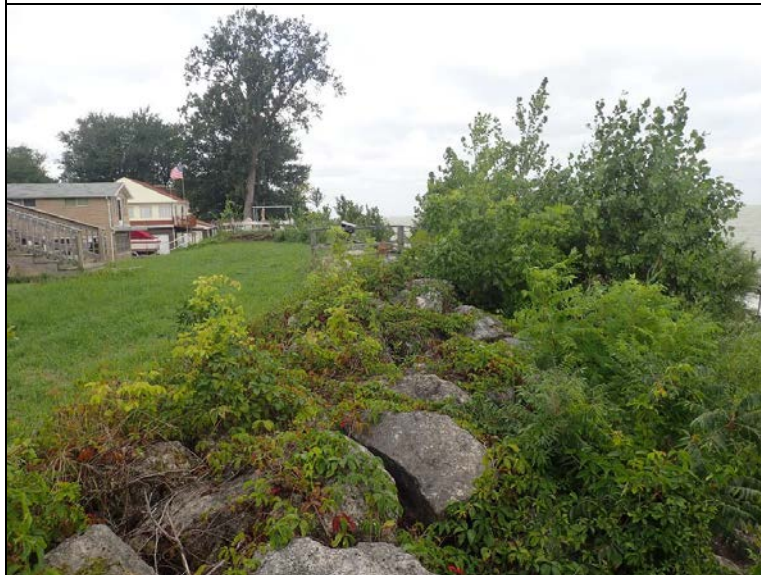
Inspect ID: OH29_2018_p_0016 **Title:** USACE_CELRB_OH29_2018_p_0016_1.jpg
Rated Item: 1. Unwanted Vegetation Growth **Caption:** Rating: Unacceptable; Remarks: Significant trees and unwanted vegetation on both slopes and crown along Lagoon Drive.; Action: Remove trees and unwanted vegetation.

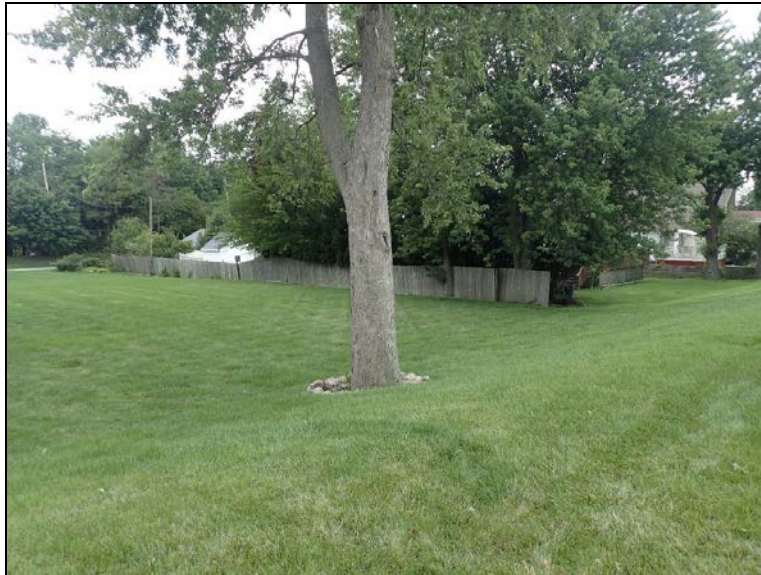
Inspect ID: OH29_2018_p_0026 **Title:** USACE_CELRB_OH29_2018_p_0026_1.jpg
Rated Item: 1. Unwanted Vegetation Growth **Caption:** Rating: Minimally Acceptable;
Remarks: Large tree on levee landside toe.; **Action:** Remove tree within the vegetation free zone and reestablish adequate sod cover. Perform regular mowing to prevent further unwanted vegetation development.

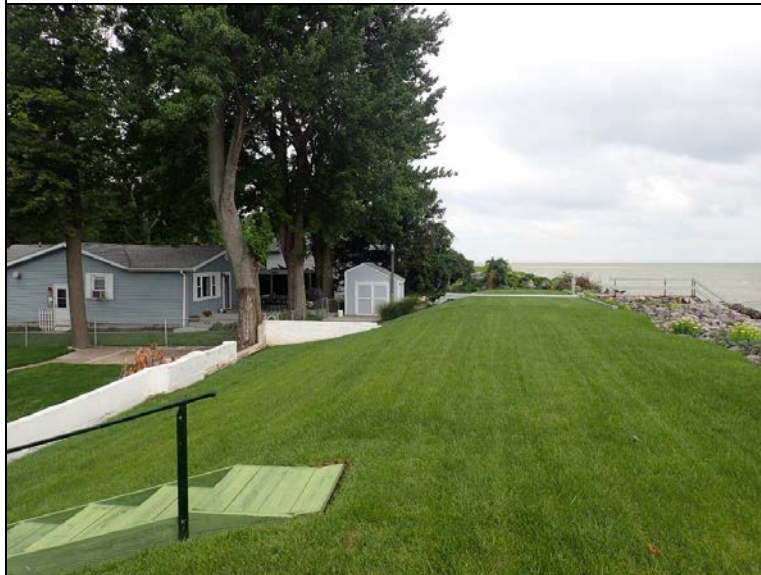
Inspect ID: OH29_2018_p_0029 **Title:** USACE_CELRB_OH29_2018_p_0029_1.jpg
Rated Item: 1. Unwanted Vegetation Growth **Caption:** Rating: Minimally Acceptable;
Remarks: Large tree on levee landside.; **Action:** Remove tree within the vegetation free zone and reestablish adequate sod cover. Perform regular mowing to prevent further unwanted vegetation development.

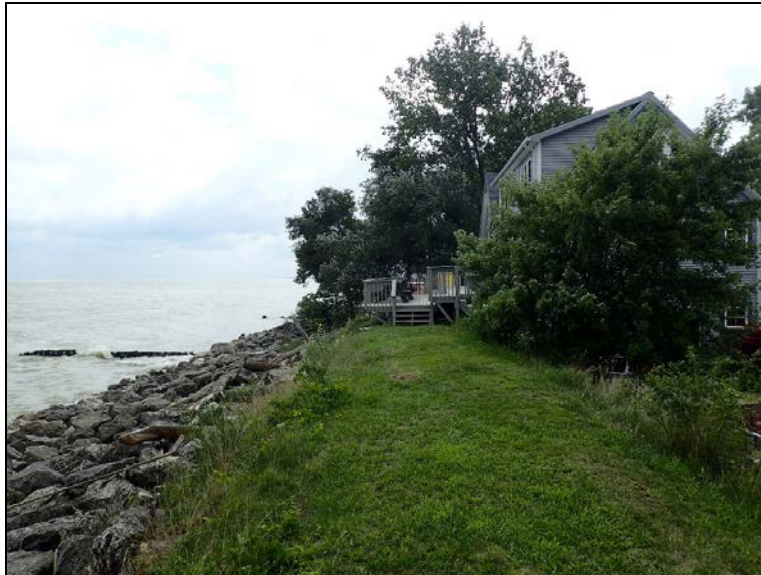
Inspect ID: OH29_2018_p_0038 **Title:** USACE_CELRB_OH29_2018_p_0038_2.jpg
Rated Item: 1. Unwanted Vegetation Growth **Caption:** Rating: Unacceptable; Remarks: Trees and unwanted vegetation on levee landside at residential home on Corduroy.;
Action: Remove unwanted vegetation within the vegetation free zone (15 feet from the levee toe) and reestablish levee prism with adequate sod cover. Perform regular mowing to prevent further unwanted vegetation development.

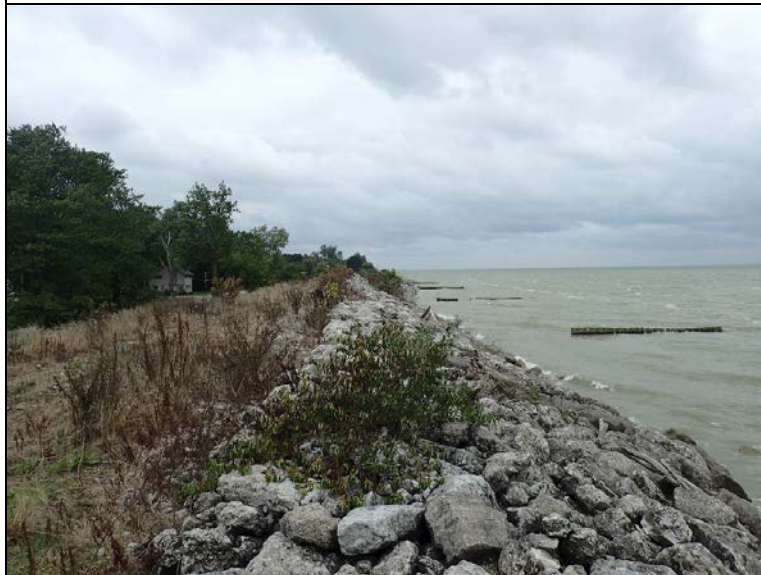
Inspect ID: OH29_2018_p_0039 **Title:** USACE_CELRB_OH29_2018_p_0039_1.jpg
Rated Item: 1. Unwanted Vegetation Growth **Caption:** Rating: Minimally Acceptable; Remarks: Soft and woody unwanted vegetation in riprap on the levee waterside from along Corduroy to 600 feet west of the pump station along Dyke Road.;
Action: Remove unwanted vegetation within the vegetation free zone. Perform regular maintenance to prevent further unwanted vegetation development.

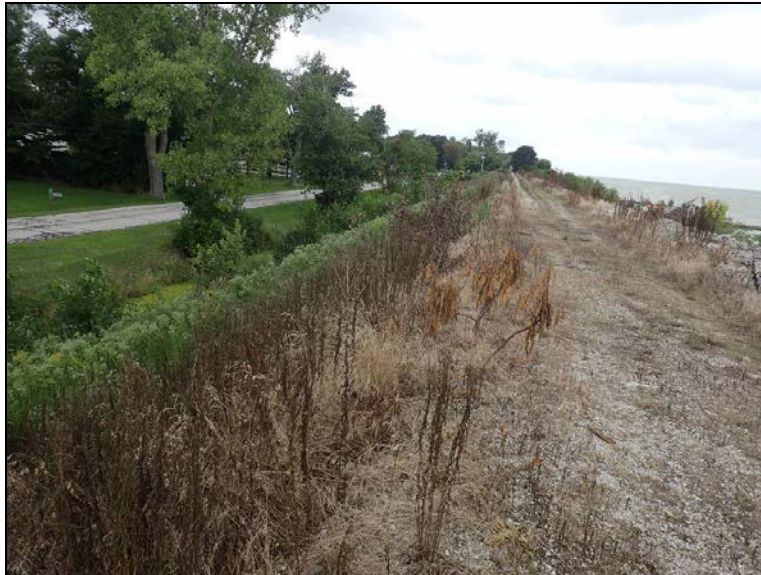
Inspect ID: OH29_2018_p_0041 **Title:** USACE_CELRB_OH29_2018_p_0041_1.jpg
Rated Item: 1. Unwanted Vegetation Growth **Caption:** Rating: Minimally Acceptable;
Remarks: Soft vegetation on levee landside slope along Corduroy.; **Action:** Remove unwanted vegetation within the vegetation free zone and reestablish levee prism with adequate sod cover. Perform regular mowing to prevent further unwanted vegetation development.

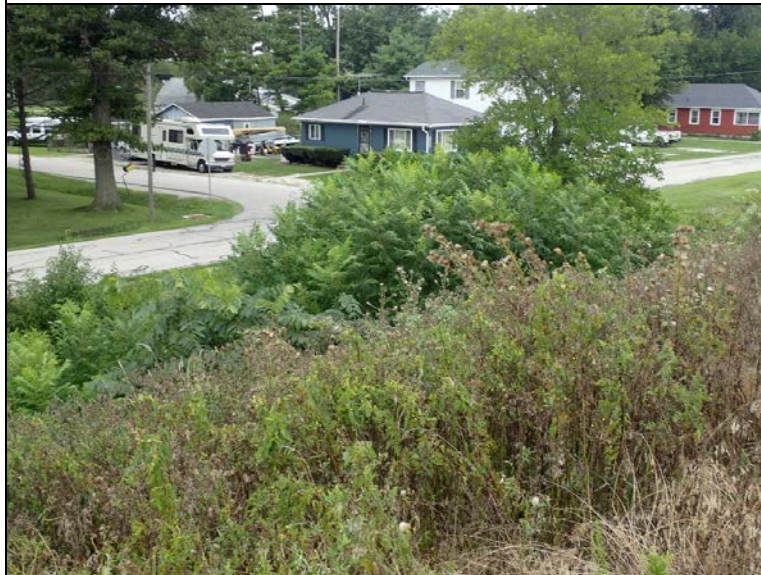
Inspect ID: OH29_2018_p_0041 **Title:** USACE_CELRB_OH29_2018_p_0041_2.jpg
Rated Item: 1. Unwanted Vegetation Growth **Caption:** Rating: Minimally Acceptable;
Remarks: Soft vegetation on levee landside slope along Corduroy.; **Action:** Remove unwanted vegetation within the vegetation free zone and reestablish levee prism with adequate sod cover. Perform regular mowing to prevent further unwanted vegetation development.

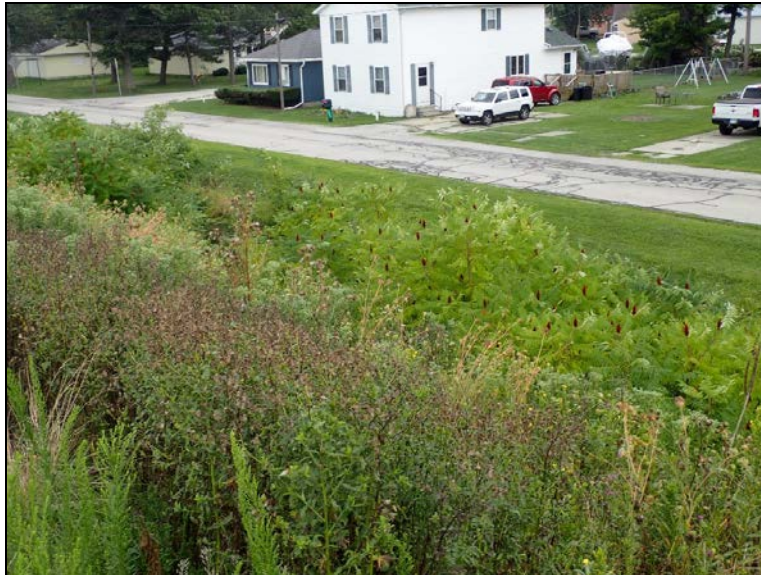
Inspect ID: OH29_2018_p_0041 **Title:** USACE_CELRB_OH29_2018_p_0041_3.jpg
Rated Item: 1. Unwanted Vegetation Growth **Caption:** Rating: Minimally Acceptable;
Remarks: Soft vegetation on levee landside slope along Corduroy.; **Action:** Remove unwanted vegetation within the vegetation free zone and reestablish levee prism with adequate sod cover. Perform regular mowing to prevent further unwanted vegetation development.

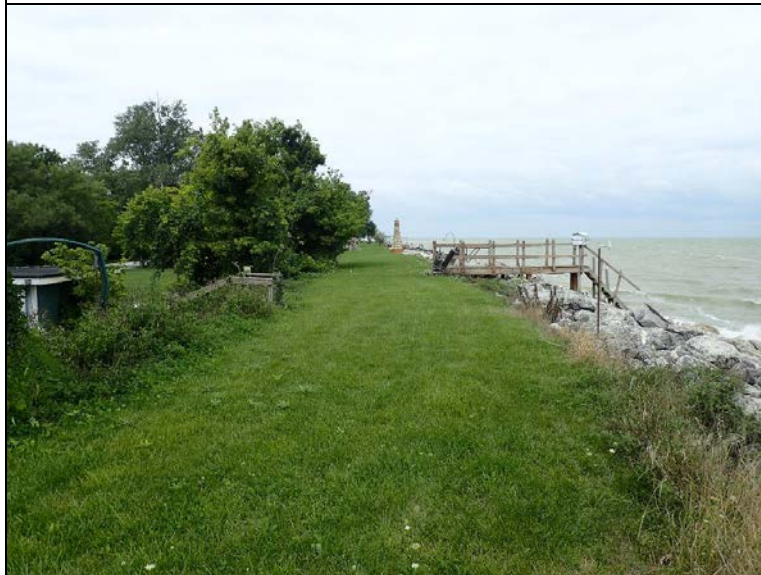
Inspect ID: OH29_2018_p_0046 **Title:** USACE_CELRB_OH29_2018_p_0046_1.jpg
Rated Item: 1. Unwanted Vegetation Growth **Caption:** Rating: Unacceptable; **Remarks:** Trees and unwanted vegetation on levee landside along Dyke Road.; **Action:** Remove unwanted vegetation within the vegetation free zone and reestablish levee prism with adequate sod cover. Perform regular mowing to prevent further unwanted vegetation development.

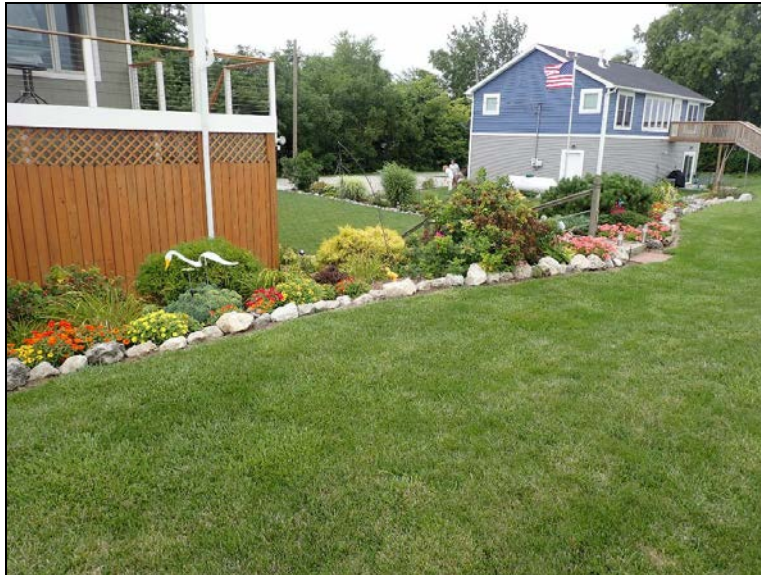
Inspect ID: OH29_2018_p_0046 **Title:** USACE_CELRB_OH29_2018_p_0046_2.jpg
Rated Item: 1. Unwanted Vegetation Growth **Caption:** Rating: Unacceptable; Remarks:
Trees and unwanted vegetation on levee landside along Dyke Road.; Action: Remove
unwanted vegetation within the vegetation free zone and reestablish levee prism with
adequate sod cover. Perform regular mowing to prevent further unwanted vegetation
development.

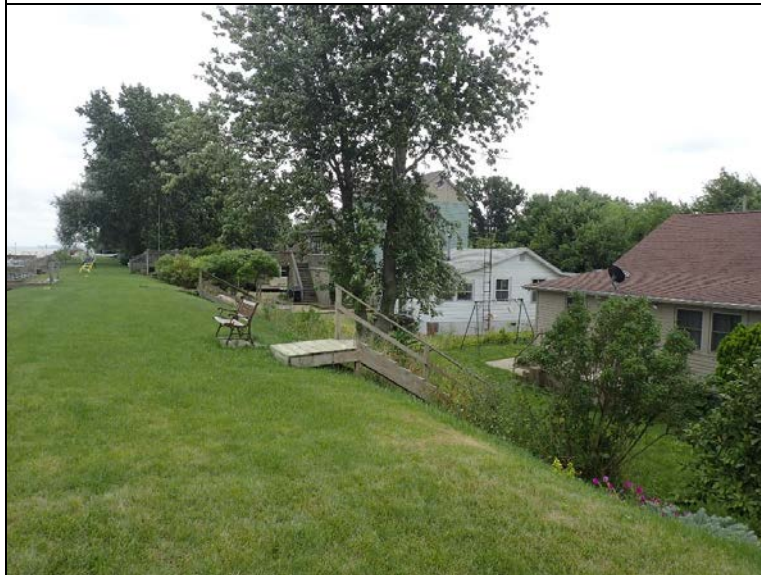
Inspect ID: OH29_2018_p_0051 **Title:** USACE_CELRB_OH29_2018_p_0051_1.jpg
Rated Item: 1. Unwanted Vegetation Growth **Caption:** Rating: Minimally Acceptable;
Remarks: 3 trees on levee landside toe 500' east of the west end of Dyke Road.; Action:
Remove trees within the vegetation free zone and reestablish adequate sod cover. Perform
regular mowing to prevent further unwanted vegetation development.

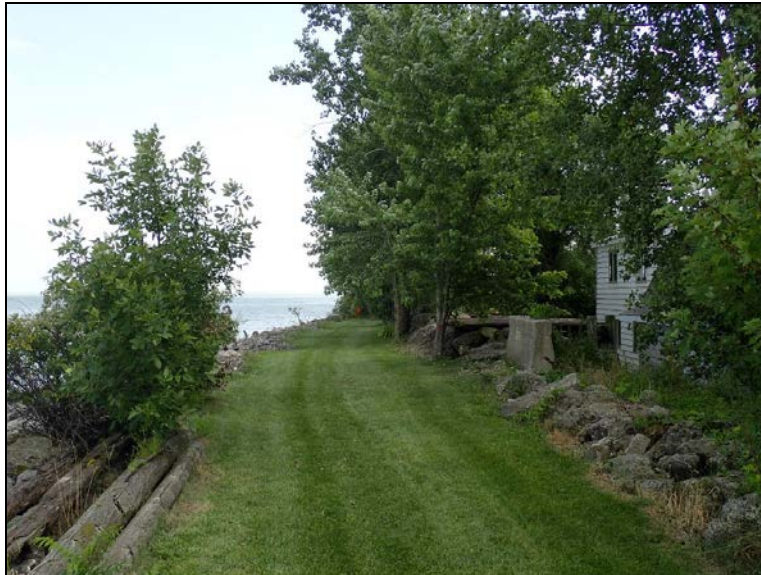
Inspect ID: OH29_2018_p_0071 **Title:** USACE_CELRB_OH29_2018_p_0071_1.jpg
Rated Item: 1. Unwanted Vegetation Growth **Caption:** Rating: Unacceptable; Remarks: Significant trees, unwanted vegetation, and gardens on levee landside slope along Dyke Road.; Action: Remove unwanted vegetation within the vegetation free zone and reestablish levee prism with adequate sod cover. Perform regular mowing to prevent further unwanted vegetation development.

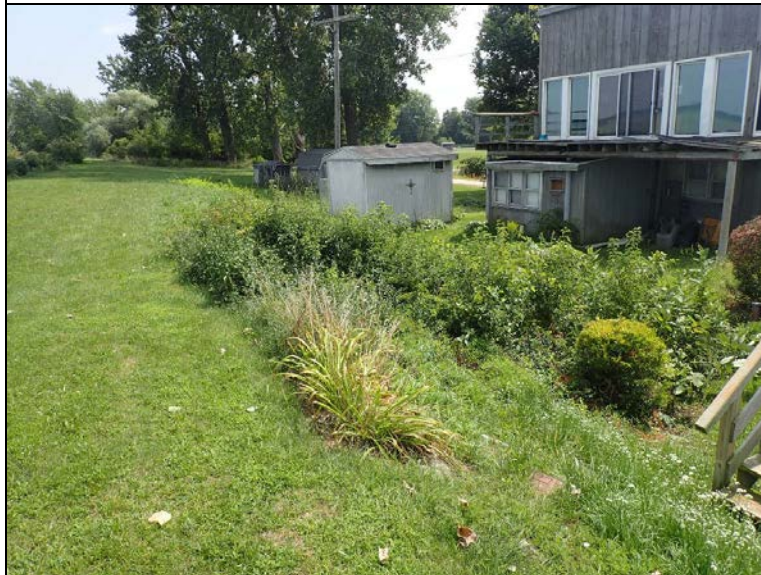
Inspect ID: OH29_2018_p_0071 **Title:** USACE_CELRB_OH29_2018_p_0071_2.jpg
Rated Item: 1. Unwanted Vegetation Growth **Caption:** Rating: Unacceptable; Remarks: Significant trees, unwanted vegetation, and gardens on levee landside slope along Dyke Road.; Action: Remove unwanted vegetation within the vegetation free zone and reestablish levee prism with adequate sod cover. Perform regular mowing to prevent further unwanted vegetation development.

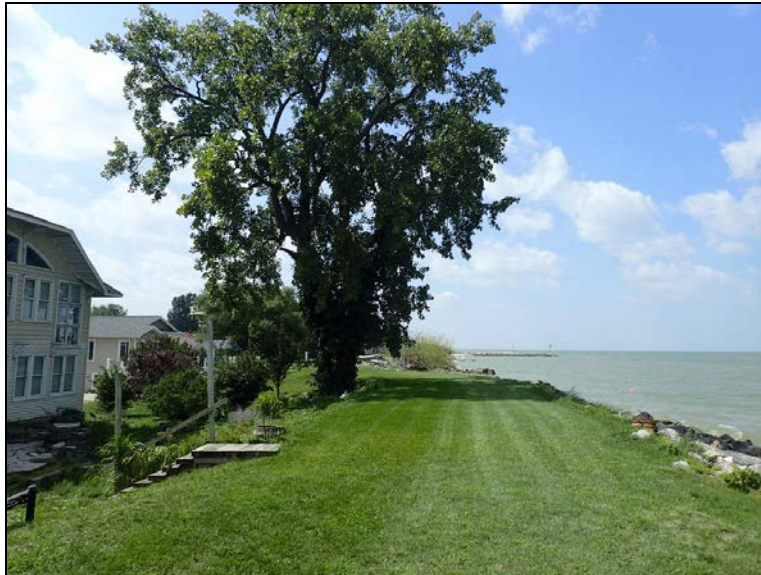
Inspect ID: OH29_2018_p_0071 **Title:** USACE_CELRB_OH29_2018_p_0071_3.jpg
Rated Item: 1. Unwanted Vegetation Growth **Caption:** Rating: Unacceptable; Remarks:
 Significant trees, unwanted vegetation, and gardens on levee landside slope along Dyke
 Road.; Action: Remove unwanted vegetation within the vegetation free zone and
 reestablish levee prism with adequate sod cover. Perform regular mowing to prevent
 further unwanted vegetation development.

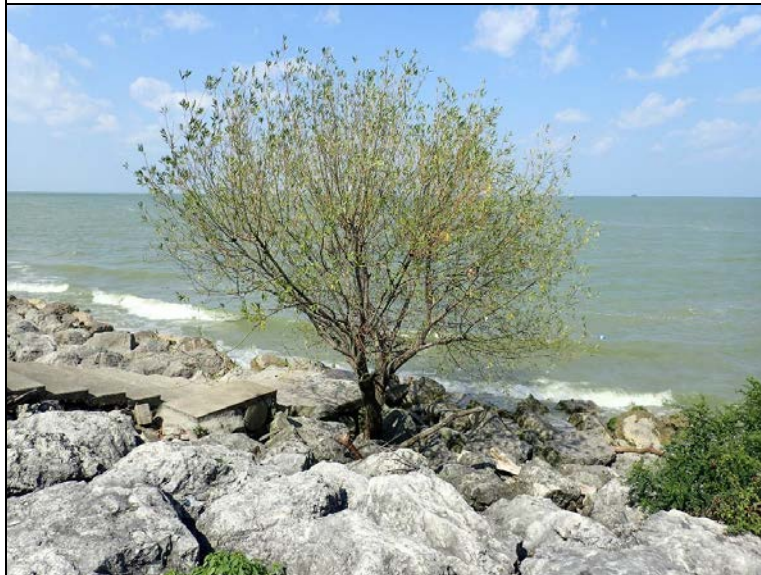
Inspect ID: OH29_2018_p_0071 **Title:** USACE_CELRB_OH29_2018_p_0071_4.jpg
Rated Item: 1. Unwanted Vegetation Growth **Caption:** Rating: Unacceptable; Remarks:
 Significant trees, unwanted vegetation, and gardens on levee landside slope along Dyke
 Road.; Action: Remove unwanted vegetation within the vegetation free zone and
 reestablish levee prism with adequate sod cover. Perform regular mowing to prevent
 further unwanted vegetation development.

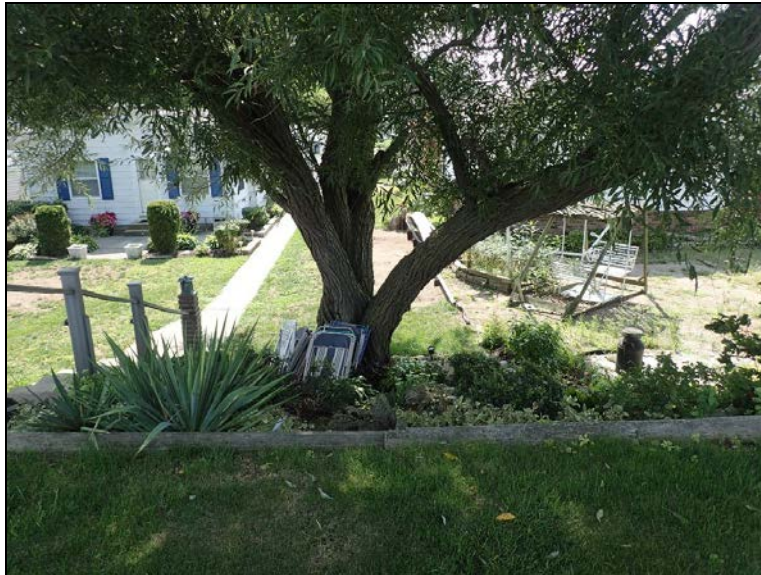
Inspect ID: OH29_2018_p_0071 **Title:** USACE_CELRB_OH29_2018_p_0071_5.jpg
Rated Item: 1. Unwanted Vegetation Growth **Caption:** Rating: Unacceptable; Remarks:
 Significant trees, unwanted vegetation, and gardens on levee landside slope along Dyke
 Road.; Action: Remove unwanted vegetation within the vegetation free zone and
 reestablish levee prism with adequate sod cover. Perform regular mowing to prevent
 further unwanted vegetation development.

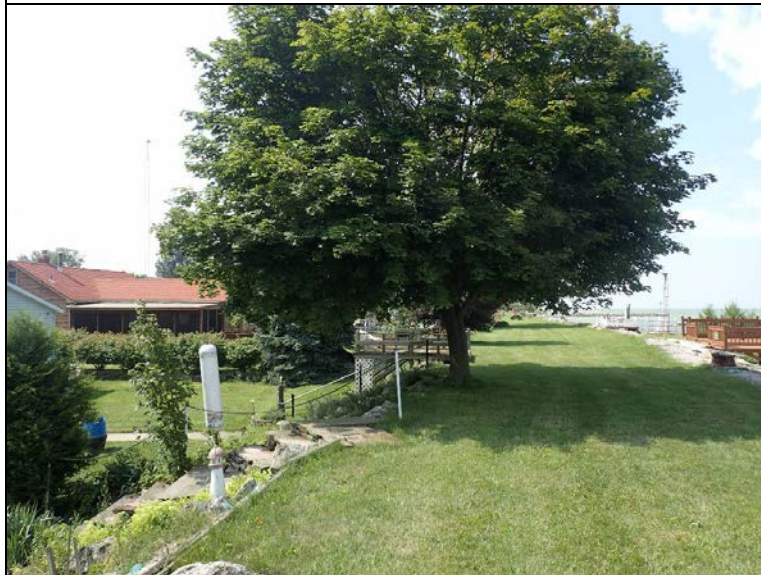
Inspect ID: OH29_2018_p_0071 **Title:** USACE_CELRB_OH29_2018_p_0071_6.jpg
Rated Item: 1. Unwanted Vegetation Growth **Caption:** Rating: Unacceptable; Remarks:
 Significant trees, unwanted vegetation, and gardens on levee landside slope along Dyke
 Road.; Action: Remove unwanted vegetation within the vegetation free zone and
 reestablish levee prism with adequate sod cover. Perform regular mowing to prevent
 further unwanted vegetation development.

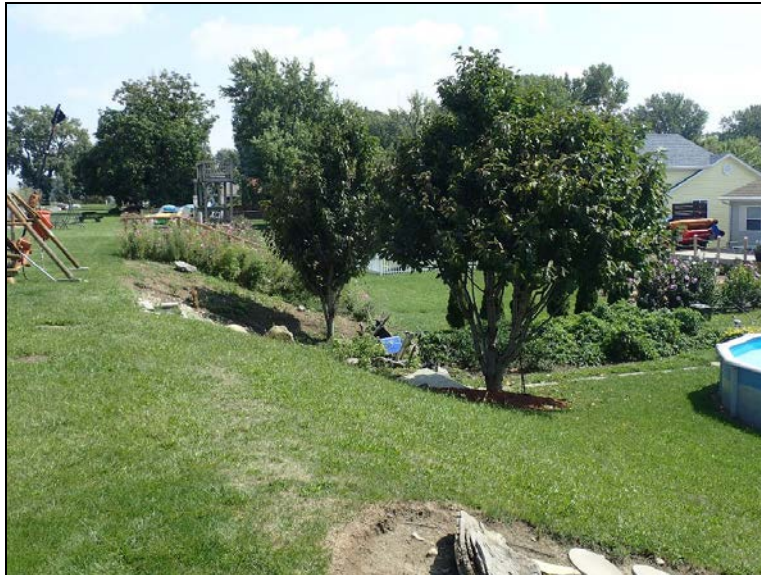
Inspect ID: OH29_2018_p_0071 **Title:** USACE_CELRB_OH29_2018_p_0071_9.jpg
Rated Item: 1. Unwanted Vegetation Growth **Caption:** Rating: Unacceptable; Remarks: Significant trees, unwanted vegetation, and gardens on levee landside slope along Dyke Road.; Action: Remove unwanted vegetation within the vegetation free zone and reestablish levee prism with adequate sod cover. Perform regular mowing to prevent further unwanted vegetation development.

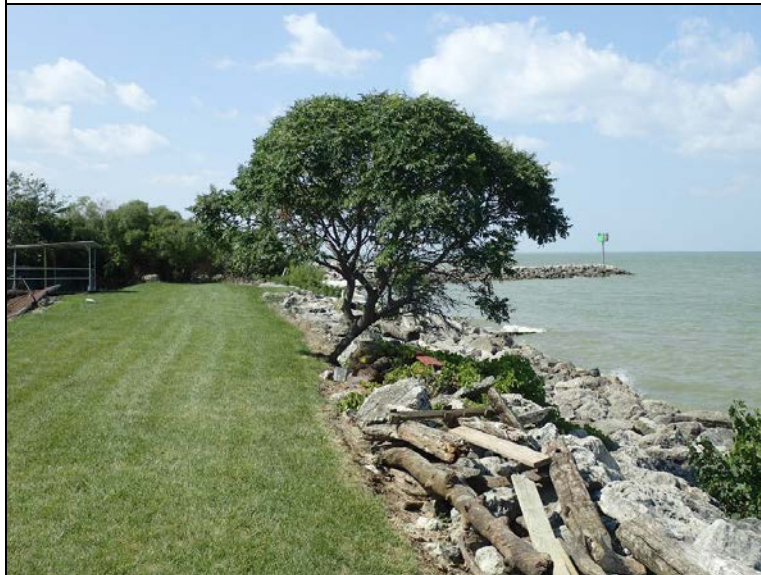
Inspect ID: OH29_2018_p_0071 **Title:** USACE_CELRB_OH29_2018_p_0071_10.jpg
Rated Item: 1. Unwanted Vegetation Growth **Caption:** Rating: Unacceptable; Remarks: Significant trees, unwanted vegetation, and gardens on levee landside slope along Dyke Road.; Action: Remove unwanted vegetation within the vegetation free zone and reestablish levee prism with adequate sod cover. Perform regular mowing to prevent further unwanted vegetation development.

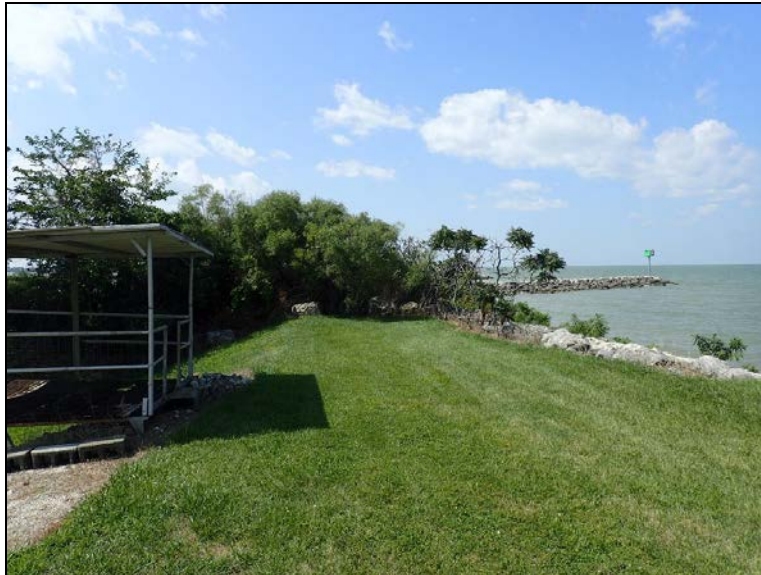
Inspect ID: OH29_2018_p_0094 **Title:** USACE_CELRB_OH29_2018_p_0094_1.jpg
Rated Item: 1. Unwanted Vegetation Growth **Caption:** Rating: Unacceptable; Remarks:
 Unwanted vegetation on crown as levee wraps around Cooley Canal.; Action: Remove
 unwanted vegetation within the vegetation free zone and reestablish levee prism with
 adequate sod cover. Perform regular mowing to prevent further unwanted vegetation
 development.

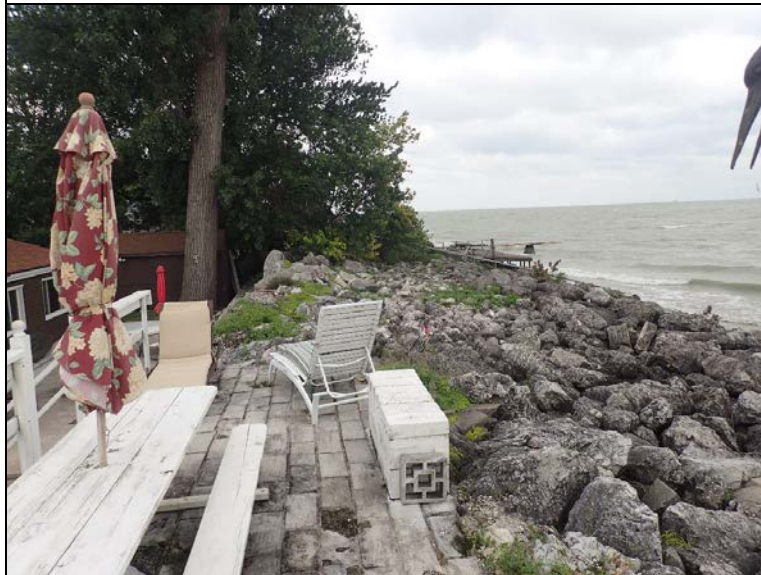
Inspect ID: OH29_2018_p_0103 **Title:** USACE_CELRB_OH29_2018_p_0103_1.jpg
Rated Item: 1. Unwanted Vegetation Growth **Caption:** Rating: Unacceptable; Remarks:
 Levee inaccessible 400' west of Wards Canal due to unwanted vegetation and
 encroachments.; Action: Remove vegetation and encroachments to provide a clear path
 for operations and maintenance, inspection, emergency patrols, and flood-fighting.

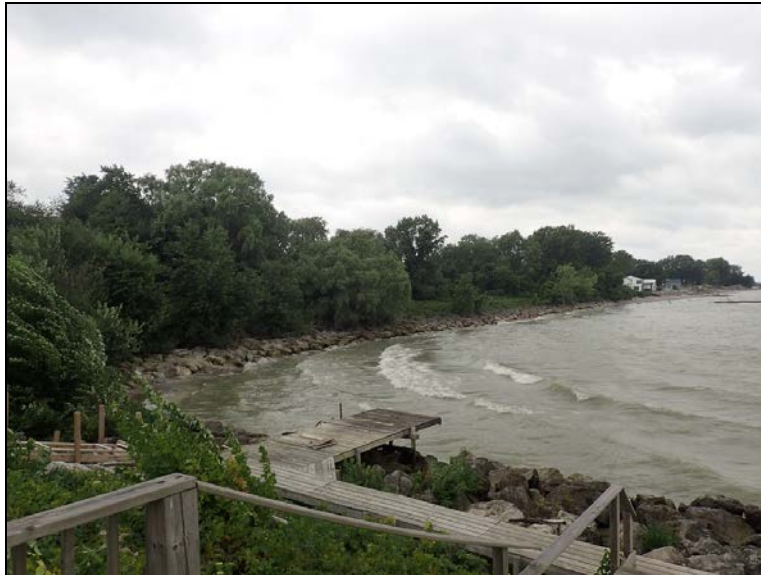
Inspect ID: OH29_2018_p_0104 **Title:** USACE_CELRB_OH29_2018_p_0104_1.jpg
Rated Item: 1. Unwanted Vegetation Growth **Caption:** Rating: Unacceptable; Remarks: Levee inaccessible from west end of Lagoon Drive to La Course Drive due to heavy vegetation and trees.; Action: Remove vegetation and encroachments to provide a clear path for operations and maintenance, inspection, emergency patrols, and flood-fighting.

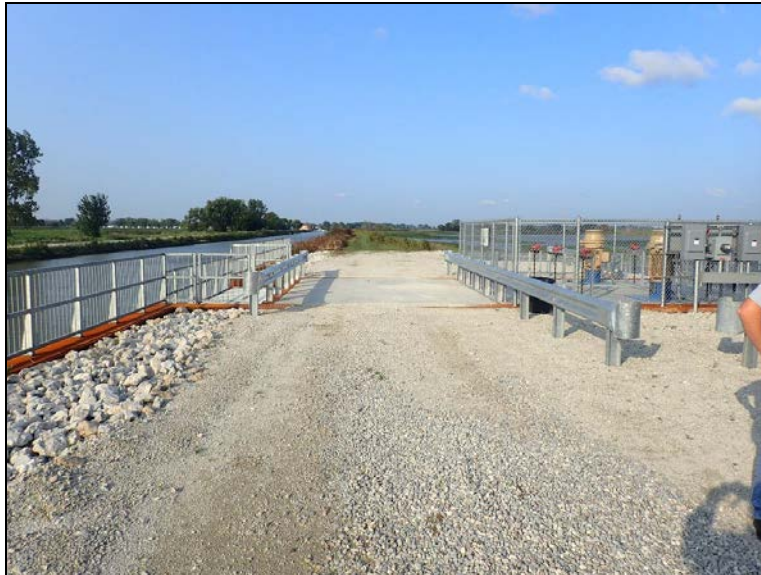
Inspect ID: OH29_2018_p_0001 **Title:** USACE_CELRB_OH29_2018_p_0001_2.jpg
Rated Item: 3. Encroachments **Caption:** Rating: Minimally Acceptable; Remarks:
 Toledo Metropark Alteration includes sub-agreement for transfer of maintenance on
 crown and landside slope of Wards Canal levee from Conservancy District to Metroparks.
 Requires inspection and guidance from USACE.; Action: Coordinate sub-agreement for
 O&M of Wards Canal levee with USACE.

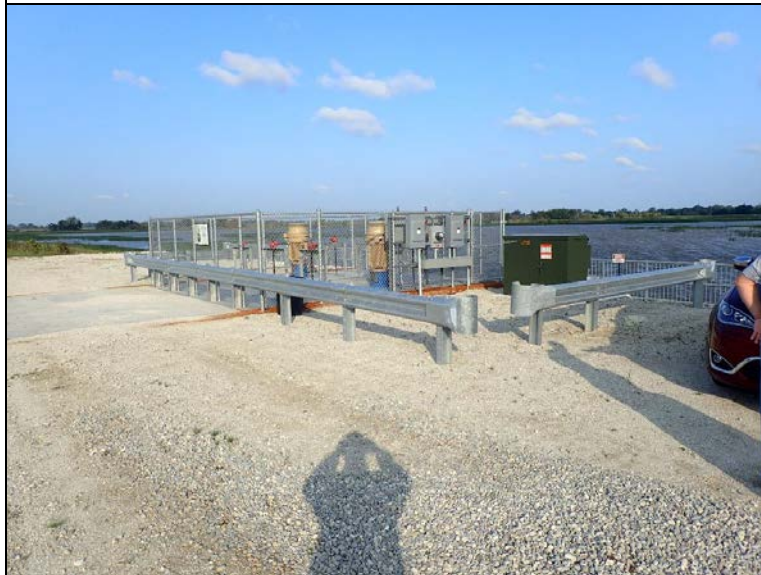
Inspect ID: OH29_2018_p_0001 **Title:** USACE_CELRB_OH29_2018_p_0001_3.jpg
Rated Item: 3. Encroachments **Caption:** Rating: Minimally Acceptable; Remarks:
 Toledo Metropark Alteration includes sub-agreement for transfer of maintenance on
 crown and landside slope of Wards Canal levee from Conservancy District to Metroparks.
 Requires inspection and guidance from USACE.; Action: Coordinate sub-agreement for
 O&M of Wards Canal levee with USACE.

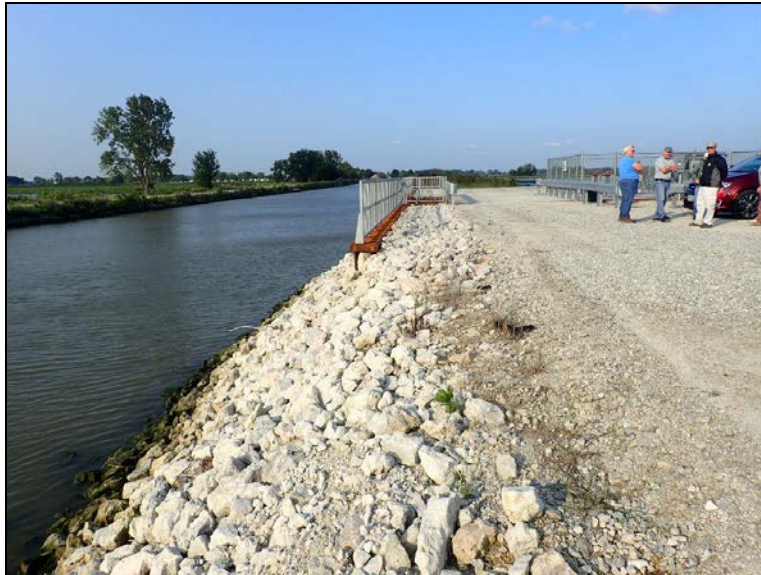
Inspect ID: OH29_2018_p_0001 **Title:** USACE_CELRB_OH29_2018_p_0001_4.jpg
Rated Item: 3. Encroachments **Caption:** Rating: Minimally Acceptable; Remarks:
Toledo Metropark Alteration includes sub-agreement for transfer of maintenance on
crown and landside slope of Wards Canal levee from Conservancy District to Metroparks.
Requires inspection and guidance from USACE.; Action: Coordinate sub-agreement for
O&M of Wards Canal levee with USACE.

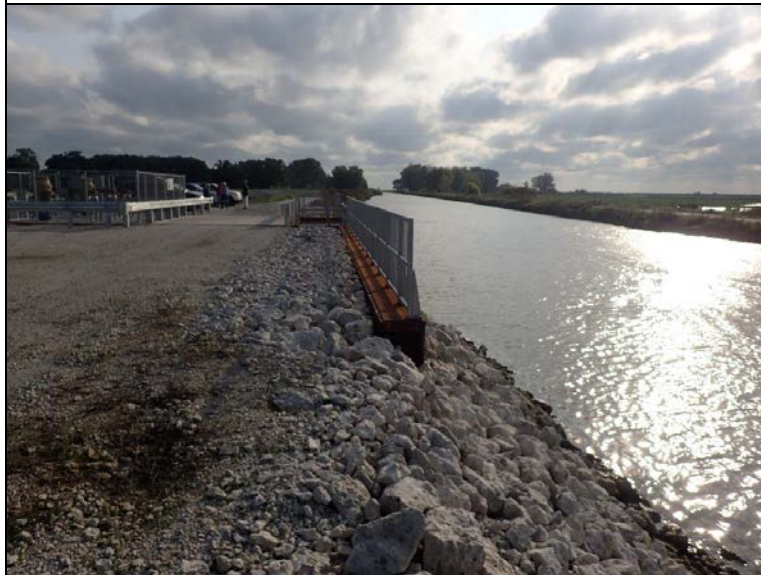
Inspect ID: OH29_2018_p_0001 **Title:** USACE_CELRB_OH29_2018_p_0001_5.jpg
Rated Item: 3. Encroachments **Caption:** Rating: Minimally Acceptable; Remarks:
Toledo Metropark Alteration includes sub-agreement for transfer of maintenance on
crown and landside slope of Wards Canal levee from Conservancy District to Metroparks.
Requires inspection and guidance from USACE.; Action: Coordinate sub-agreement for
O&M of Wards Canal levee with USACE.

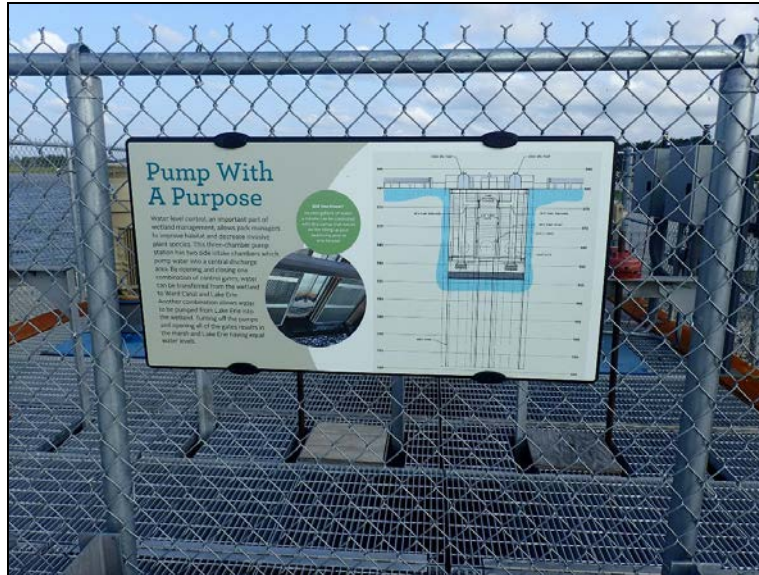
Inspect ID: OH29_2018_p_0001 **Title:** USACE_CELRB_OH29_2018_p_0001_8.jpg
Rated Item: 3. Encroachments **Caption:** Rating: Minimally Acceptable; Remarks:
 Toledo Metropark Alteration includes sub-agreement for transfer of maintenance on
 crown and landside slope of Wards Canal levee from Conservancy District to Metroparks.
 Requires inspection and guidance from USACE.; Action: Coordinate sub-agreement for
 O&M of Wards Canal levee with USACE.

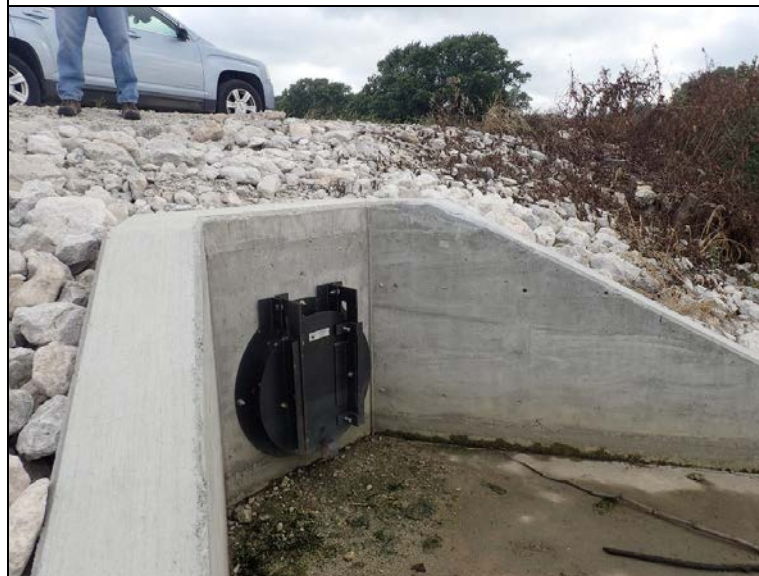
Inspect ID: OH29_2018_p_0007 **Title:** USACE_CELRB_OH29_2018_p_0007_1.jpg
Rated Item: 3. Encroachments **Caption:** Rating: Acceptable; Remarks: Toledo
 Metroparks Alteration - 24" outfall with flapgate on waterside of Wards Canal levee.;
 Action: NA

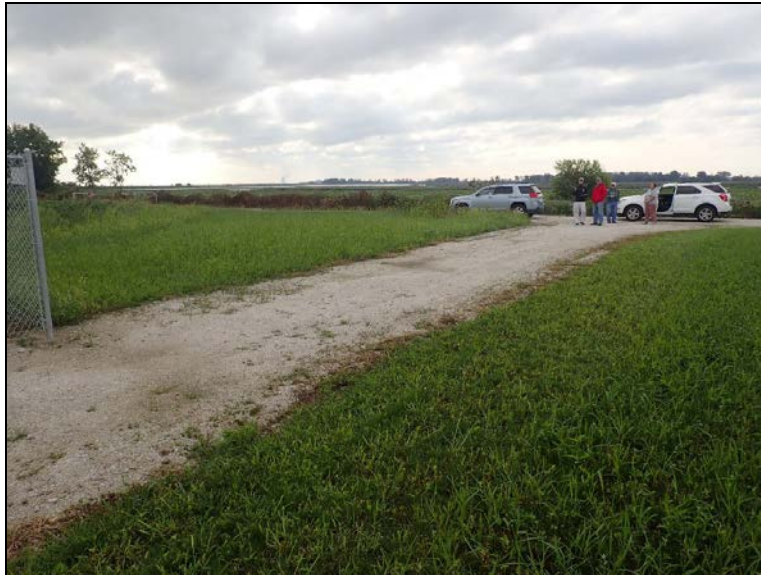
Inspect ID: OH29_2018_p_0008 **Title:** USACE_CELRB_OH29_2018_p_0008_1.jpg
Rated Item: 3. Encroachments **Caption:** Rating: Acceptable; Remarks: Toledo
Metroparks Alteration - Metroparks levee ties into Wards Canal levee.; Action: NA

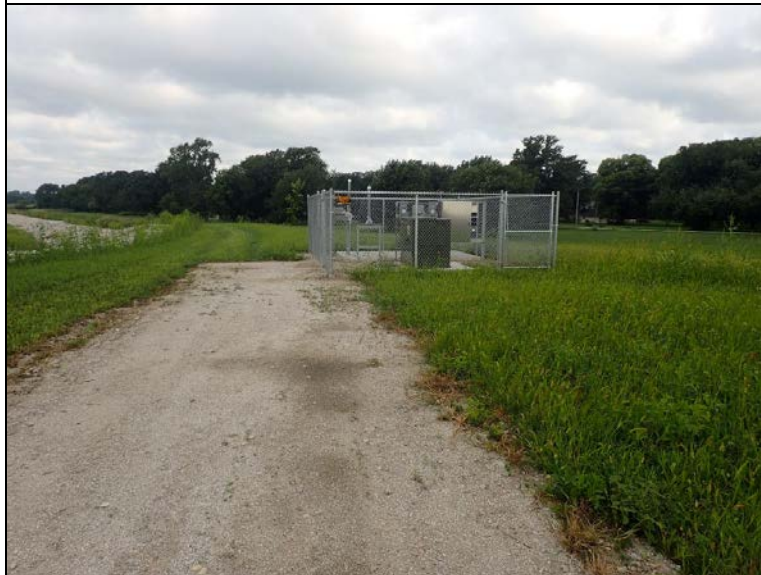
Inspect ID: OH29_2018_p_0009 **Title:** USACE_CELRB_OH29_2018_p_0009_1.jpg
Rated Item: 3. Encroachments **Caption:** Rating: Acceptable; Remarks: Toledo
Metroparks Alteration - Pump station to be operated by Conservancy District per sub-
agreement.; Action: NA

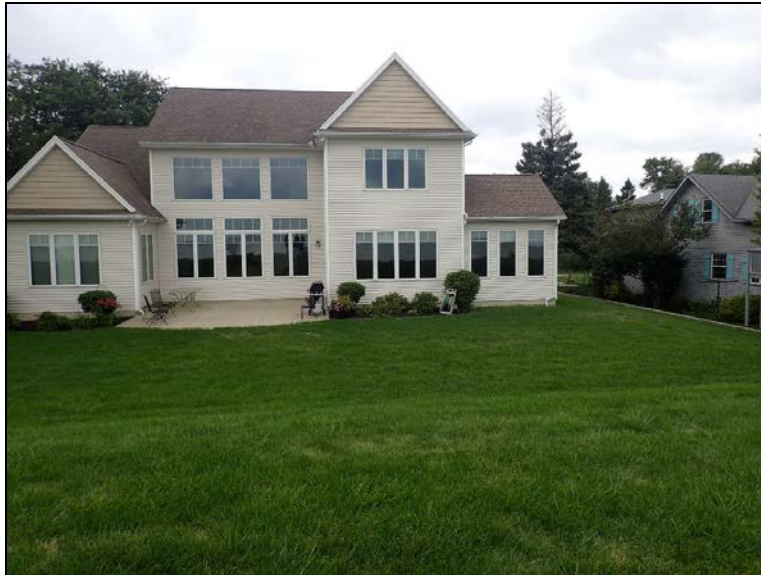
Inspect ID: OH29_2018_p_0025 **Title:** USACE_CELRB_OH29_2018_p_0025_1.jpg
Rated Item: 3. Encroachments **Caption:** Rating: Unacceptable; Remarks: Unauthorized alteration - two house encroachments on landside slope of levee along Lagoon Drive East near Marais Drive. See photos 29-32, FY08 Inspection Report. ; Action: Submit Section 408 Alteration Request to USACE or remove encroachments.

20	M	Crown settling into levee and sporadic holes near transition from stone levee to soil levee 750' west of Wards Canal along Lagoon Drive.	Repair settlement and fill holes with suitable material using compaction methods according to original plans and specifications.	20_1.jpg	Levee Embankments	Settlement	NA	5+07	NA
22	M	Residents and Conservancy District indicate seepage between two residential homes along Lagoon Drive.	Coordinate with USACE to mitigate seepage.	22_1.jpg	Levee Embankments	Seepage	NA	9+57	NA
24	M	Unauthorized alteration - satellite dish encroachment w conduit running through levee crown.	Submit Section 408 Alteration Request to USACE or remove encroachment.	24_1.jpg	Levee Embankments	Encroachments	NA	16+68	NA
25	U	Unauthorized alteration - two house encroachments on landside slope of levee along Lagoon Drive East near Marais Drive. See photos 29-32, FY08 Inspection Report.	Submit Section 408 Alteration Request to USACE or remove encroachments.	25_1.jpg	Levee Embankments	Encroachments	NA	20+00	NA

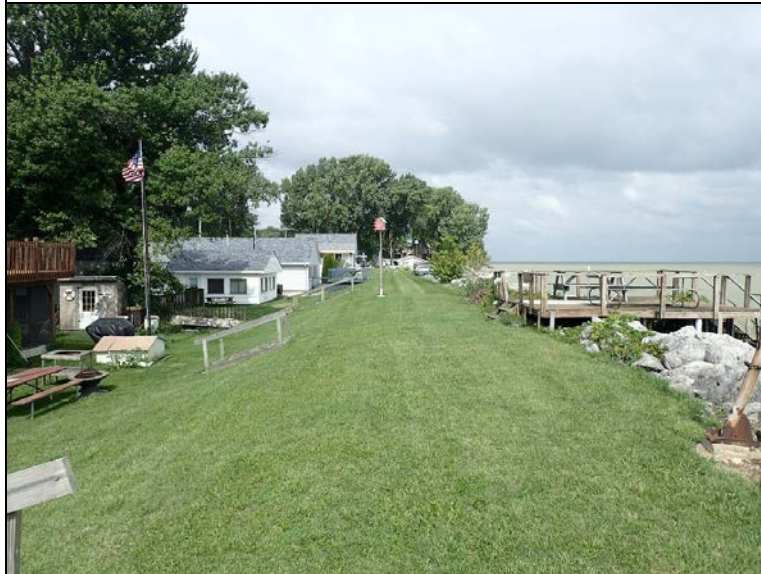
Inspect ID: OH29_2018_p_0033 **Title:** USACE_CELRB_OH29_2018_p_0033_1.jpg
Rated Item: 3. Encroachments **Caption:** Rating: Minimally Acceptable; Remarks: Unauthorized alteration - encroachments on both slopes and crown along La Course Drive.; Action: Submit Section 408 Alteration Request to USACE or remove encroachments.

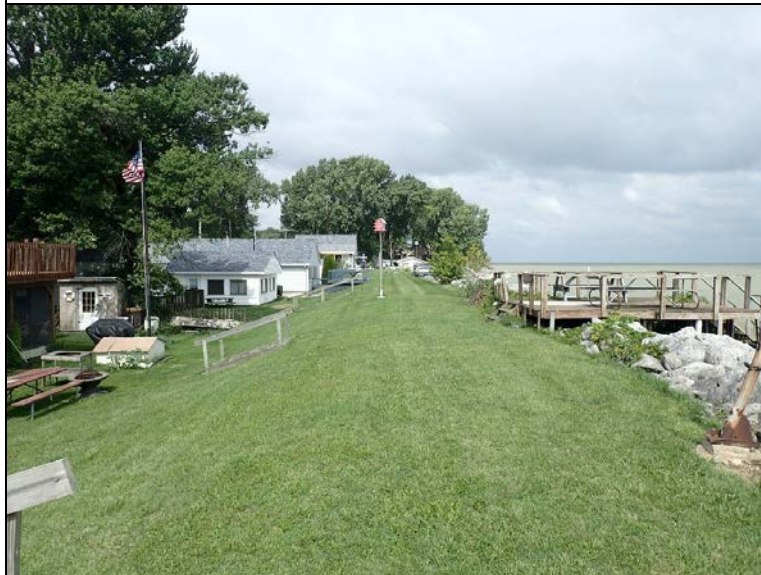
Inspect ID: OH29_2018_p_0034 **Title:** USACE_CELRB_OH29_2018_p_0034_1.jpg
Rated Item: 3. Encroachments **Caption:** Rating: Unacceptable; Remarks: Minor unwanted vegetation in riprap on waterside slope.; Action: Remove unwanted vegetation within the vegetation free zone.

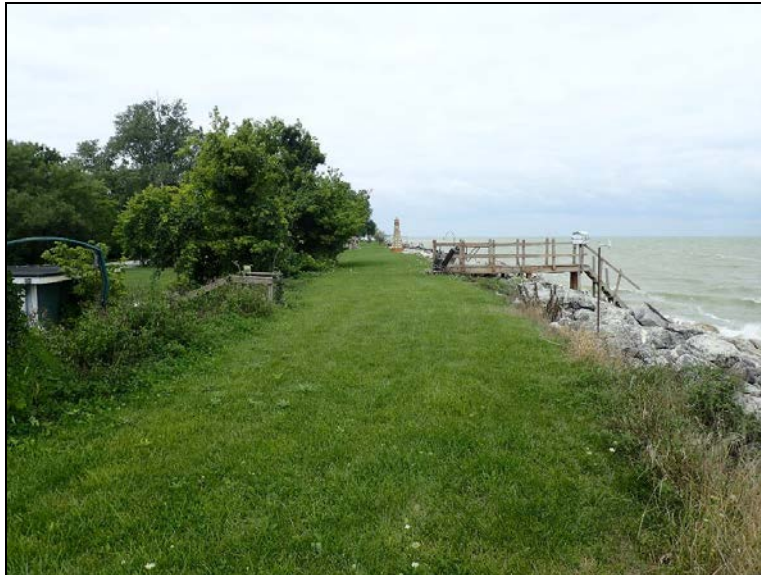
Inspect ID: OH29_2018_p_0047 **Title:** USACE_CELRB_OH29_2018_p_0047_1.jpg
Rated Item: 3. Encroachments **Caption:** Rating: Minimally Acceptable; Remarks:
Unauthorized alterations - encroachments on levee waterside and crown along Dyke Road.
Examples include: wooden decks, boat launches, concrete pad, debris, flag pole, large light
house, and concrete rubble.; Action: Submit Section 408 Alteration Request to USACE or
remove encroachments.

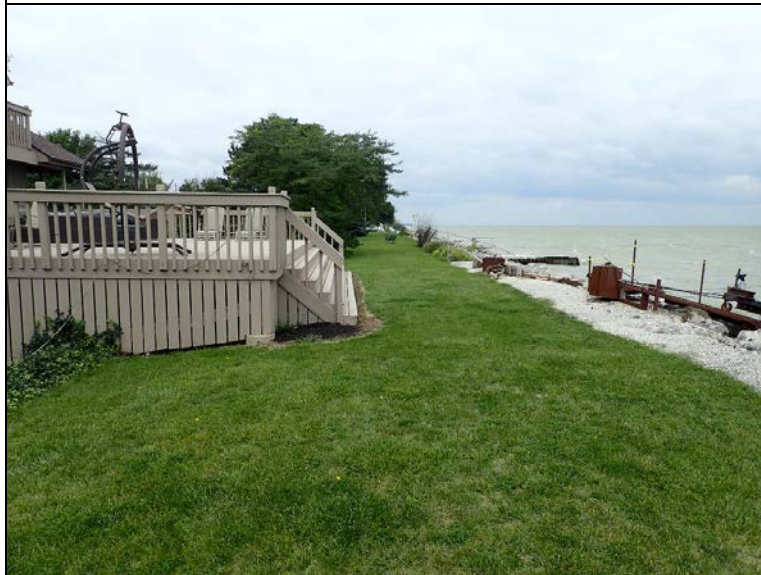
Inspect ID: OH29_2018_p_0047 **Title:** USACE_CELRB_OH29_2018_p_0047_2.jpg
Rated Item: 3. Encroachments **Caption:** Rating: Minimally Acceptable; Remarks:
Unauthorized alterations - encroachments on levee waterside and crown along Dyke Road.
Examples include: wooden decks, boat launches, concrete pad, debris, flag pole, large light
house, and concrete rubble.; Action: Submit Section 408 Alteration Request to USACE or
remove encroachments.

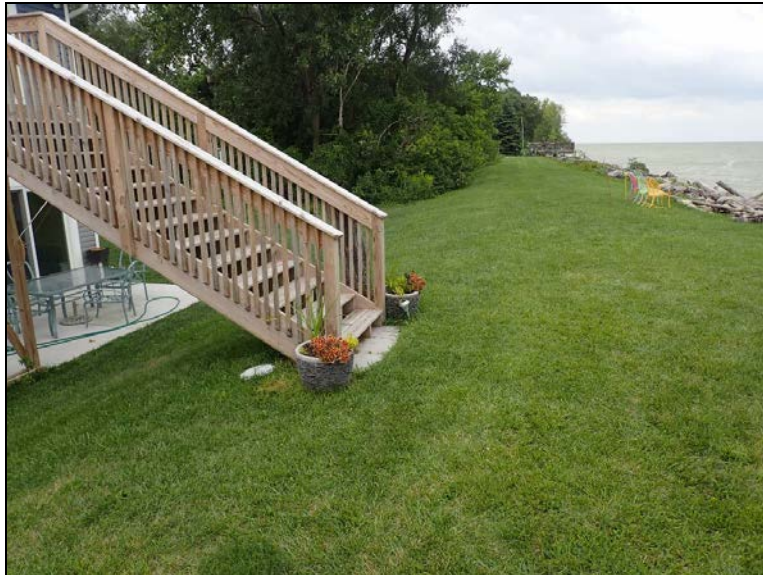
Inspect ID: OH29_2018_p_0052 **Title:** USACE_CELRB_OH29_2018_p_0052_1.jpg
Rated Item: 3. Encroachments **Caption:** Rating: Minimally Acceptable; Remarks:
Unauthorized alteration - stairs encroaches on crown from new house on Dyke Street.
House is beyond 15' from toe and not an encroachment.; Action: Submit Section 408
Alteration Request to USACE or remove encroachment.

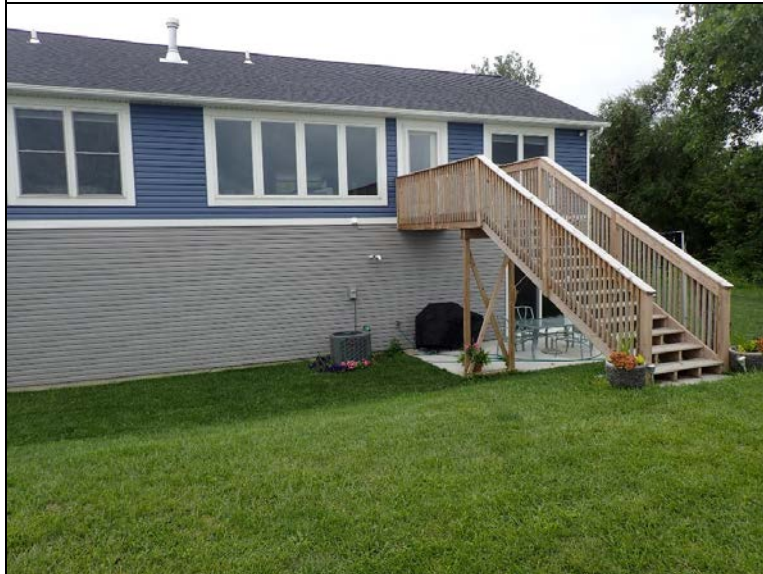
Inspect ID: OH29_2018_p_0052 **Title:** USACE_CELRB_OH29_2018_p_0052_2.jpg
Rated Item: 3. Encroachments **Caption:** Rating: Minimally Acceptable; Remarks:
Unauthorized alteration - stairs encroaches on crown from new house on Dyke Street.
House is beyond 15' from toe and not an encroachment.; Action: Submit Section 408
Alteration Request to USACE or remove encroachment.

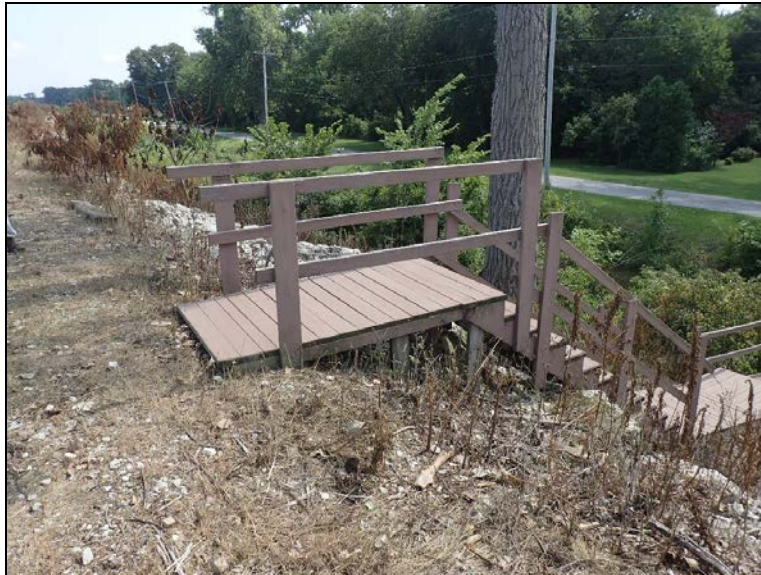
Inspect ID: OH29_2018_p_0057 **Title:** USACE_CELRB_OH29_2018_p_0057_1.jpg
Rated Item: 3. Encroachments **Caption:** Rating: Minimally Acceptable; Remarks:
Unauthorized alteration - stairs encroachment on levee landside slop 900' east of Dyke
Road.; Action: Submit Section 408 Alteration Request to USACE or remove
encroachment.

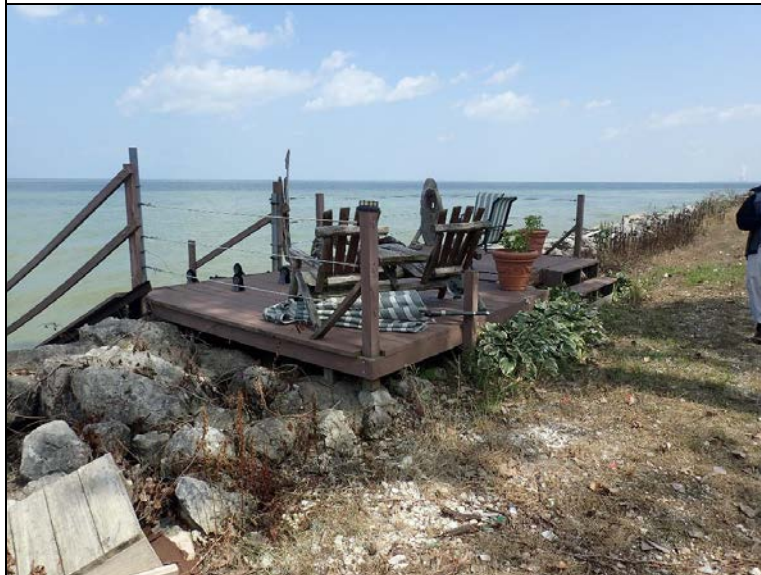
Inspect ID: OH29_2018_p_0058 **Title:** USACE_CELRB_OH29_2018_p_0058_1.jpg
Rated Item: 3. Encroachments **Caption:** Rating: Minimally Acceptable; Remarks:
Unauthorized alteration - deck and ramp on levee waterside and crown 900' east of Dyke
Road.; Action: Submit Section 408 Alteration Request to USACE or remove
encroachment.

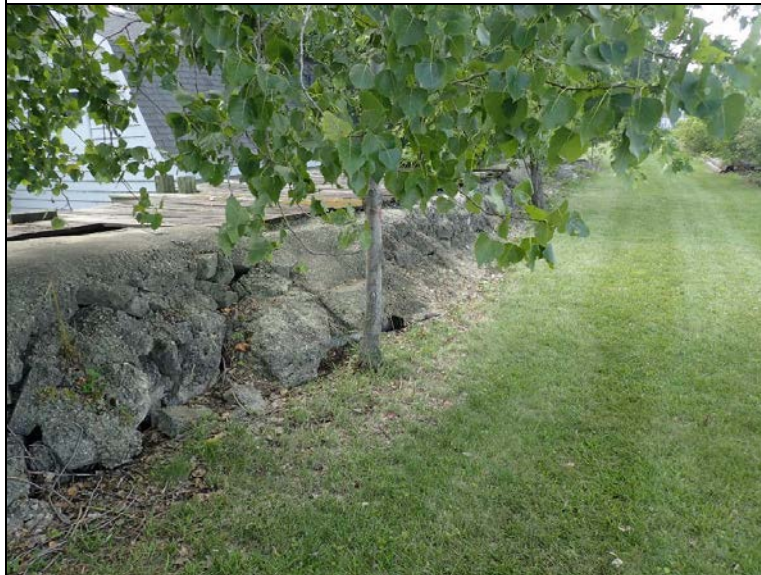
Inspect ID: OH29_2018_p_0063 **Title:** USACE_CELRB_OH29_2018_p_0063_1.jpg
Rated Item: 3. Encroachments **Caption:** Rating: Minimally Acceptable; Remarks:
 Unauthorized alterations - encroachments on levee landside slope and crown along Dyke Road. Examples include: metal platform, ramps, flag poles, stone, swimming pool, stairs, decks, landscaping, poles, ornaments, birdhouses, debris, and sheds.; Action: Submit Section 408 Alteration Request to USACE or remove encroachments.
