SUBJECT: FY18 Periodic Inspection, Flood Risk Management Project, Reno Beach-Howard Farms, Lucas County, Ohio (08/22/18)

Lake Erie – Reno Beach

FY 2018 PERIODIC INSPECTION REPORT

INSPECTED 22 AUGUST 2018

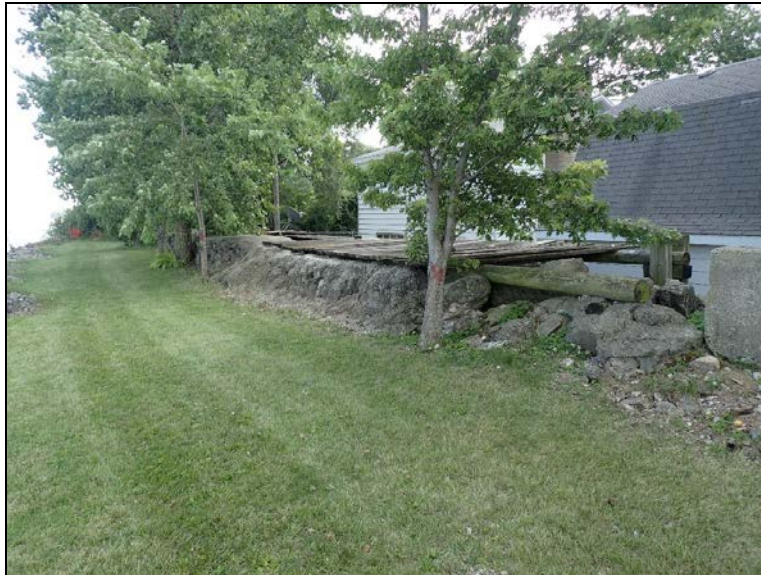
Inspect ID: OH29_2018_p_0063 **Title:** USACE_CELRB_OH29_2018_p_0063_2.jpg
Rated Item: 3. Encroachments **Caption:** Rating: Minimally Acceptable; Remarks:
 Unauthorized alterations - encroachments on levee landside slope and crown along Dyke
 Road. Examples include: metal platform, ramps, flag poles, stone, swimming pool, stairs,
 decks, landscaping, poles, ornaments, birdhouses, debris, and sheds.; Action: Submit
 Section 408 Alteration Request to USACE or remove encroachments.

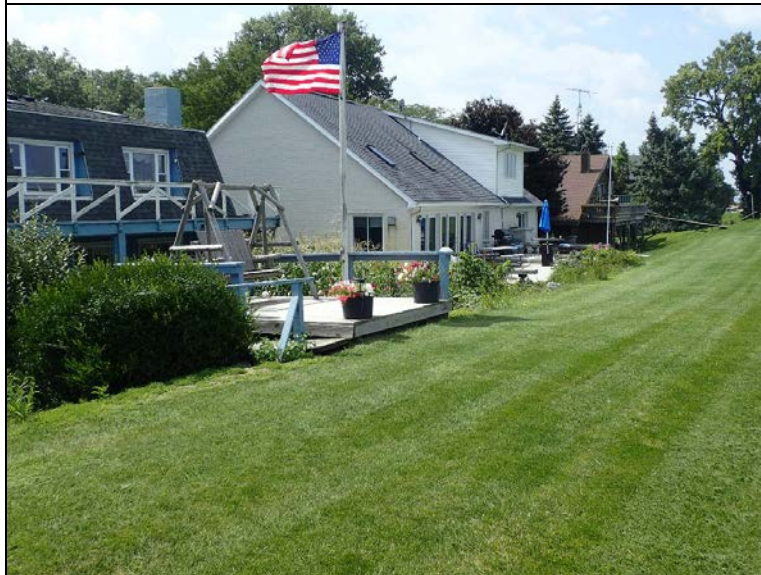
Inspect ID: OH29_2018_p_0063 **Title:** USACE_CELRB_OH29_2018_p_0063_3.jpg
Rated Item: 3. Encroachments **Caption:** Rating: Minimally Acceptable; Remarks:
 Unauthorized alterations - encroachments on levee landside slope and crown along Dyke
 Road. Examples include: metal platform, ramps, flag poles, stone, swimming pool, stairs,
 decks, landscaping, poles, ornaments, birdhouses, debris, and sheds.; Action: Submit
 Section 408 Alteration Request to USACE or remove encroachments.

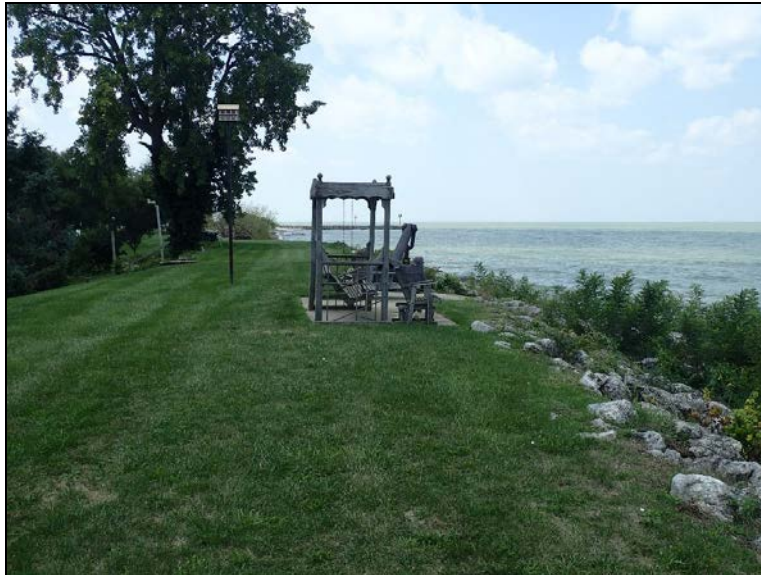
Inspect ID: OH29_2018_p_0063 **Title:** USACE_CELRB_OH29_2018_p_0063_4.jpg
Rated Item: 3. Encroachments **Caption:** Rating: Minimally Acceptable; Remarks:
Unauthorized alterations - encroachments on levee landside slope and crown along Dyke Road. Examples include: metal platform, ramps, flag poles, stone, swimming pool, stairs, decks, landscaping, poles, ornaments, birdhouses, debris, and sheds.; Action: Submit Section 408 Alteration Request to USACE or remove encroachments.

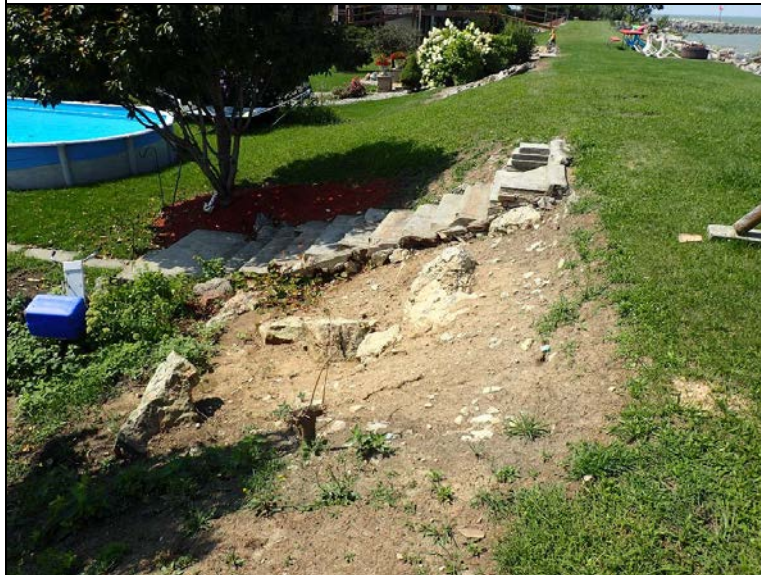
Inspect ID: OH29_2018_p_0063 **Title:** USACE_CELRB_OH29_2018_p_0063_5.jpg
Rated Item: 3. Encroachments **Caption:** Rating: Minimally Acceptable; Remarks:
Unauthorized alterations - encroachments on levee landside slope and crown along Dyke Road. Examples include: metal platform, ramps, flag poles, stone, swimming pool, stairs, decks, landscaping, poles, ornaments, birdhouses, debris, and sheds.; Action: Submit Section 408 Alteration Request to USACE or remove encroachments.

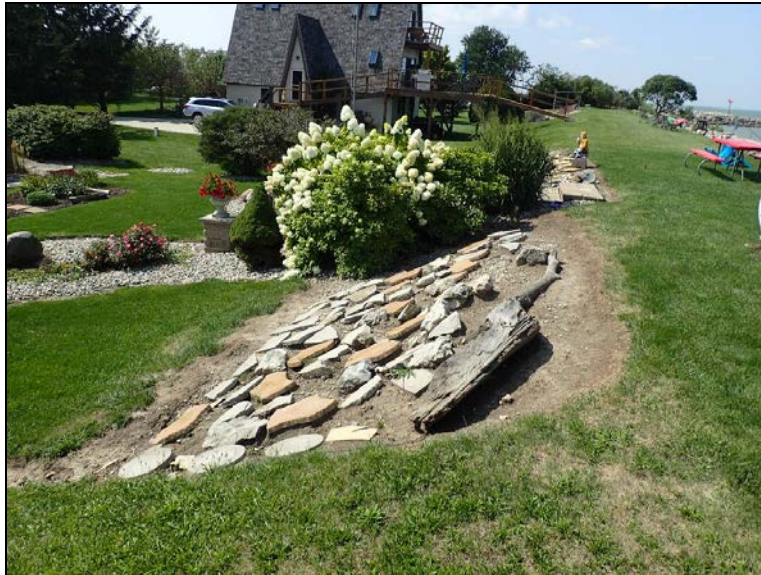
Inspect ID: OH29_2018_p_0063 **Title:** USACE_CELRB_OH29_2018_p_0063_6.jpg
Rated Item: 3. Encroachments **Caption:** Rating: Minimally Acceptable; Remarks:
 Unauthorized alterations - encroachments on levee landside slope and crown along Dyke Road. Examples include: metal platform, ramps, flag poles, stone, swimming pool, stairs, decks, landscaping, poles, ornaments, birdhouses, debris, and sheds.; Action: Submit Section 408 Alteration Request to USACE or remove encroachments.

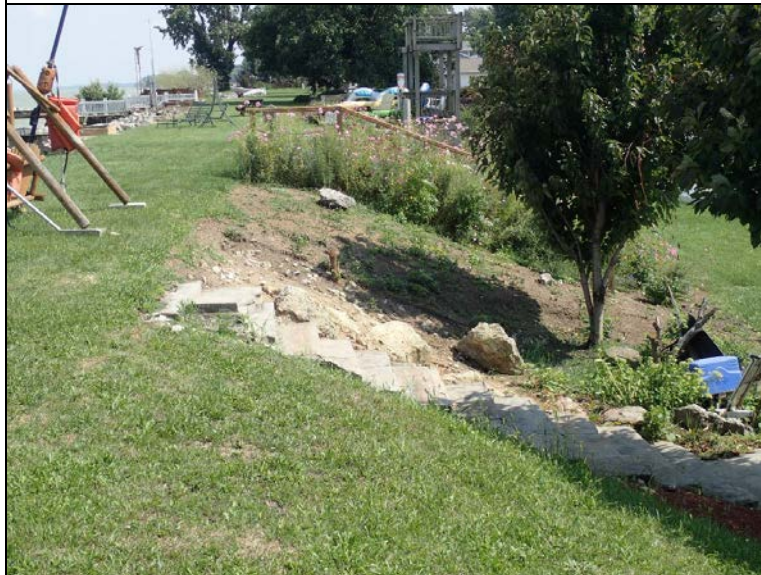
Inspect ID: OH29_2018_p_0063 **Title:** USACE_CELRB_OH29_2018_p_0063_7.jpg
Rated Item: 3. Encroachments **Caption:** Rating: Minimally Acceptable; Remarks:
 Unauthorized alterations - encroachments on levee landside slope and crown along Dyke Road. Examples include: metal platform, ramps, flag poles, stone, swimming pool, stairs, decks, landscaping, poles, ornaments, birdhouses, debris, and sheds.; Action: Submit Section 408 Alteration Request to USACE or remove encroachments.

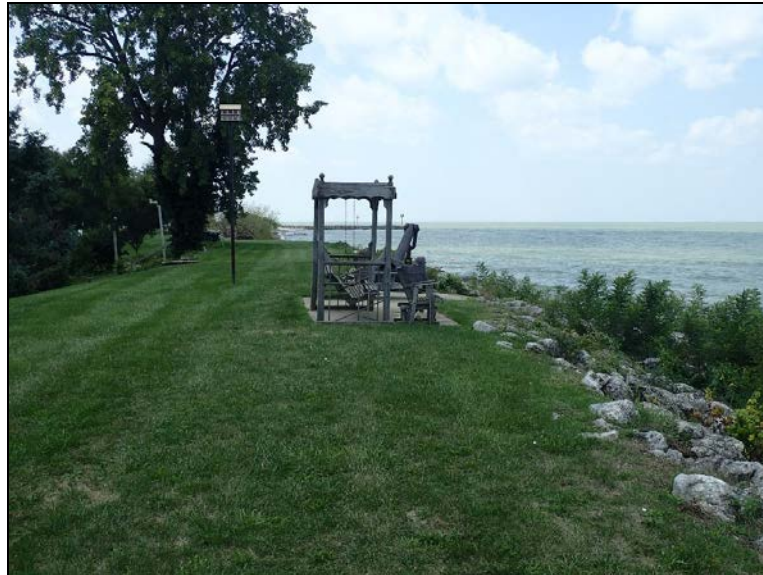
Inspect ID: OH29_2018_p_0064 **Title:** USACE_CELRB_OH29_2018_p_0064_1.jpg
Rated Item: 3. Encroachments **Caption:** Rating: Minimally Acceptable; Remarks:
 Unauthorized alteration - encroachments on levee waterside slope. Examples include:
 concrete pad, bench, decks, fills on riprap, walkways, poles, debris, boats, launch, shed,
 stairs, concrete rubble, ornamental anchor, ramps, and porch.; Action: Submit Section 408
 Alteration Request to USACE or remove encroachments.

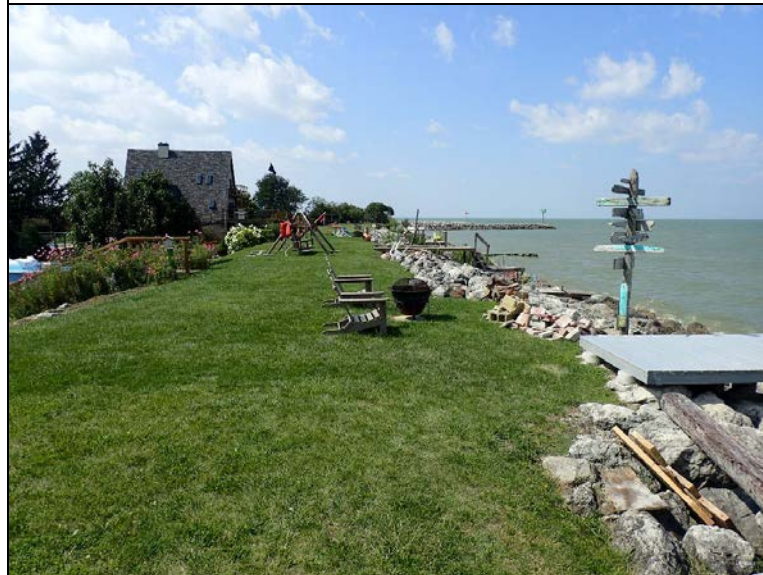
Inspect ID: OH29_2018_p_0064 **Title:** USACE_CELRB_OH29_2018_p_0064_2.jpg
Rated Item: 3. Encroachments **Caption:** Rating: Minimally Acceptable; Remarks:
 Unauthorized alteration - encroachments on levee waterside slope. Examples include:
 concrete pad, bench, decks, fills on riprap, walkways, poles, debris, boats, launch, shed,
 stairs, concrete rubble, ornamental anchor, ramps, and porch.; Action: Submit Section 408
 Alteration Request to USACE or remove encroachments.

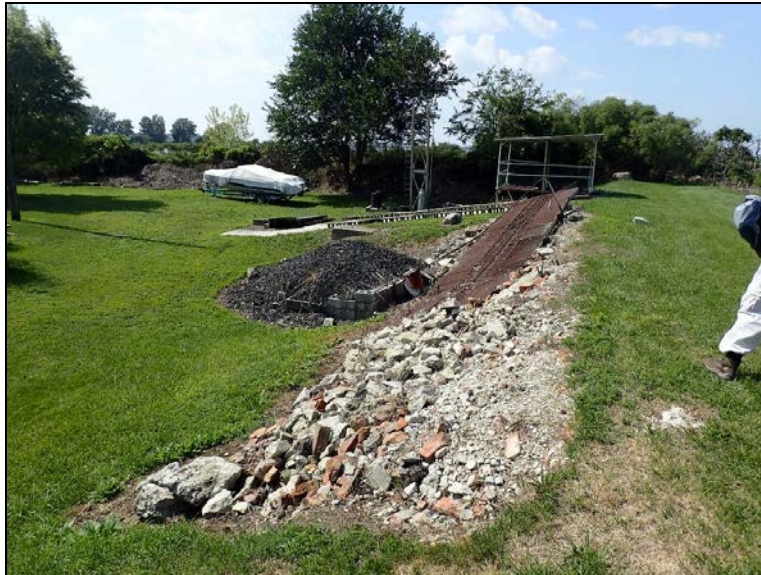
Inspect ID: OH29_2018_p_0096 **Title:** USACE_CELRB_OH29_2018_p_0096_1.jpg
Rated Item: 3. Encroachments **Caption:** Rating: Minimally Acceptable; Remarks: Unauthorized alteration - multiple encroachments on levee landside slope at levee wrap around at Cooley Canal.; Action: Submit Section 408 Alteration Request to USACE or remove encroachments.

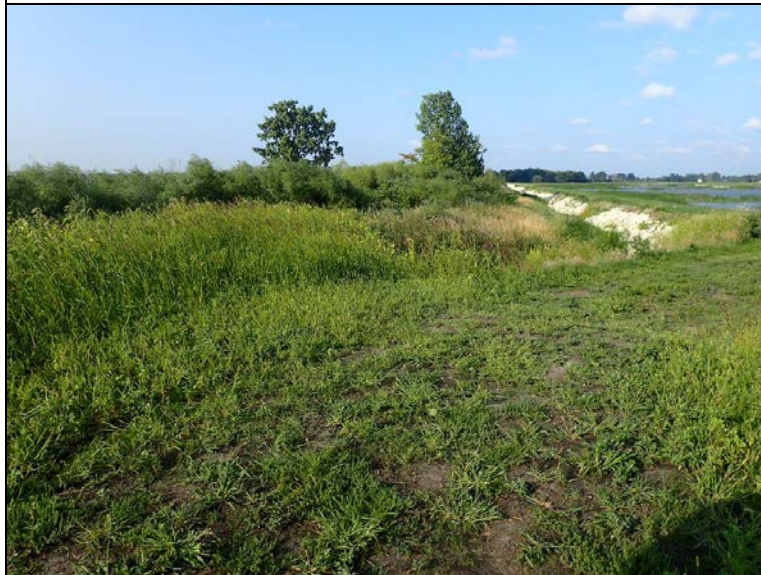
Inspect ID: OH29_2018_p_0006 **Title:** USACE_CELRB_OH29_2018_p_0006_1.jpg
Rated Item: 5. Slope Stability **Caption:** Rating: Acceptable; Remarks: Project limit at Wards Canal, levee ties into non-project segment.; Action: NA

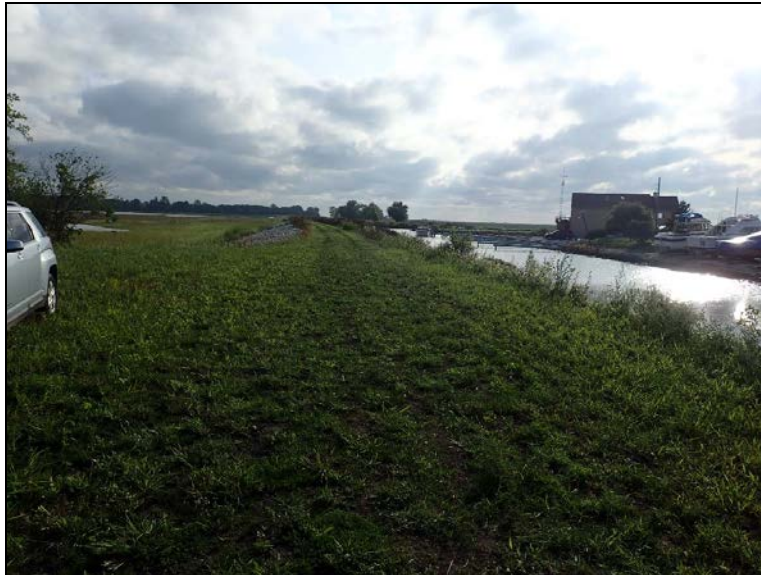
Inspect ID: OH29_2018_p_0006 **Title:** USACE_CELRB_OH29_2018_p_0006_2.jpg
Rated Item: 5. Slope Stability **Caption:** Rating: Acceptable; Remarks: Project limit at Wards Canal, levee ties into non-project segment.; Action: NA

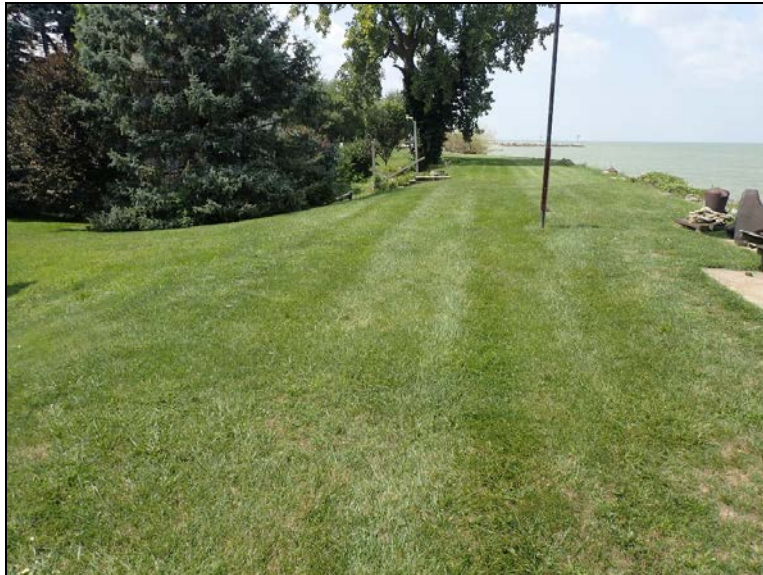
Inspect ID: OH29_2018_p_0072 **Title:** USACE_CELRB_OH29_2018_p_0072_1.jpg
Rated Item: 8. Depressions/ Rutting **Caption:** Rating: Minimally Acceptable; Remarks:
Minor depression on crown 150' west of Park Colony Boulevard.; Action: Fill
depression.

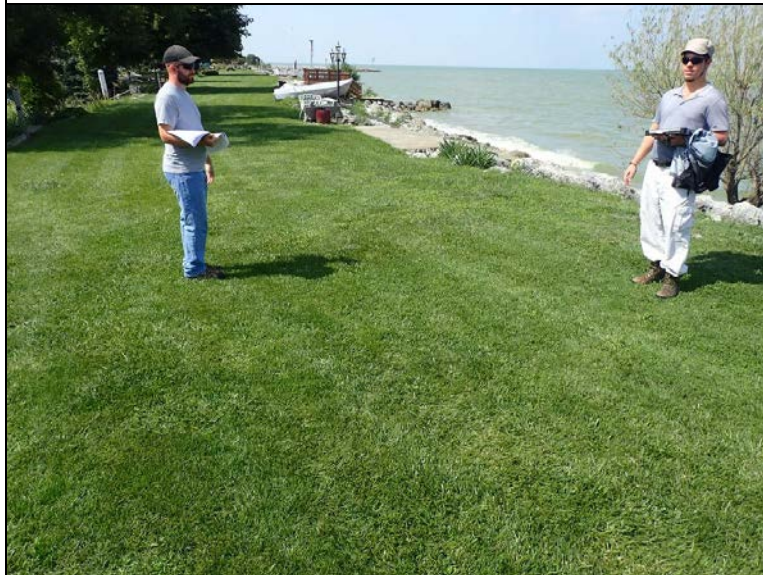
Inspect ID: OH29_2018_p_0081 **Title:** USACE_CELRB_OH29_2018_p_0081_1.jpg
Rated Item: 8. Depressions/ Rutting **Caption:** Rating: Minimally Acceptable; Remarks:
Minor depression on crown 300' east of Riceland Road.; Action: Fill depression.

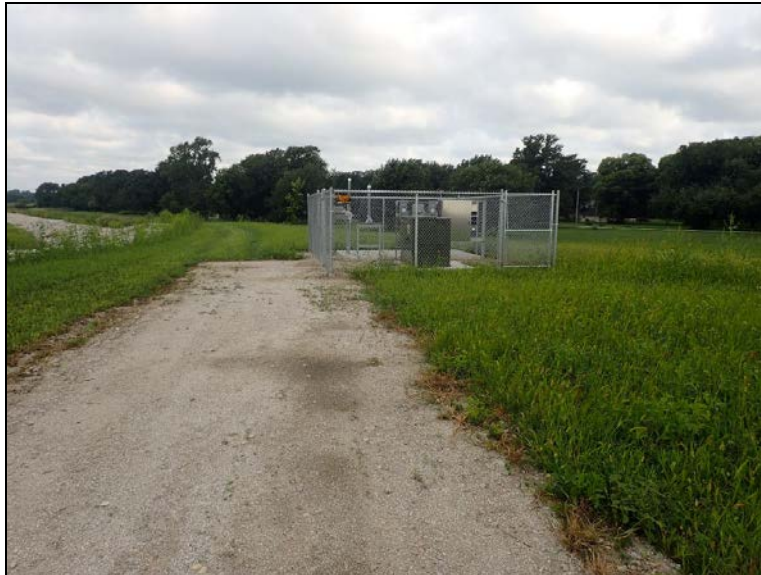
Inspect ID: OH29_2018_p_0109 **Title:** USACE_CELRB_OH29_2018_p_0109_2.jpg
Rated Item: 11. Culverts/ Discharge Pipes (This item includes both concrete and corrugated metal pipes.) **Caption:** Rating: Acceptable; Remarks: Toledo Metropark Alteration pump station discharge pipe to Wards Canal penetrates through the levee system. Therefore, it will require videotape inspection every 5-years.; Action: NA

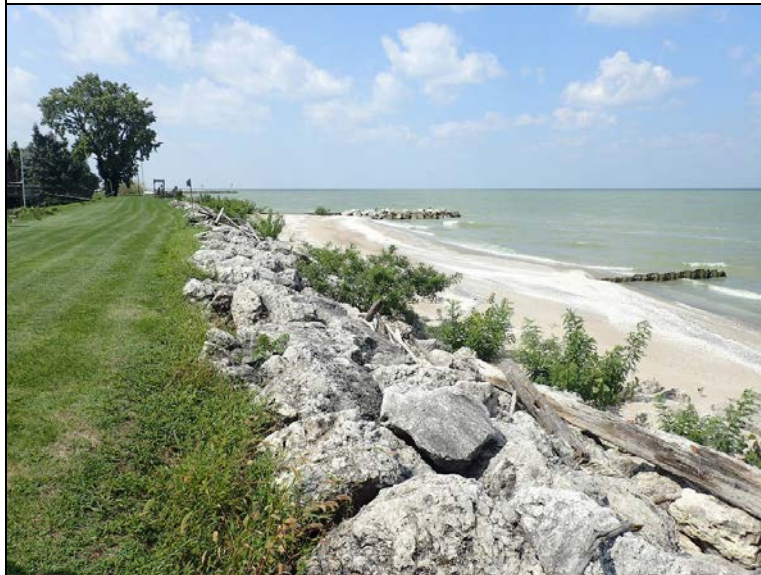
Inspect ID: OH29_2018_p_0070 **Title:** USACE_CELRB_OH29_2018_p_0070_1.jpg
Rated Item: 12. Riprap Revetments & Bank Protection **Caption:** Rating: Minimally Acceptable; **Remarks:** Sporadic unwanted vegetation exists within riprap along Dyke Road. Examples include: small trees, shrubs, bushes.; **Action:** Remove unwanted vegetation.

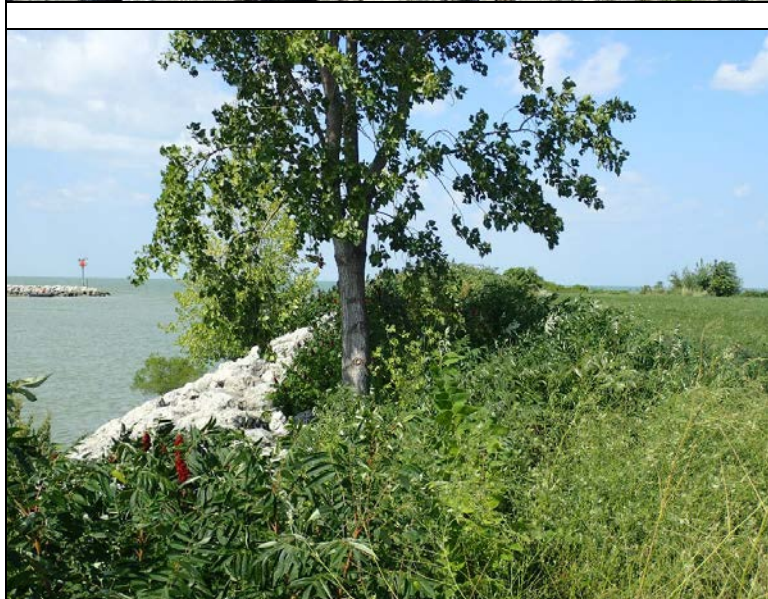
<p>Inspect ID: OH29_2018_p_0098 Title: USACE_CELRB_OH29_2018_p_0098_1.jpg Rated Item: 12. Riprap Revetments & Bank Protection Caption: Rating: Unacceptable; Remarks: Significant vegetation and trees in riprap on Cooley Canal levee.; Action: Remove unwanted vegetation within the vegetation free zone and reestablish adequate riprap. Perform regular maintenance to prevent further unwanted vegetation development.</p>

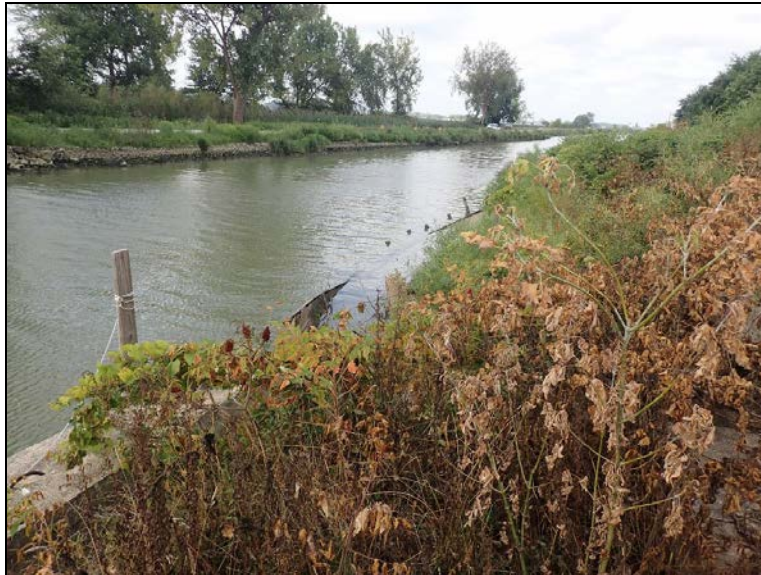
Inspect ID: OH29_2018_p_0012 **Title:** USACE_CELRB_OH29_2018_p_0012_1.jpg
Rated Item: 13. Revetments other than Riprap **Caption:** Rating: Unacceptable;
Remarks: SSP wall failure at Wards Canal levee waterside toe threatens dike integrity 300' upstream of canal entrance.; **Action:** Repair and stabilize SSP wall.

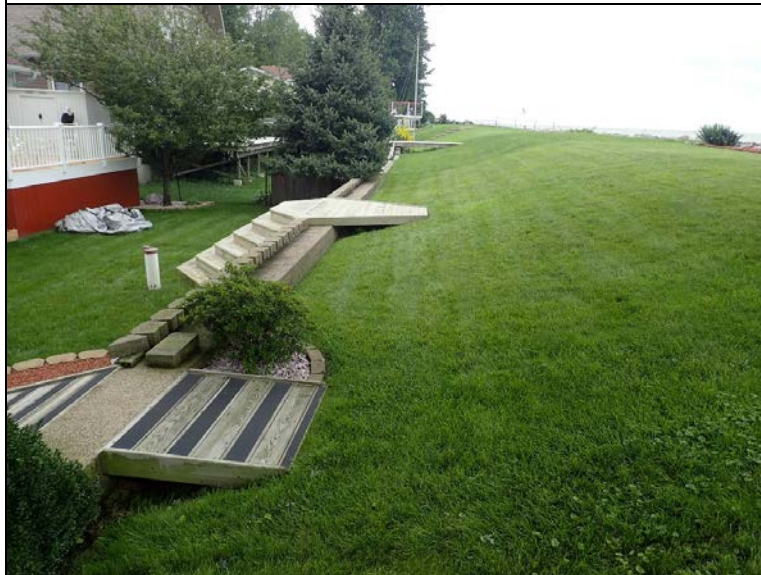
Inspect ID: OH29_2018_p_0028 **Title:** USACE_CELRB_OH29_2018_p_0028_1.jpg
Rated Item: 13. Revetments other than Riprap **Caption:** Rating: Acceptable; **Remarks:** Retaining wall is stable on landside at west end of Lagoon Drive.; **Action:** NA

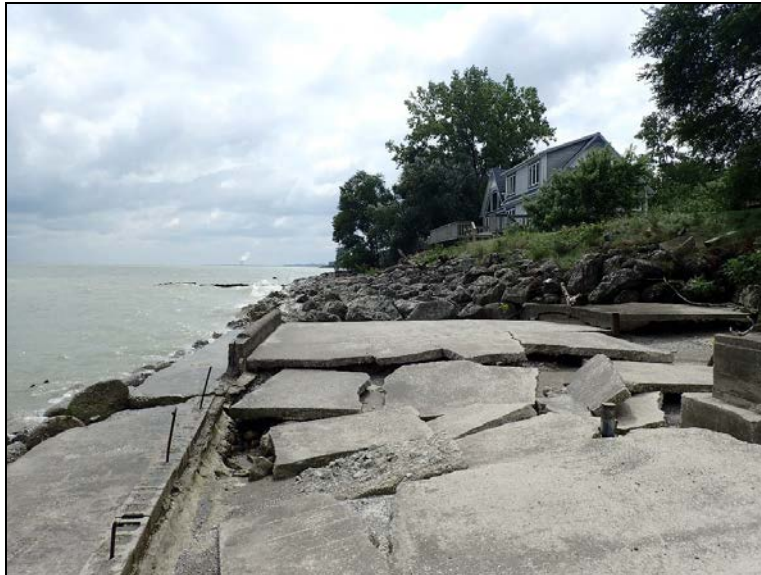
Inspect ID: OH29_2018_p_0040 **Title:** USACE_CELRB_OH29_2018_p_0040_1.jpg
Rated Item: 13. Revetments other than Riprap **Caption:** Rating: Minimally Acceptable;
Remarks: Deteriorated concrete revetment on waterside of levee, shown on As-Built Sheet 9 of 28 on Drawing Number 86-RBP-1/9, is incorporated into the project. The failing concrete is starting to expose the toe of the waterside slope.; **Action:** Repair concrete revetment or replace with suitable material to protect levee.

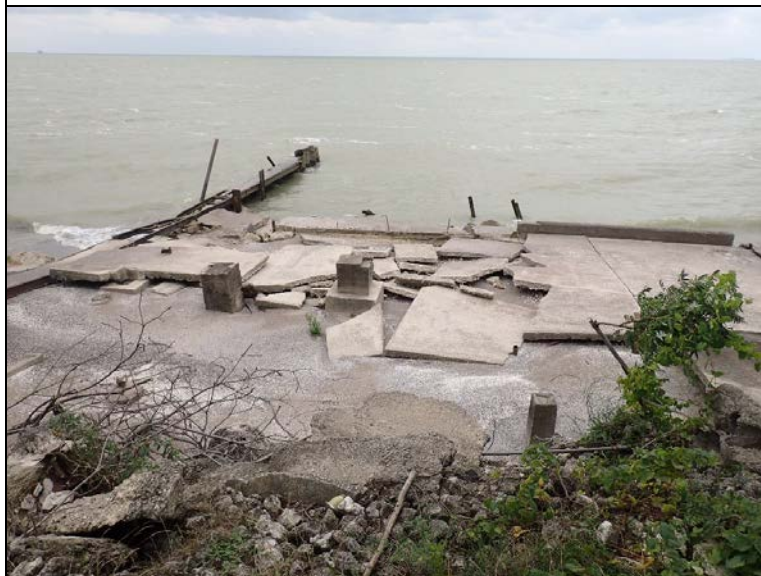
Inspect ID: OH29_2018_p_0040 **Title:** USACE_CELRB_OH29_2018_p_0040_2.jpg
Rated Item: 13. Revetments other than Riprap **Caption:** Rating: Minimally Acceptable;
Remarks: Deteriorated concrete revetment on waterside of levee, shown on As-Built Sheet 9 of 28 on Drawing Number 86-RBP-1/9, is incorporated into the project. The failing concrete is starting to expose the toe of the waterside slope.; **Action:** Repair concrete revetment or replace with suitable material to protect levee.

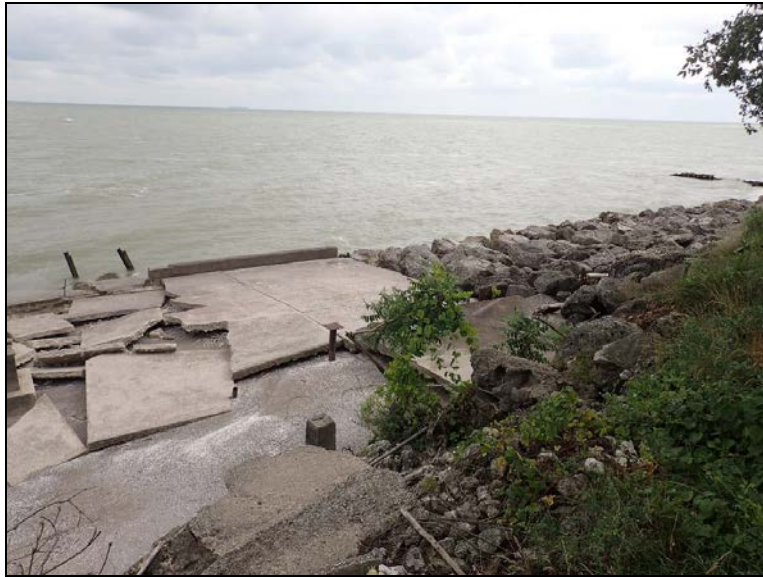
Inspect ID: OH29_2018_p_0040 **Title:** USACE_CELRB_OH29_2018_p_0040_3.jpg
Rated Item: 13. Revetments other than Riprap **Caption:** Rating: Minimally Acceptable;
Remarks: Deteriorated concrete revetment on waterside of levee, shown on As-Built Sheet 9 of 28 on Drawing Number 86-RBP-1/9, is incorporated into the project. The failing concrete is starting to expose the toe of the waterside slope.; **Action:** Repair concrete revetment or replace with suitable material to protect levee.

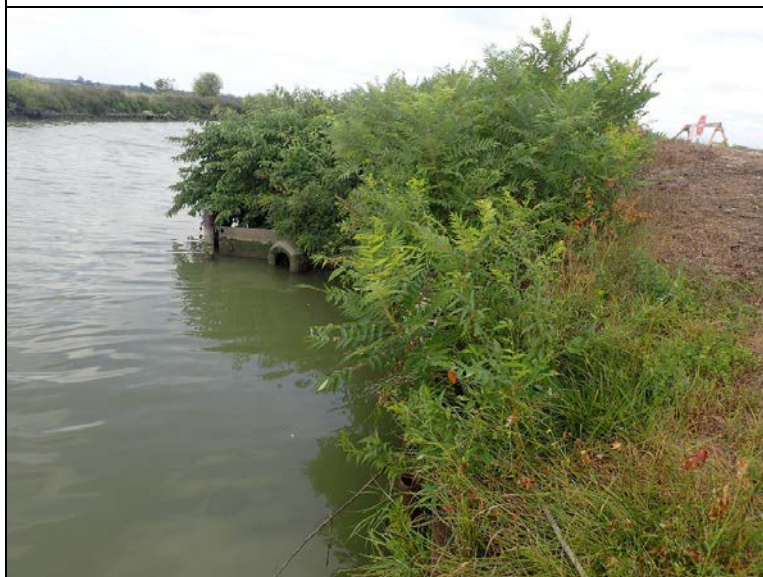
Inspect ID: OH29_2018_p_0102 **Title:** USACE_CELRB_OH29_2018_p_0102_1.jpg
Rated Item: 13. Revetments other than Riprap **Caption:** Rating: Minimally Acceptable;
Remarks: Failing SSP wall bulkheading along Ward's Canal shoreline threatens dike integrity. There is a concrete gravity wall on the waterside slope with unwanted vegetation that appears to be showing signs of tilting.; **Action:** Repair and stabilize bulkheading.

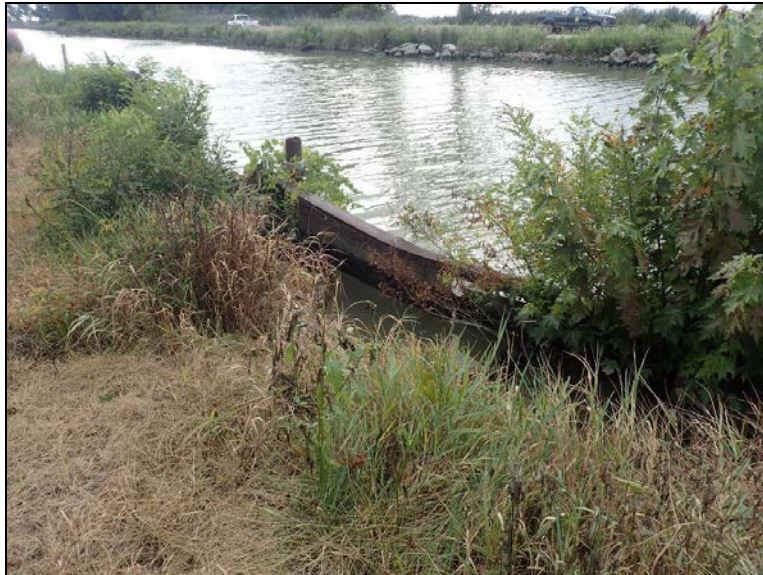
Inspect ID: OH29_2018_p_0102 **Title:** USACE_CELRB_OH29_2018_p_0102_2.jpg
Rated Item: 13. Revetments other than Riprap **Caption:** Rating: Minimally Acceptable;
 Remarks: Failing SSP wall bulkheading along Ward's Canal shoreline threatens dike integrity. There is a concrete gravity wall on the waterside slope with unwanted vegetation that appears to be showing signs of tilting.; Action: Repair and stabilize bulkheading.

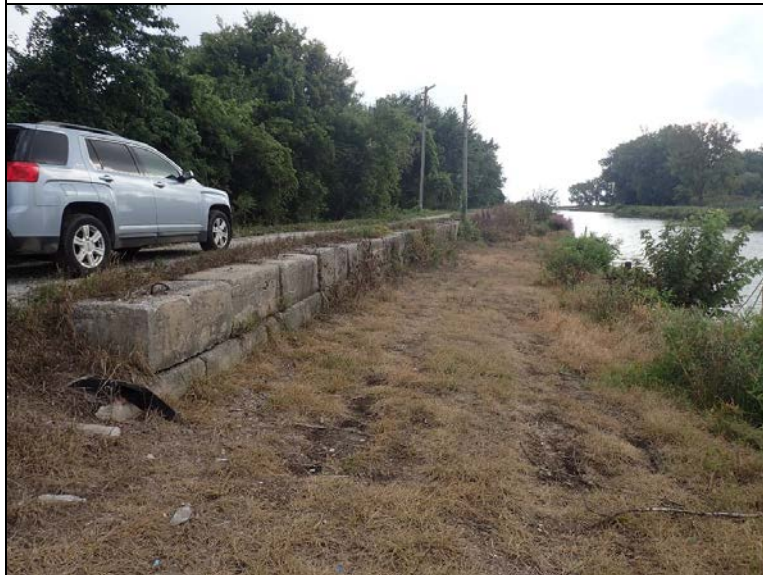
Inspect ID: OH29_2018_p_0102 **Title:** USACE_CELRB_OH29_2018_p_0102_3.jpg
Rated Item: 13. Revetments other than Riprap **Caption:** Rating: Minimally Acceptable;
 Remarks: Failing SSP wall bulkheading along Ward's Canal shoreline threatens dike integrity. There is a concrete gravity wall on the waterside slope with unwanted vegetation that appears to be showing signs of tilting.; Action: Repair and stabilize bulkheading.

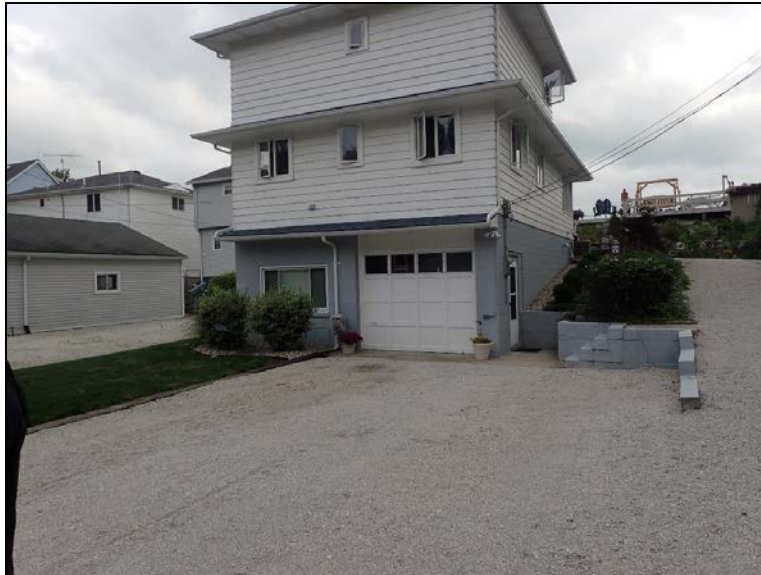
Inspect ID: OH29_2018_p_0019 **Title:** USACE_CELRB_OH29_2018_p_0019_1.jpg
Rated Item: 15. Seepage **Caption:** Rating: Minimally Acceptable; Remarks: Residents and Conservancy District indicate seepage for group of residential homes along Lagoon Drive.; Action: Coordinate with USACE to mitigate seepage.

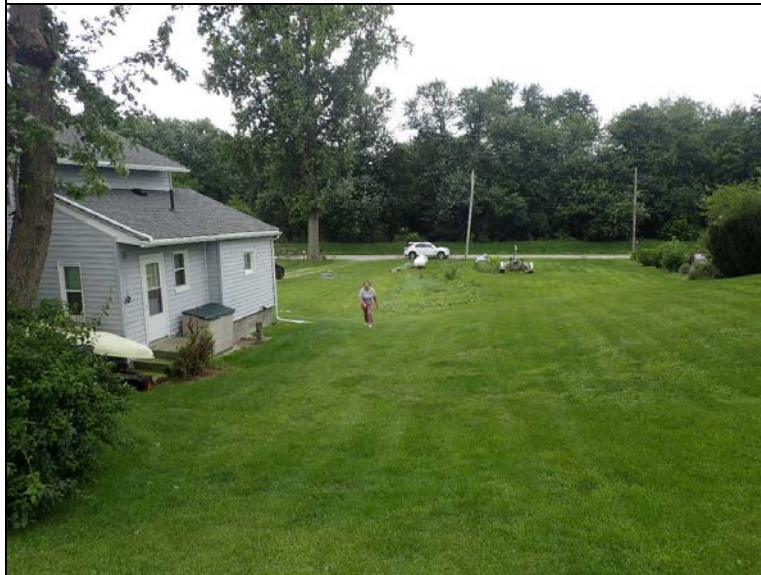
Inspect ID: OH29_2018_p_0022 **Title:** USACE_CELRB_OH29_2018_p_0022_1.jpg
Rated Item: 15. Seepage **Caption:** Rating: Minimally Acceptable; Remarks: Residents and Conservancy District indicate seepage between two residential homes along Lagoon Drive.; Action: Coordinate with USACE to mitigate seepage.

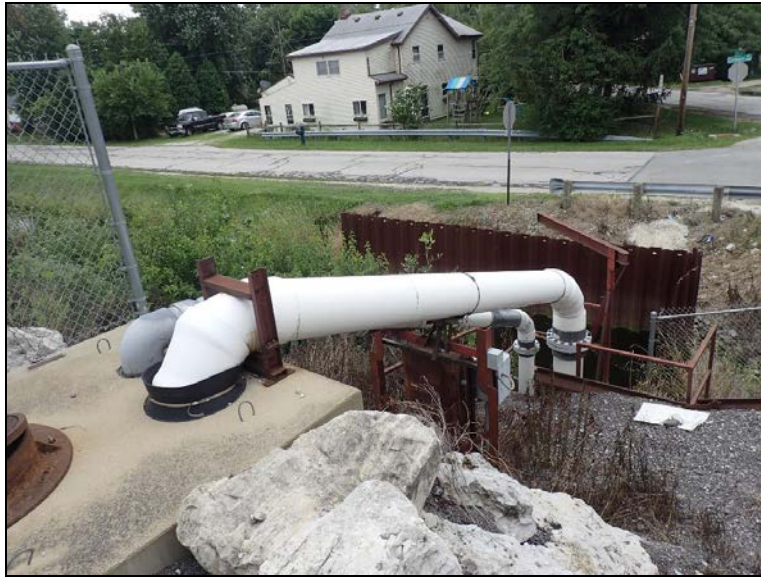
Inspect ID: OH29_2018_p_0042 **Title:** USACE_CELRB_OH29_2018_p_0042_1.jpg
Rated Item: 1. Pump Stations Operating, Maintenance, Training, & Inspection Records
Caption: Rating: Acceptable; Remarks: Project Pump Station at east end of Dyke Road. Records of operation are tracked hourly. 150-200 million gallons per year. Pump Station exercised during inspection. ; Action: NA

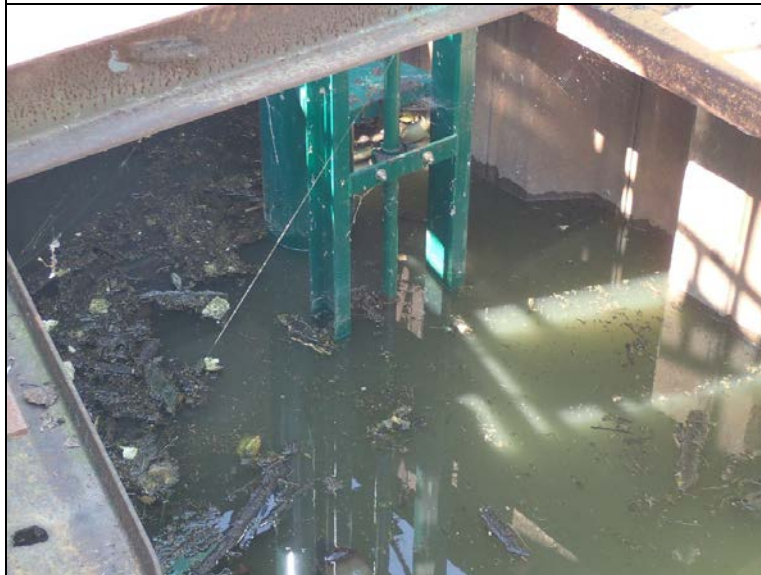
Inspect ID: OH29_2018_p_0101 **Title:** USACE_CELRB_OH29_2018_p_0101_1.jpg
Rated Item: 7. Pumps **Caption:** Rating: Acceptable; Remarks: Cooley Canal Pump Station in adequate condition.; Action: NA

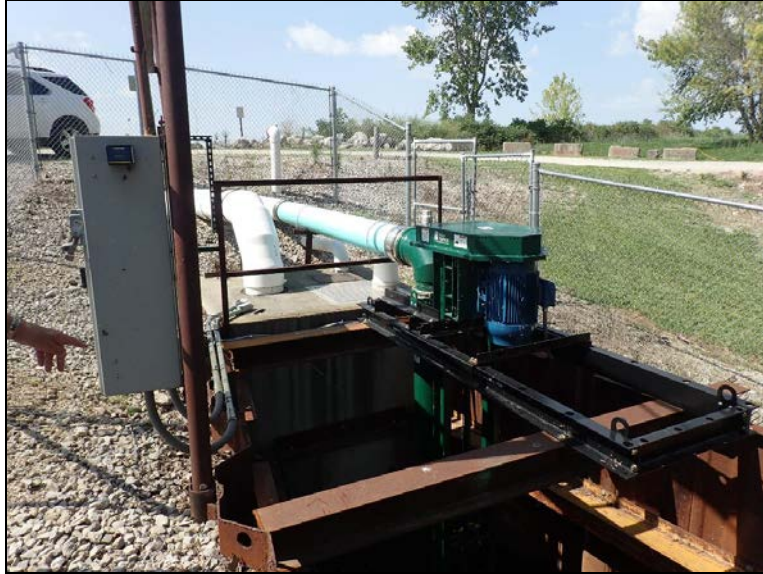
Inspect ID: OH29_2018_p_0101 **Title:** USACE_CELRB_OH29_2018_p_0101_2.jpg
Rated Item: 7. Pumps **Caption:** Rating: Acceptable; Remarks: Cooley Canal Pump Station in adequate condition.; Action: NA

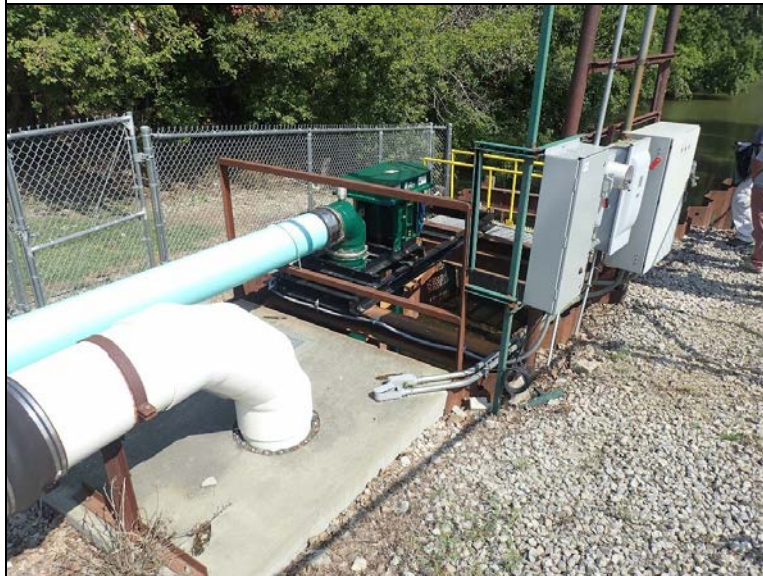
Inspect ID: OH29_2018_p_0101 **Title:** USACE_CELRB_OH29_2018_p_0101_3.jpg
Rated Item: 7. Pumps **Caption:** Rating: Acceptable; Remarks: Cooley Canal Pump Station in adequate condition.; Action: NA

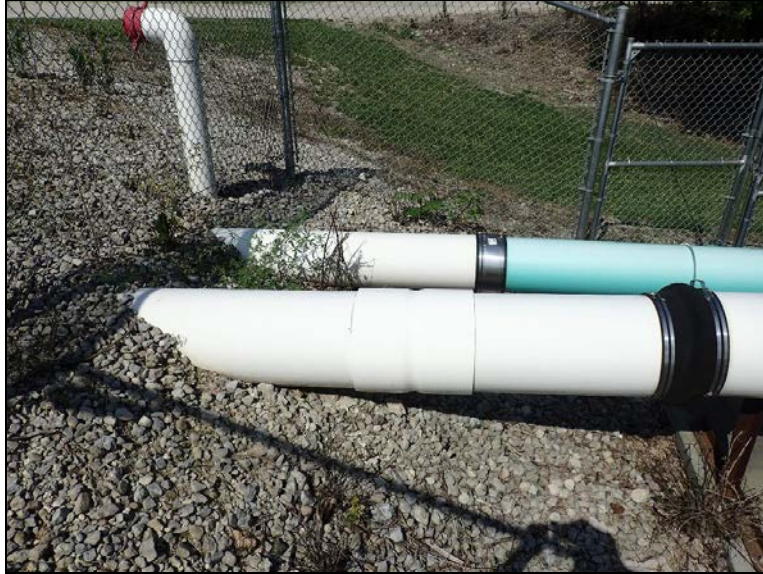
Inspect ID: OH29_2018_p_0101 **Title:** USACE_CELRB_OH29_2018_p_0101_4.jpg
Rated Item: 7. Pumps **Caption:** Rating: Acceptable; Remarks: Cooley Canal Pump Station in adequate condition.; Action: NA

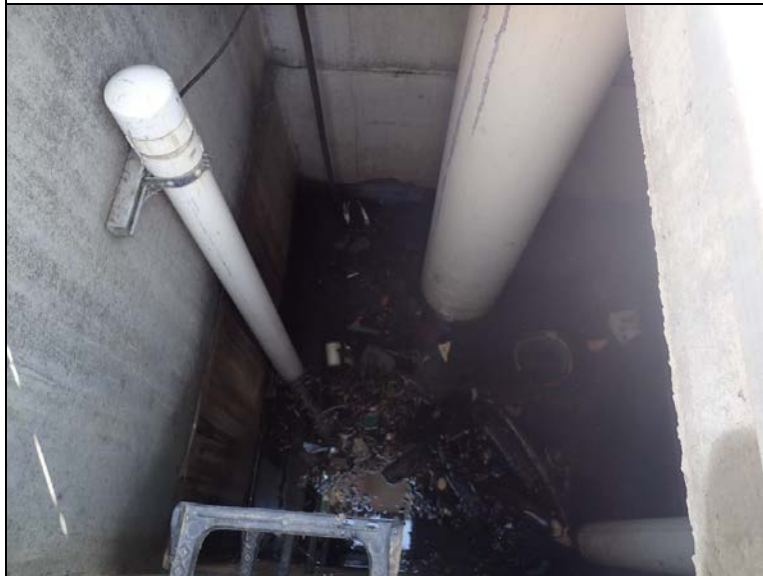
Inspect ID: OH29_2018_p_0101 **Title:** USACE_CELRB_OH29_2018_p_0101_5.jpg
Rated Item: 7. Pumps **Caption:** Rating: Acceptable; Remarks: Cooley Canal Pump Station in adequate condition.; Action: NA

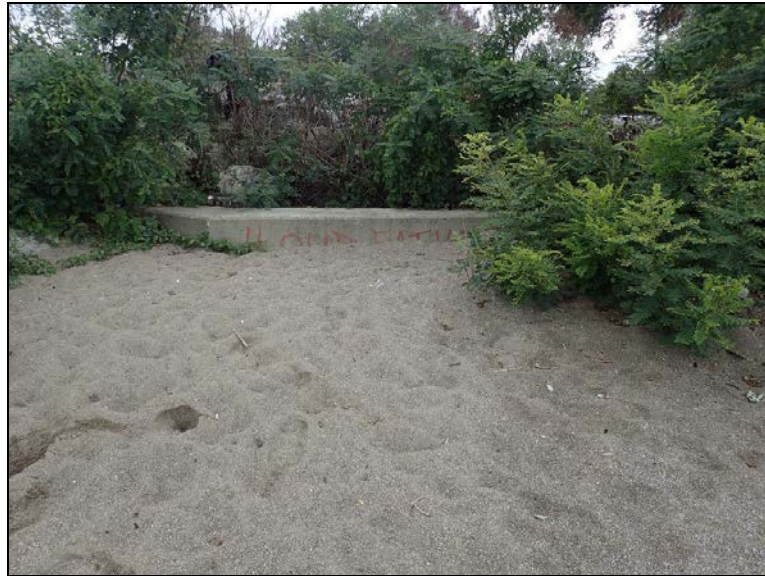
17. Intake and Discharge Pipelines	NA	A	Intake and discharge pipelines have no corrosion and paint is intact, except for minor touch up required. Pipe couplings and anchors have no leakage or corrosion.	OH29_2018_p_0043: Station_1 63+15: Discharge pipe for pump station completely shoaled in. Sponsor digs out sand with shovel. Typically clears out during operation but could be serious issue. Headwall appears to be installed backwards. 2 pumps: big and small. 24" outfall pipe.: NA (A) OH29_2018_p_0099: Station_1 154+44: Cooley Canal Pump Station Outfall in acceptable condition.: Perform videotape inspection. (A) OH29_2018_p_0100: Station_1 154+44: Cooley Canal Pump Station intake in acceptable condition.: NA (A)
		M	Intake and discharge pipelines have minor corrosion and repair and painting is required. Pipe coupling with anchors have minor leakage, corrosion and require bolts to be tightened.

Inspect ID: OH29_2018_p_0043 **Title:** USACE_CELRB_OH29_2018_p_0043_1.jpg
Rated Item: 17. Intake and Discharge Pipelines **Caption:** Rating: Acceptable; Remarks: Discharge pipe for pump station completely shoaled in. Sponsor digs out sand with shovel. Typically clears out during operation but could be serious issue. Headwall appears to be installed backwards. 2 pumps: big and small. 24" outfall pipe. ; Action: NA

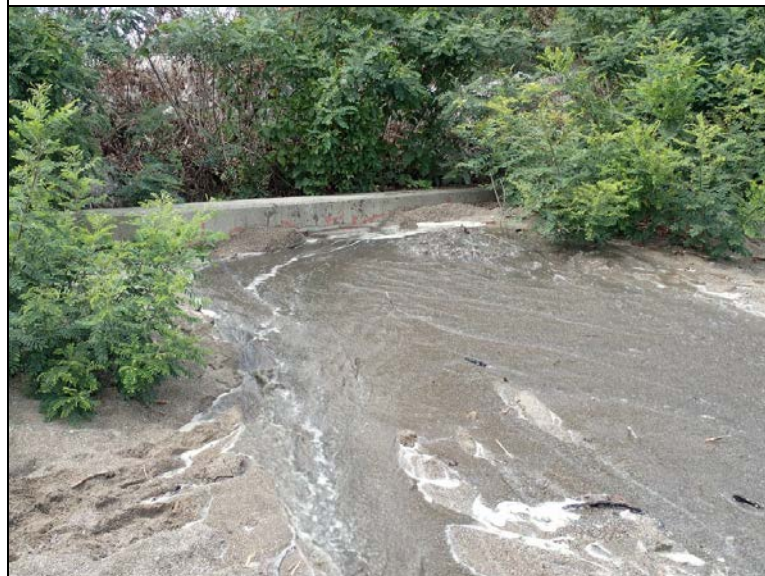
Inspect ID: OH29_2018_p_0043 **Title:** USACE_CELRB_OH29_2018_p_0043_2.jpg
Rated Item: 17. Intake and Discharge Pipelines **Caption:** Rating: Acceptable; Remarks: Discharge pipe for pump station completely shoaled in. Sponsor digs out sand with shovel. Typically clears out during operation but could be serious issue. Headwall appears to be installed backwards. 2 pumps: big and small. 24" outfall pipe. ; Action: NA

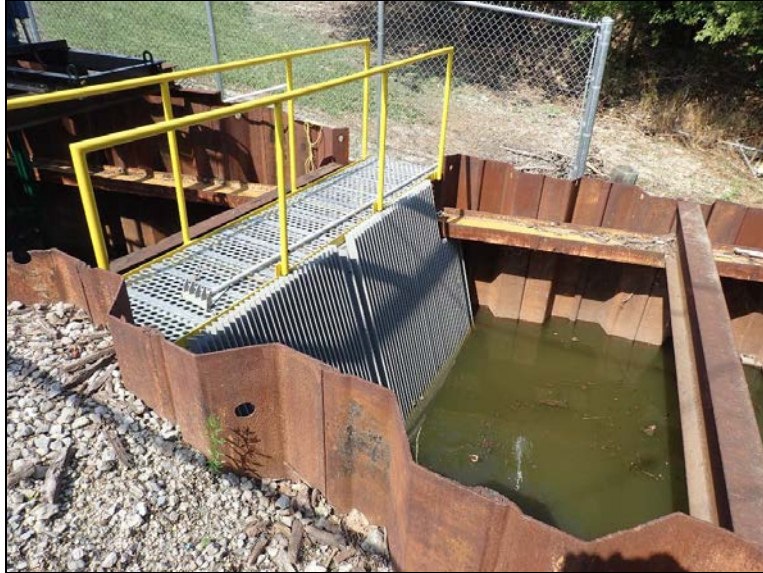
Inspect ID: OH29_2018_p_0099 **Title:** USACE_CELRB_OH29_2018_p_0099_1.jpg
Rated Item: 17. Intake and Discharge Pipelines **Caption:** Rating: Acceptable; Remarks: Cooley Canal Pump Station Outfall in acceptable condition.; Action: Perform videotape inspection.

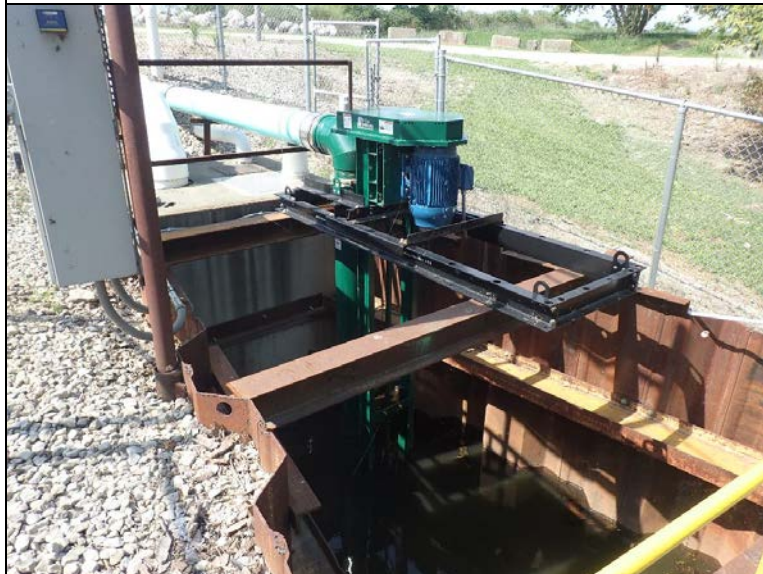
Inspect ID: OH29_2018_p_0099 **Title:** USACE_CELRB_OH29_2018_p_0099_2.jpg
Rated Item: 17. Intake and Discharge Pipelines **Caption:** Rating: Acceptable; Remarks: Cooley Canal Pump Station Outfall in acceptable condition.; Action: Perform videotape inspection.

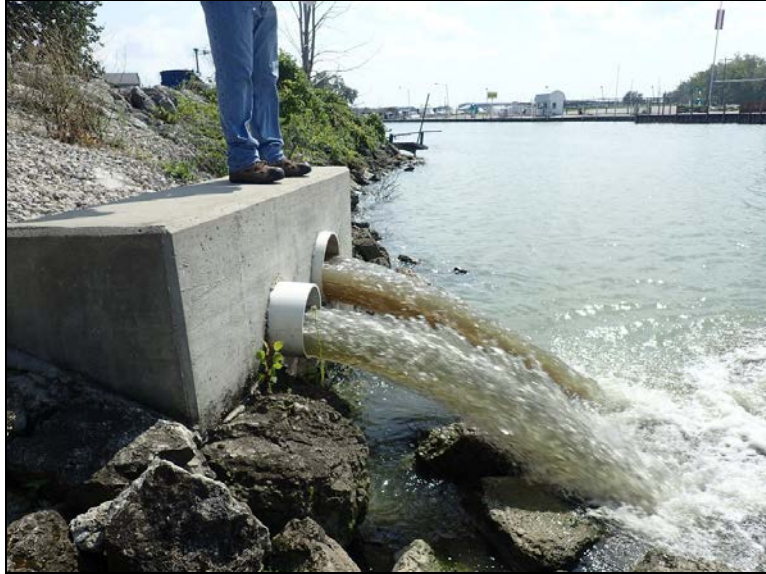
Inspect ID: OH29_2018_p_0100 **Title:** USACE_CELRB_OH29_2018_p_0100_1.jpg
Rated Item: 17. Intake and Discharge Pipelines **Caption:** Rating: Acceptable; Remarks:
Cooley Canal Pump Station intake in acceptable condition.; Action: NA
